SITE OBSERVATION FORM: DNV Landslide Risk Assessment
LOCATION: 2391 Carman Place
INSPECTION DATE: (mm/dd/yy) 10/31/05
WEATHER: Raining heavily, heavy rain for several days prior to visit.

Project : DNV Landslide Risk Assessment

Project No. : 0404-002-01

Client: District of North Vancouver

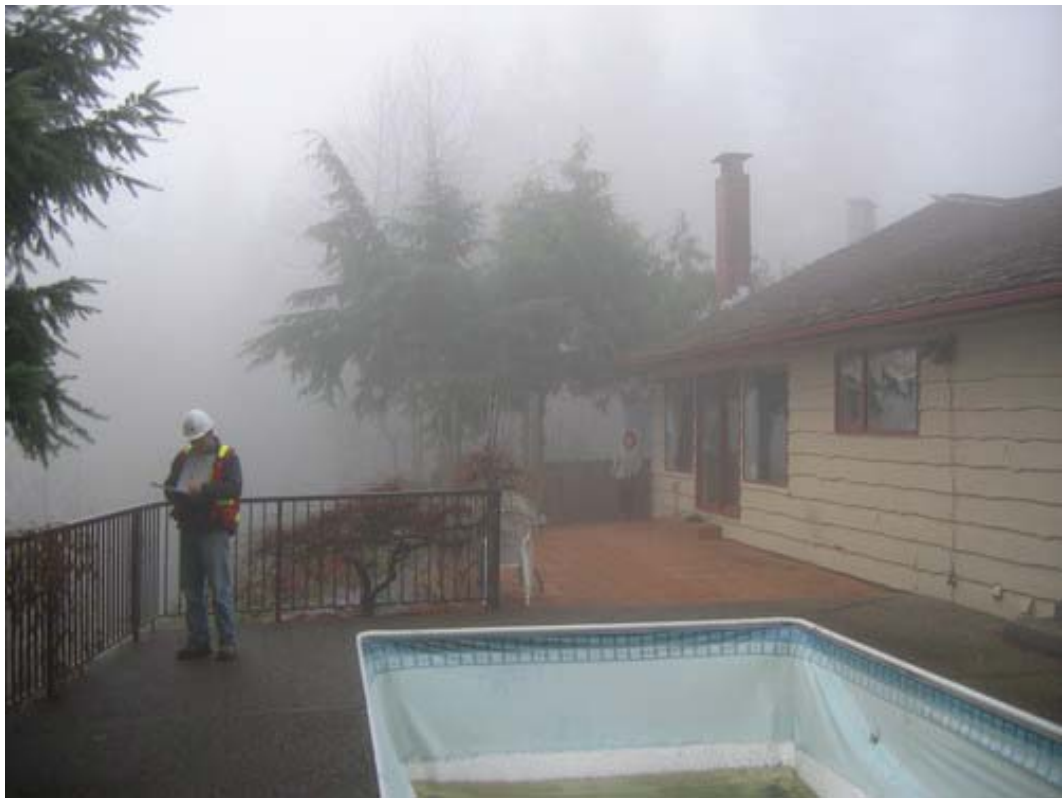
DEFORMATION IN BACKYARD	YES <input checked="" type="checkbox"/>	NO
LOCATION: Patio around pool near crest of slope.		
DESCRIPTION: Tilted patio (cement blocks) around pool on down slope side of pool.

Figure 2. 2391 Carman Place – View of backyard looking west

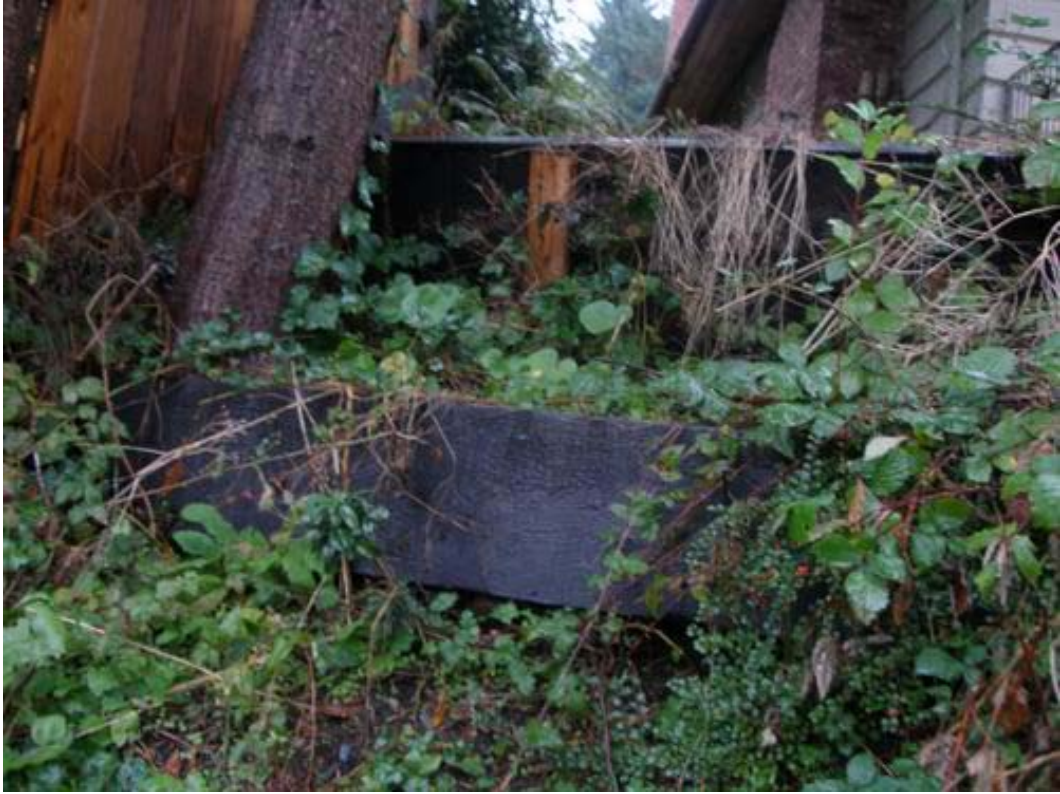
RETAINING STRUCTURES	YES <input checked="" type="checkbox"/>	NO	HEIGHT= 1.5 m
TYPE	CONCRETE <input checked="" type="checkbox"/>	TIMBER CRIB	OTHER: Wooden planks/stumps/PVC/concrete <input checked="" type="checkbox"/>
DEFORMATION	UNDEFORMED	CRACKED	SETTLED
			BULGING <input checked="" type="checkbox"/>
OBSERVATIONS: Wooden planks placed behind stumps at crest of slope. PVC and log retaining structures 15 m down slope are leaning down slope. An undeformed 15 cm thick, 2 m high concrete wall located approximately 18 m down slope from crest.

Figure 3. 2391 Carman Place – Timber retaining wall

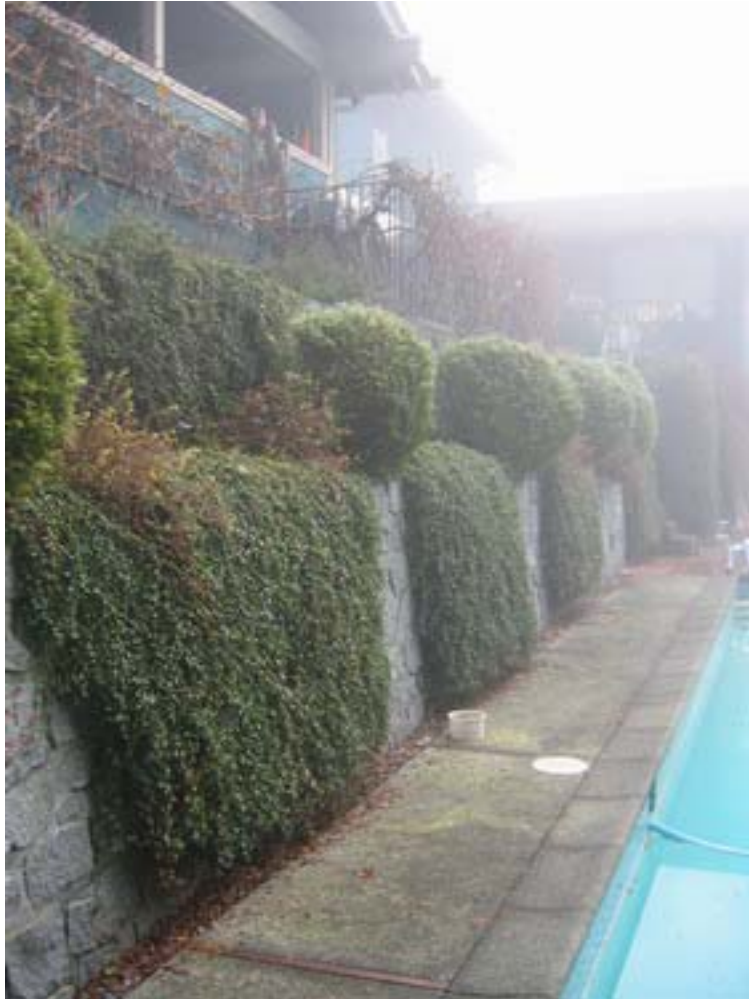
Figure 3. 2379 Carman Place – Concrete and rock retaining wall between the house and pool

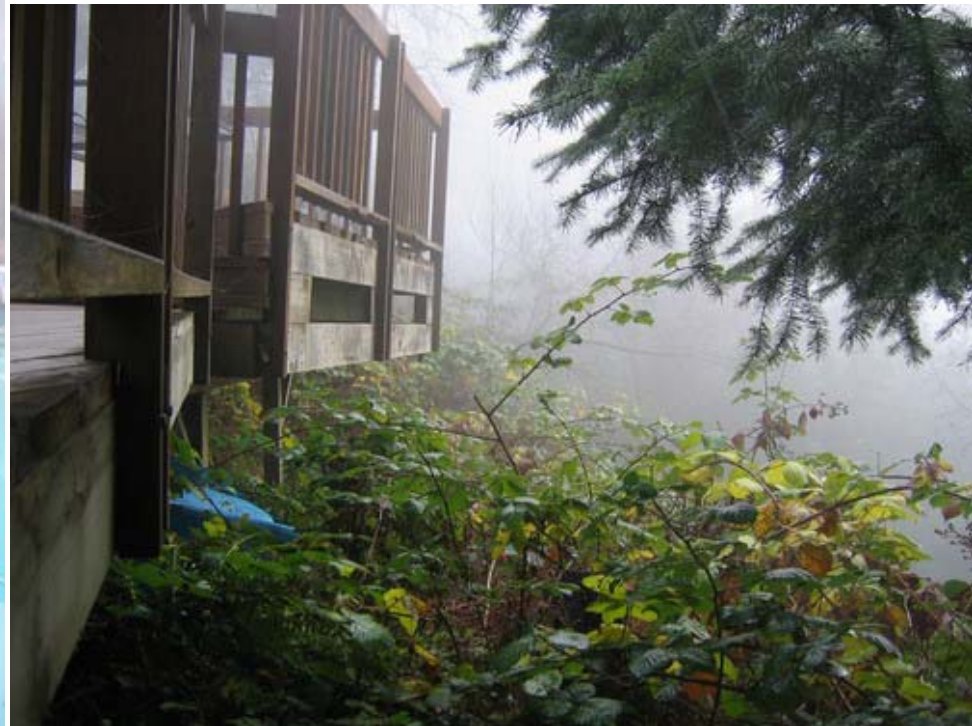
- Site of 1979 slide, slope now covered with deciduous trees.
- South west corner of wooden deck overhangs a portion of the 1979 head scarp, leaking pipe located down slope from deck.
- Auger hole at crest located at the north side of fence line in fill.

Figure 4. 2379 Carman Place – View looking SE along crest

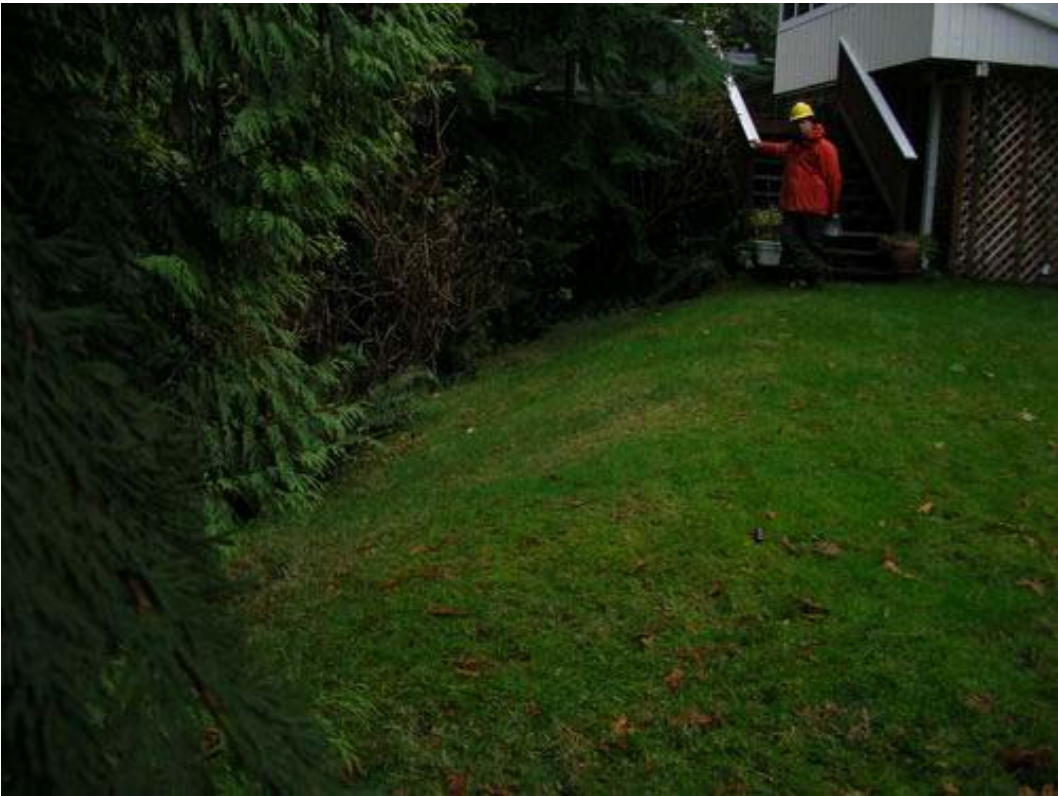
DEFORMATION IN BACKYARD	YES <input checked="" type="checkbox"/>	NO
LOCATION: South west corner of property on lawn at crest of slope.		
DESCRIPTION: Minor slumping or settlement.

Figure 2. 2360 Carman Place – View looking NW along crest

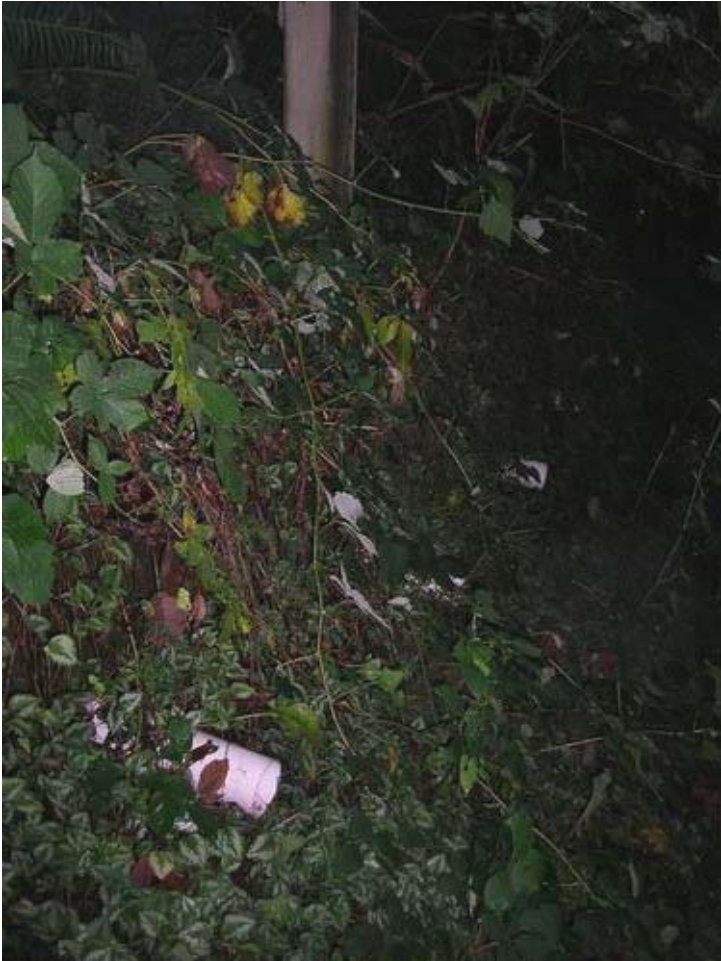
- GENERAL OBSERVATIONS**
- Site of 1979 slide, slope now covered with deciduous trees and dense shrubs.
 - Concrete patio foundations are located 3 m below the crest of the scarp. 3" drains embedded in concrete to dewater the upslope side of the patio foundations. Water exits onto the base of the uppermost head scarp.
 - Appears to be a second smaller scarp approximately 3 m below patio foundation.
 - Eaves are over flowing and draining towards crest.

Figure 3. 2360 Carman Place – Drainage pipe exit on slope

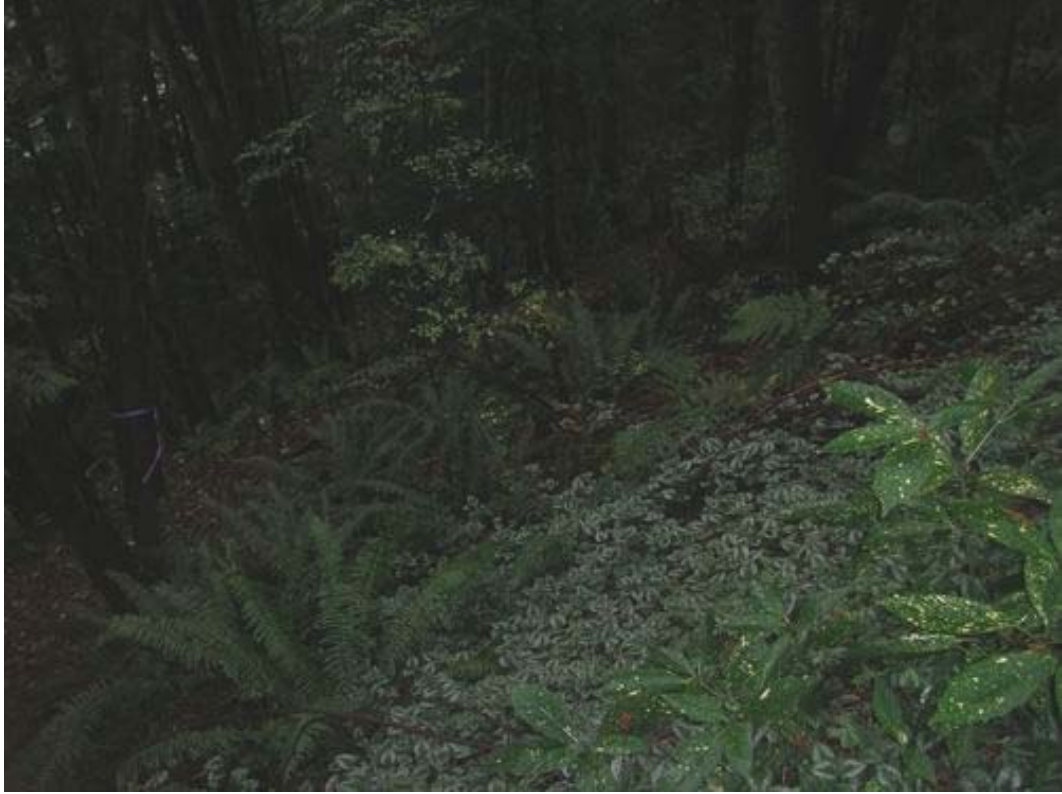
- Garage/bunkhouse located 0-2 m from crest.
- Crest appears natural, rounded; backyard is relatively flat.
- Compost dumped over crest.

Figure 3. 2372 Carman Place – View down-slope from the crest

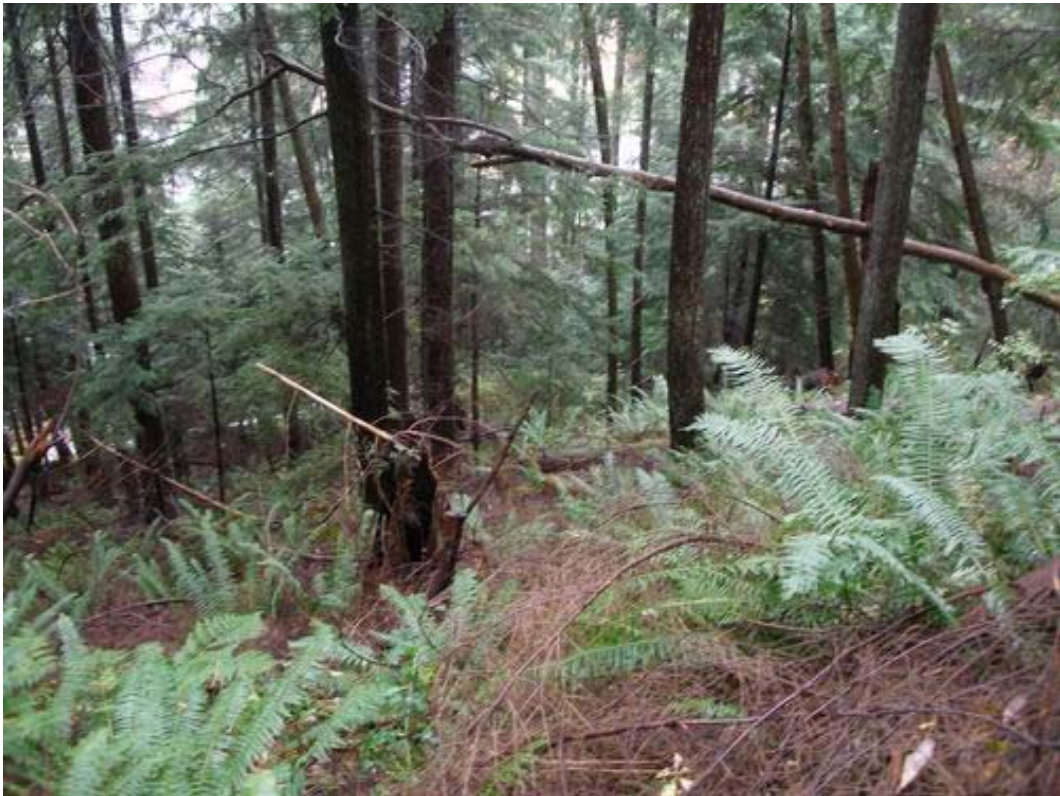
- Occupant notes that vegetation along slope is not as thick as it has always been, and believes the conifers to be dying.
- Occupant notes that soil was scraped off lot and material pushed over slope crest.
- No basement in house.

Figure 4. 2386 Carman Place – View down-slope looking north from west side of crest
