SITE OBSERVATION FORM: DNV Landslide Risk Assessment
LOCATION: 1839 Layton Drive
INSPECTION DATE: (mm/dd/yy) 10/31/05
WEATHER: Raining, heavy rain for several days prior to visit.

Project : DNV Landslide Risk Assessment

Project No. : 0404-002-01

Client: District of North Vancouver

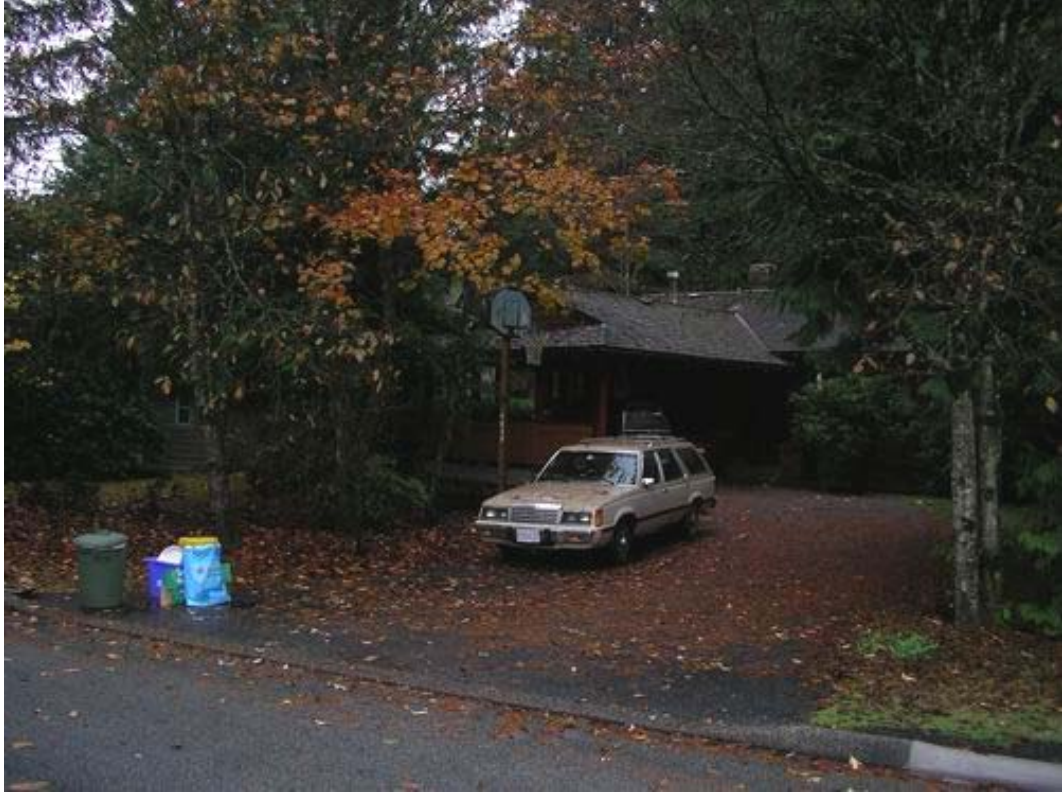
Figure 1. 1839 Layton Drive – Front of the house

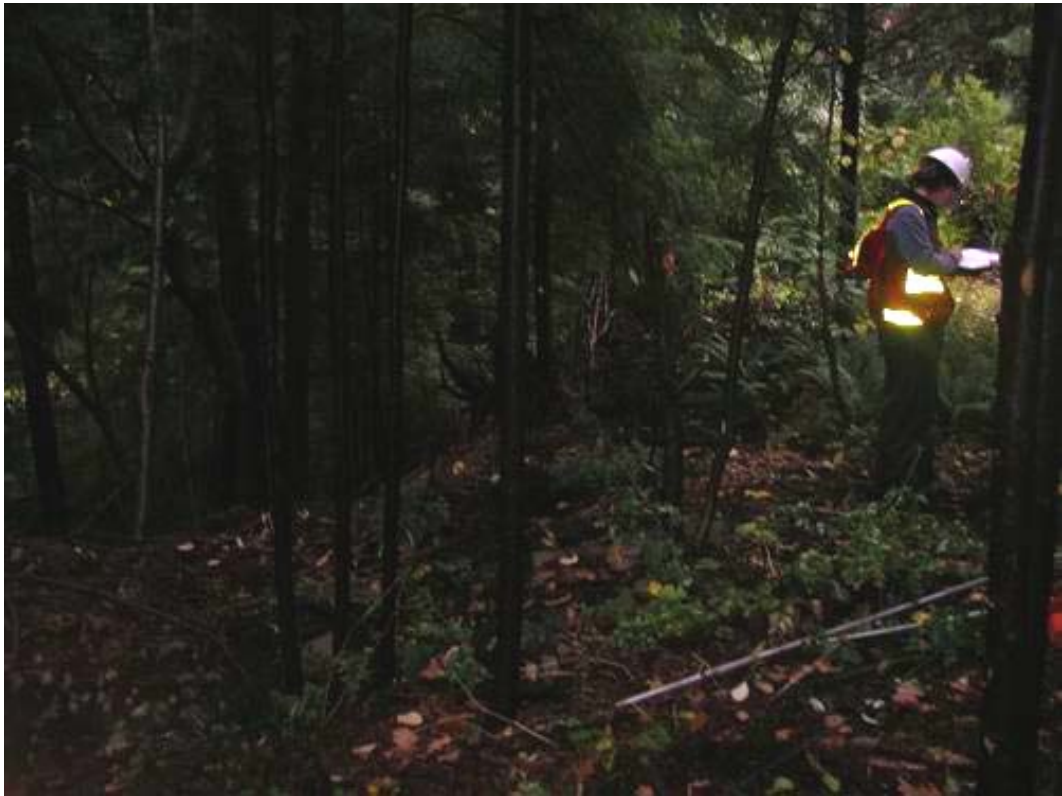
- Oversteepening at crest of slope due to loose, organic compost deposit
- 25m from crest (downslope) 1m vertical outcrop of Sand (SP) med-coarse sand, also found @ 1.2m in downslope hole
- Appears to be very little fill in backyard for levelling purposes

Figure 2. 1839 Layton Drive – View looking north along crest

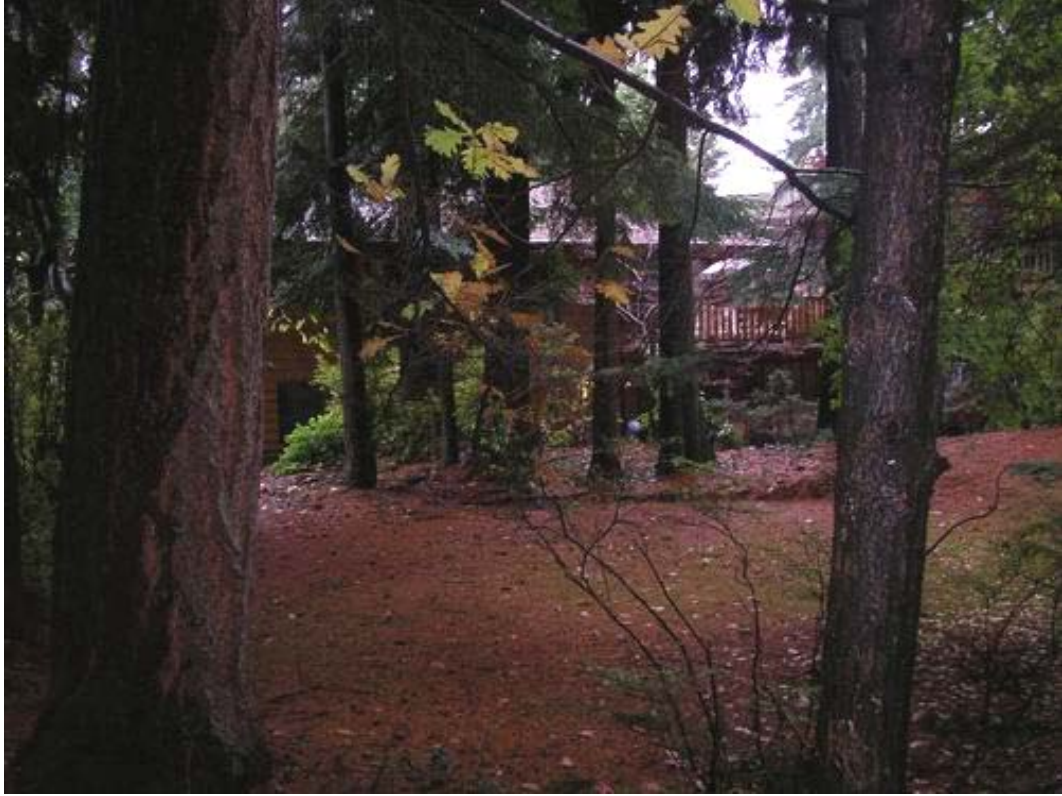
Figure 3. 1839 Layton Drive – View looking SE towards house from crest

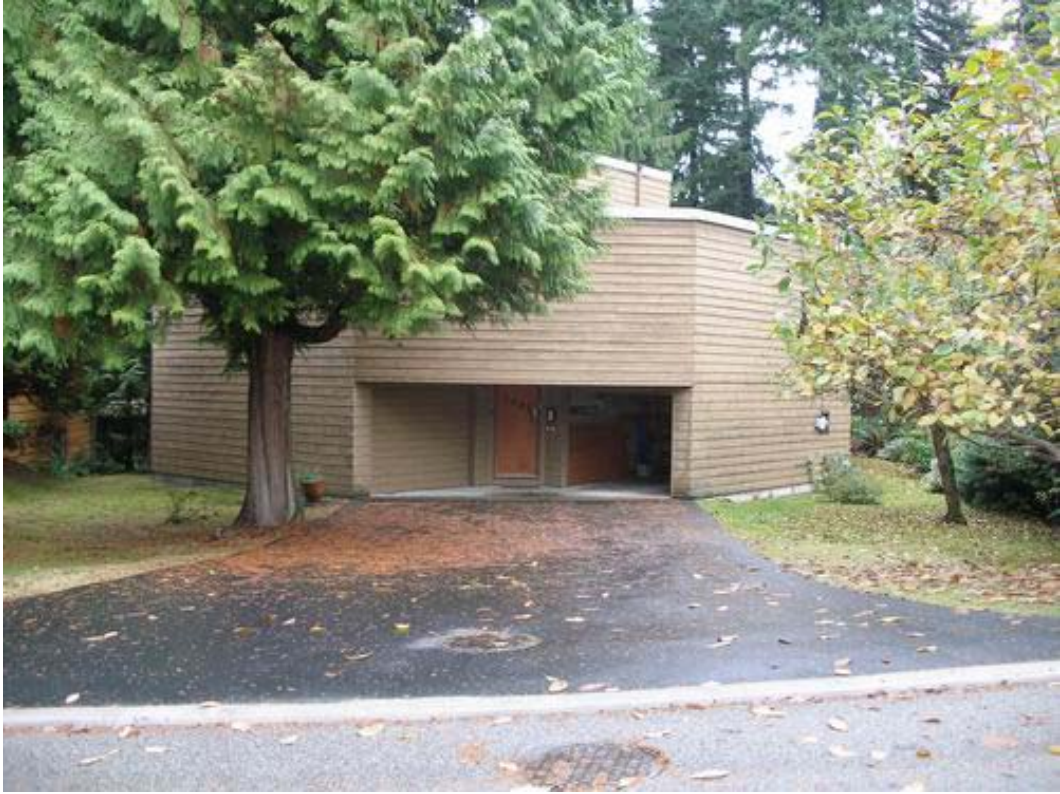
RECEIVES SURFACE RUNOFF FROM	BACKYARD	1/2 ROOF	FULL ROOF	FRONT YARD	STREET
	<input checked="" type="checkbox"/>	<input checked="" type="checkbox"/>	<input checked="" type="checkbox"/>	<input checked="" type="checkbox"/>	<input checked="" type="checkbox"/>
OBSERVATIONS: Storm/high-flow waters could potentially overtop curb and flow around south side of house between the house and berm (against neighbour's house).

Figure 1. 1847 Layton Drive – Front of the house

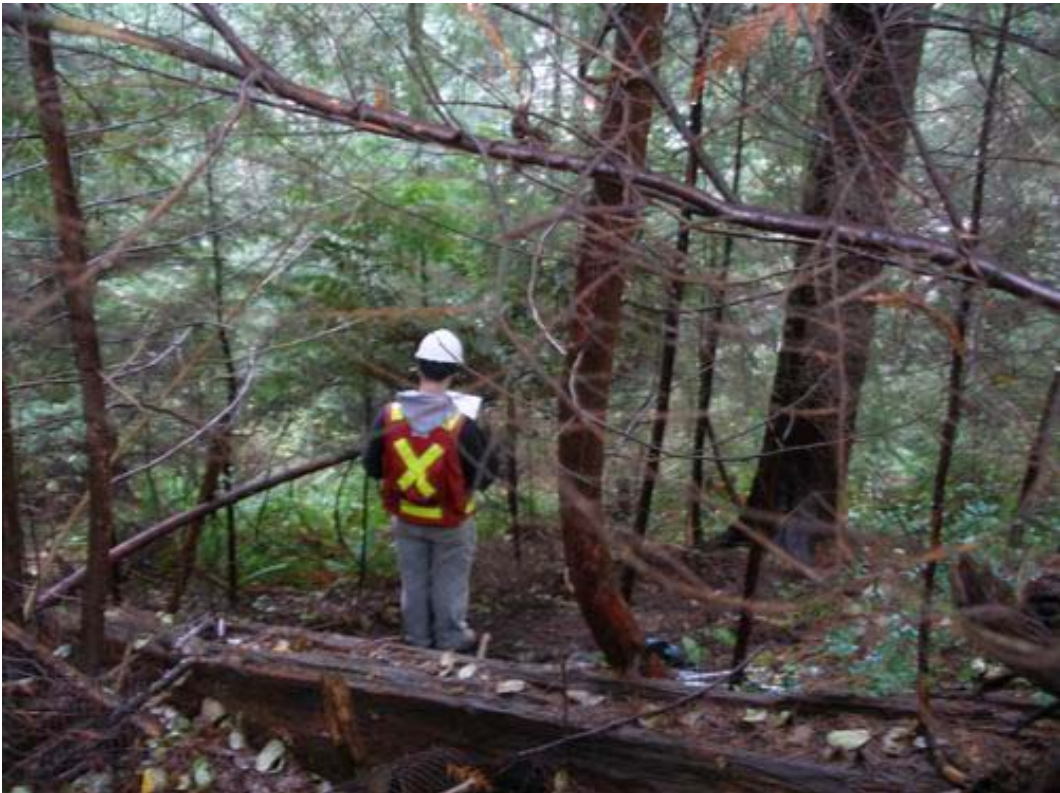
SLOPE BELOW FENCE/ RETAINING STRUCTURE	SLOPE = 31°		
	CRACKS	SLIDES	EROSION
OBSERVATIONS: A few fallen trees, no signs of erosion

Figure 2. 1847 Layton Drive – View looking NW downslope from crest

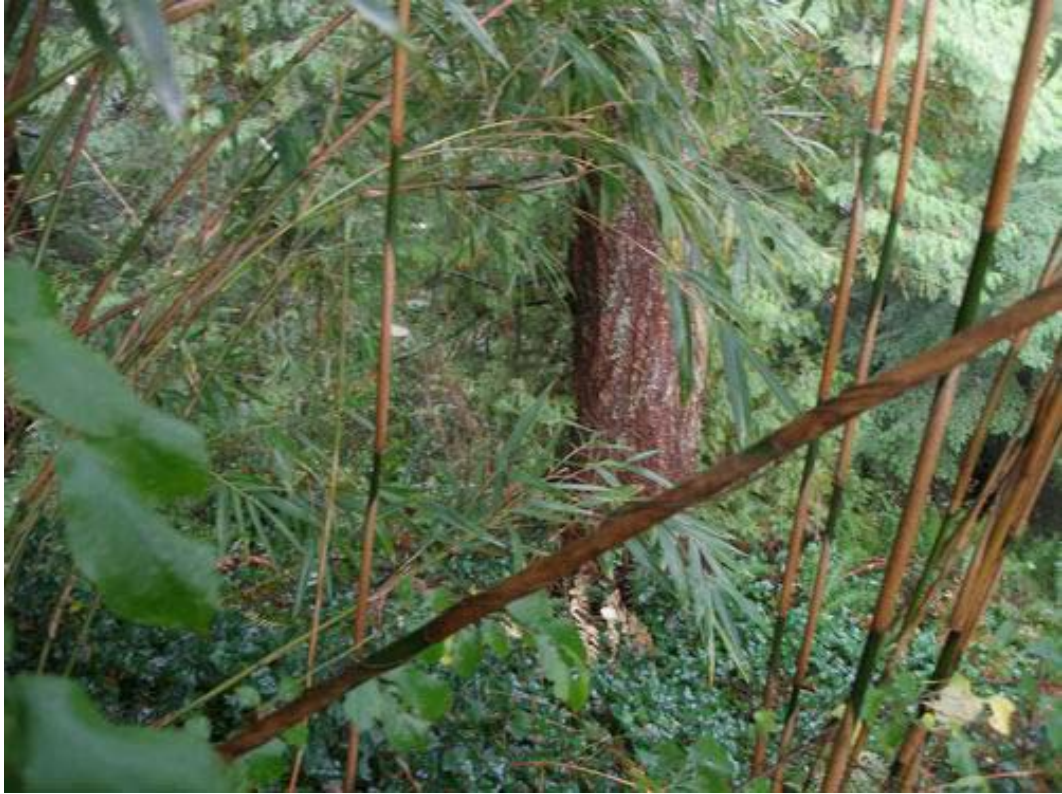
Figure 3. 1847 Layton Drive – View downslope looking west from north side of property

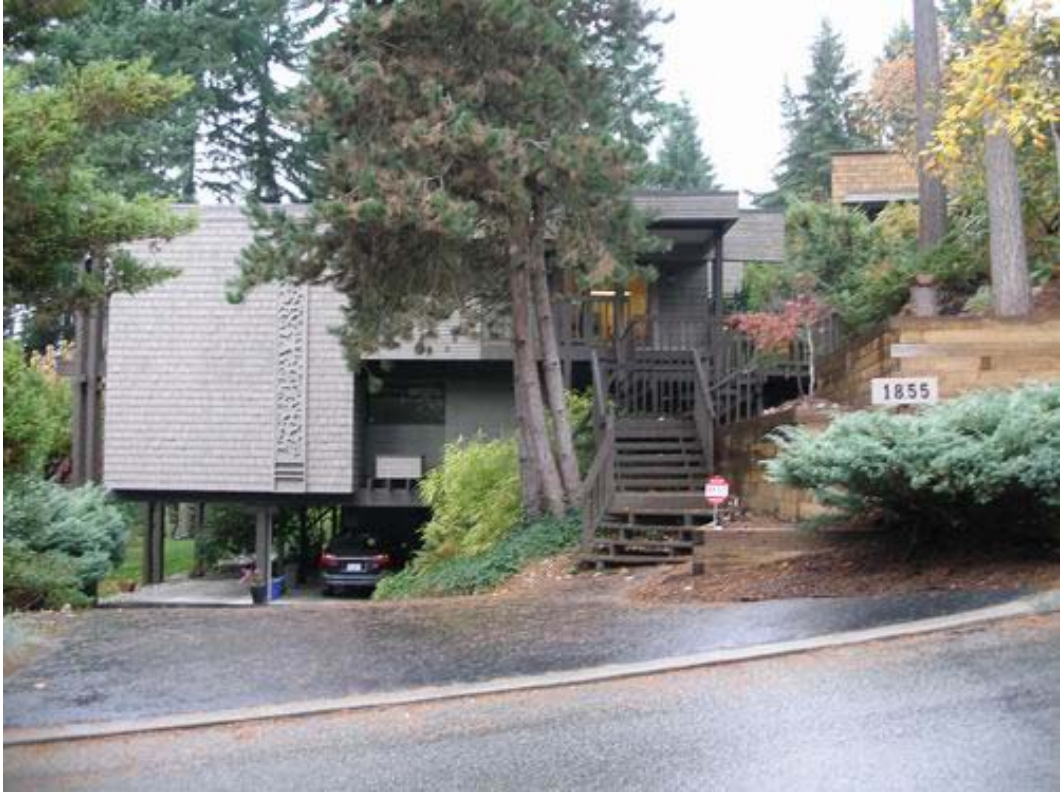
RECEIVES SURFACE RUNOFF FROM	BACKYARD	1/2 ROOF	FULL ROOF	FRONT YARD	STREET
	<input checked="" type="checkbox"/>	<input checked="" type="checkbox"/>	<input checked="" type="checkbox"/>	<input checked="" type="checkbox"/>	<input checked="" type="checkbox"/>
OBSERVATIONS: Frontyard dips away from street towards house. Potential for storm waters to run into yard.

Figure 1. 1855 Layton Drive – Front of the house

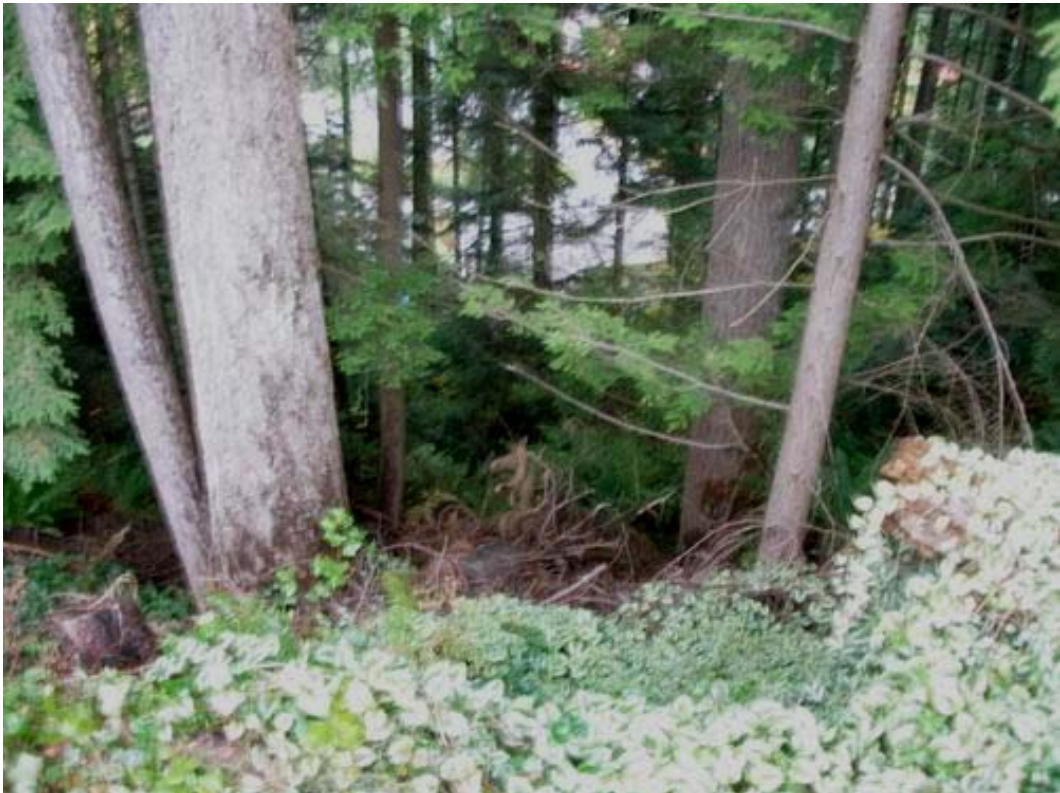
- Many fallen logs on slope

Figure 2. 1855 Layton Drive – View looking NW downslope from crest

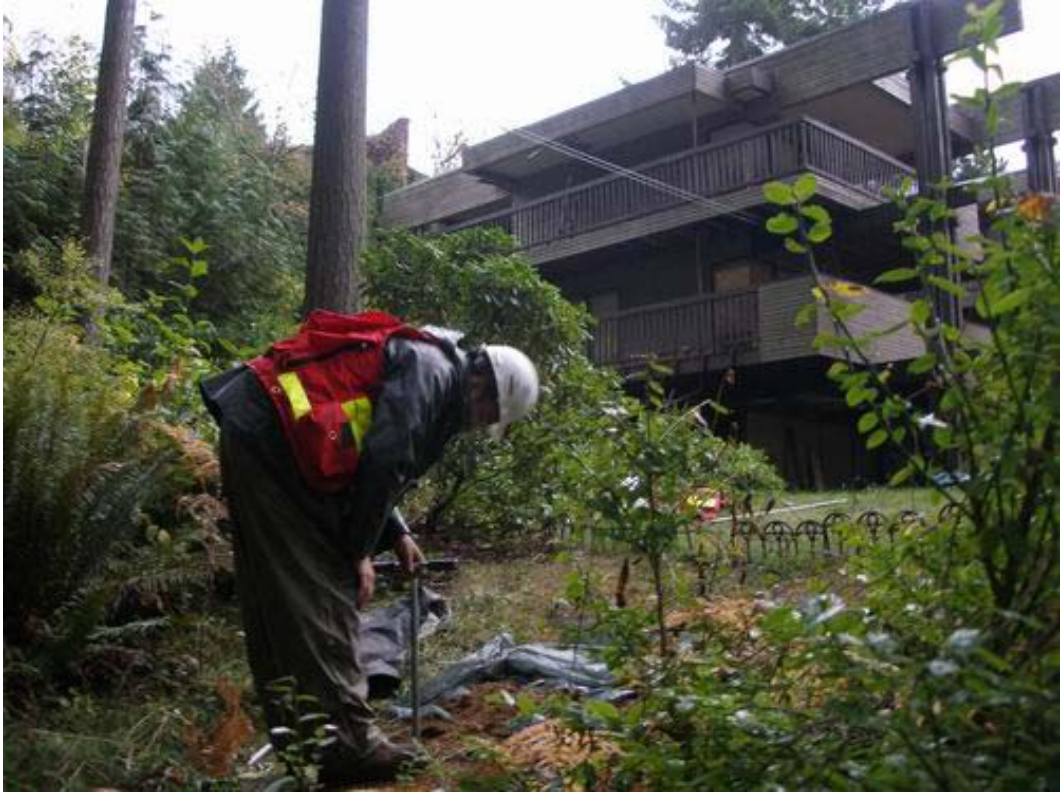
Figure 3. 1855 Layton Drive – Back of the house looking east

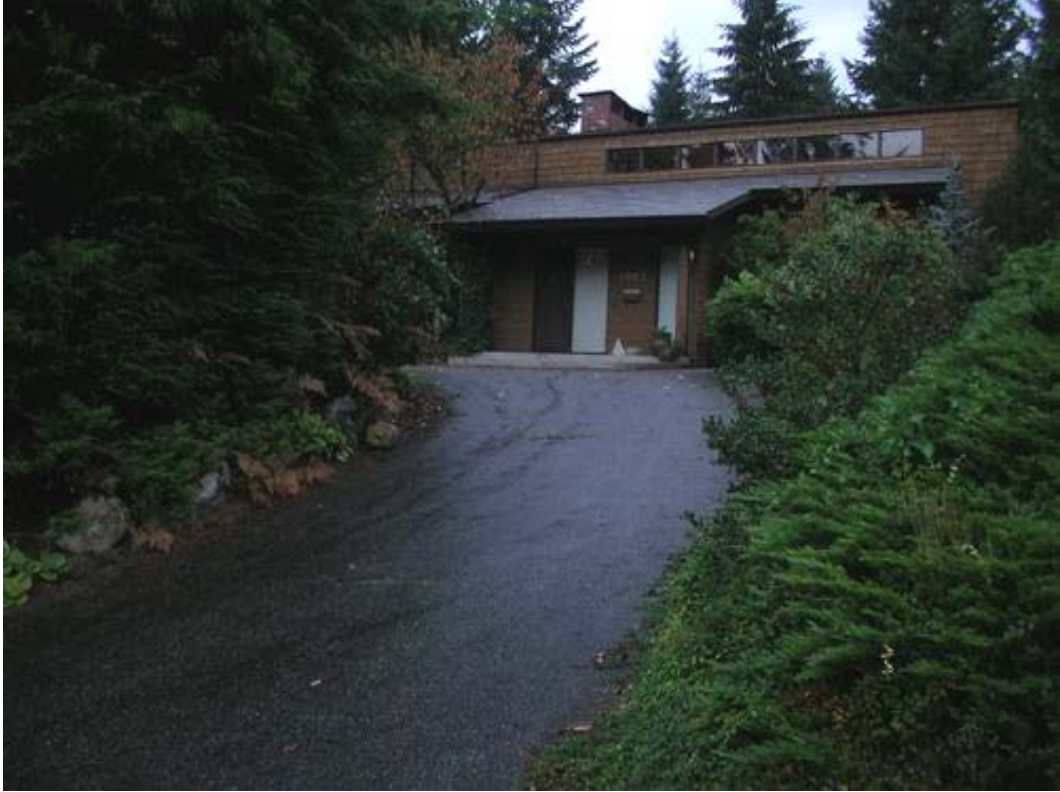
Figure 1. 1863 Layton Drive – Front of the house

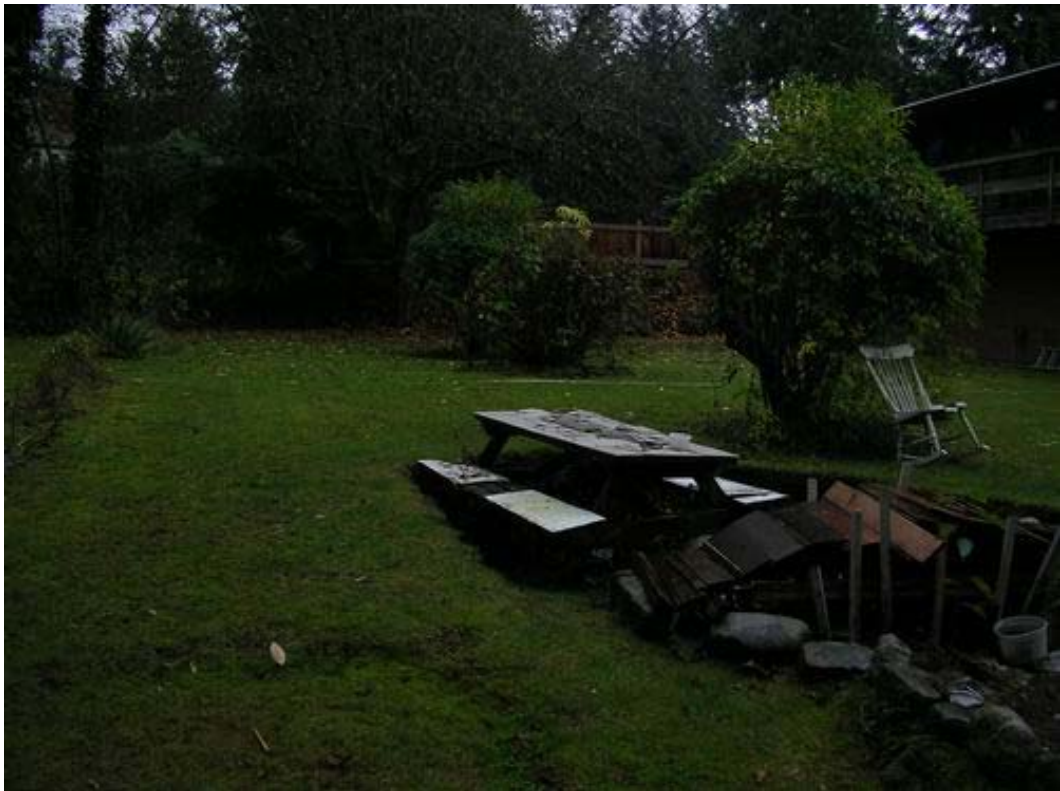
- There is a 3 m high over steepened slope below crest undercut by a trail.
- North east corner of back yard backs onto old gravel pit active in the 1950's
- Crest of slope oversteepened.

Figure 2. 1863 Layton Drive – View of backyard looking NE

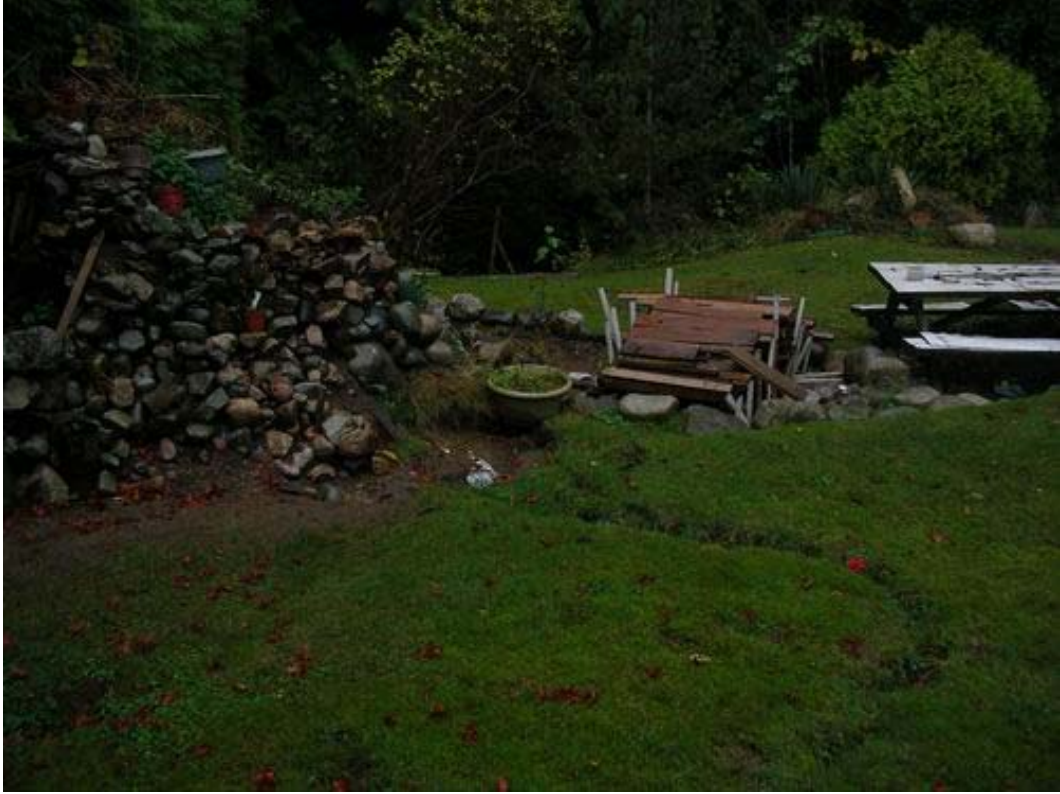
SLOPE BELOW FENCE/ RETAINING STRUCTURE	SLOPE = 42° below crest and 34° below inflection		
	CRACKS	SLIDES	EROSION
OBSERVATIONS: No deformation observed. Crest of slope oversteepened.

RECEIVES SURFACE RUNOFF FROM	BACKYARD <input checked="" type="checkbox"/>	½ ROOF <input checked="" type="checkbox"/>	FULL ROOF <input checked="" type="checkbox"/>	FRONT YARD	STREET
OBSERVATIONS: Roof drain at back of house drains into yard into a hand-dug channel towards the crest of the slope. Front driveway/yard dips steeply toward the street.

Figure 3. 1863 Layton Drive – View of backyard towards slope crest looking NW
