SITE OBSERVATION FORM: DNV Landslide Risk Assessment
LOCATION: Hayseed-Layton Gully
INSPECTION DATE: (mm/dd/yy) 10/28/05
WEATHER: Cloudy with periods of rain

BGC ENGINEERING INC.
 AN APPLIED EARTH SCIENCES COMPANY

Project : DNV Landslide Risk Assessment

Project No. : 0404-002-01

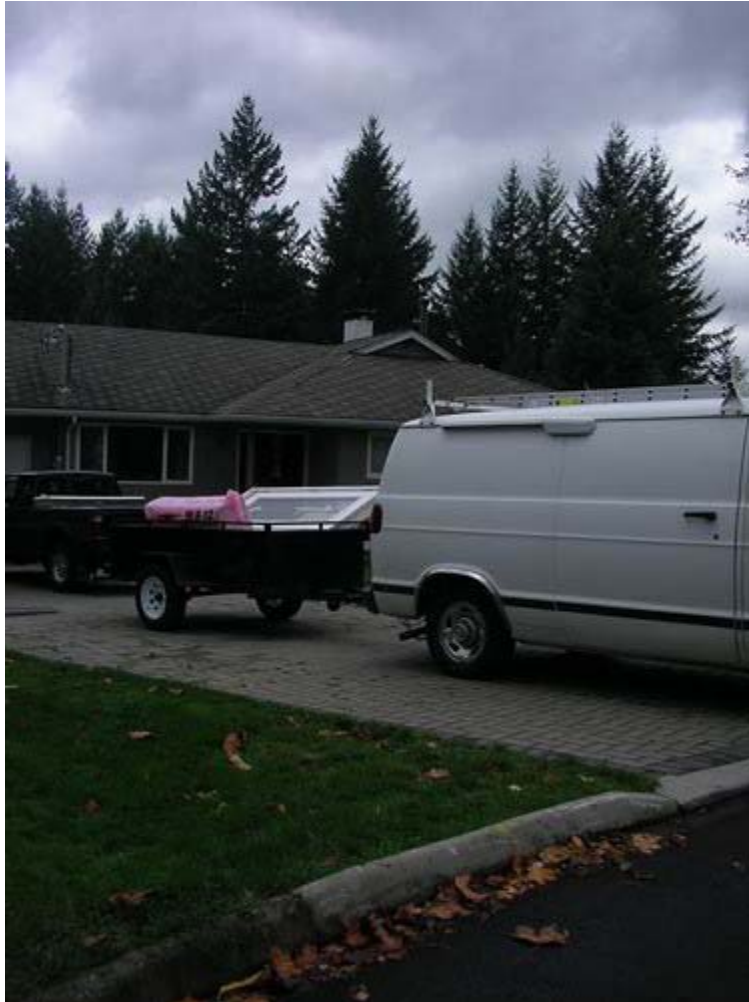
Figure 1. Hayseed-Layton Gully - Front of 2442 Hayseed

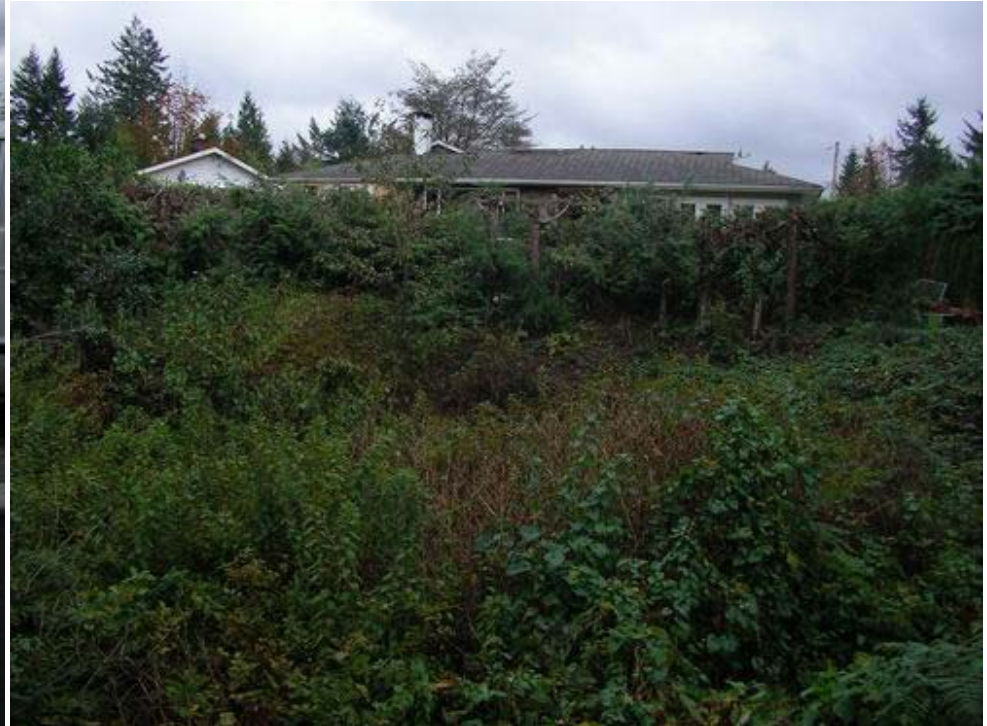
Figure 2. Hayseed-Layton Gully – View of 2442 Hayseed looking north from south side of gravel pit

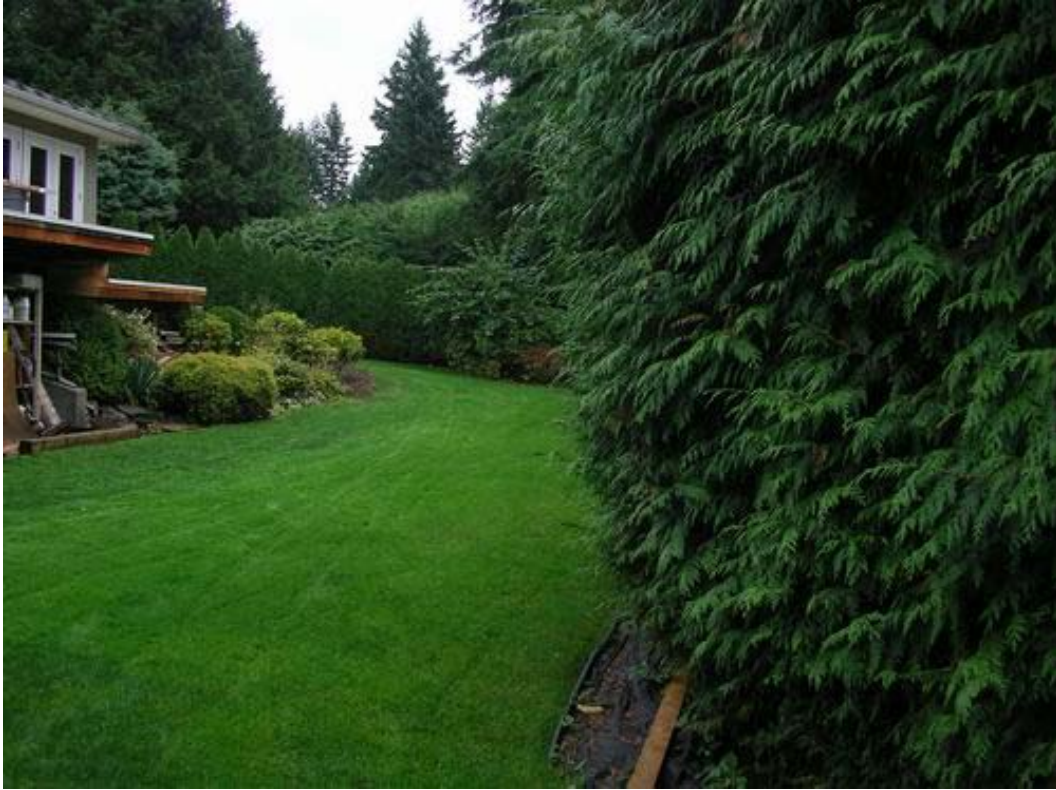
Figure 3. Hayseed-Layton Gully – View looking SE along property line of 2442 Hayseed

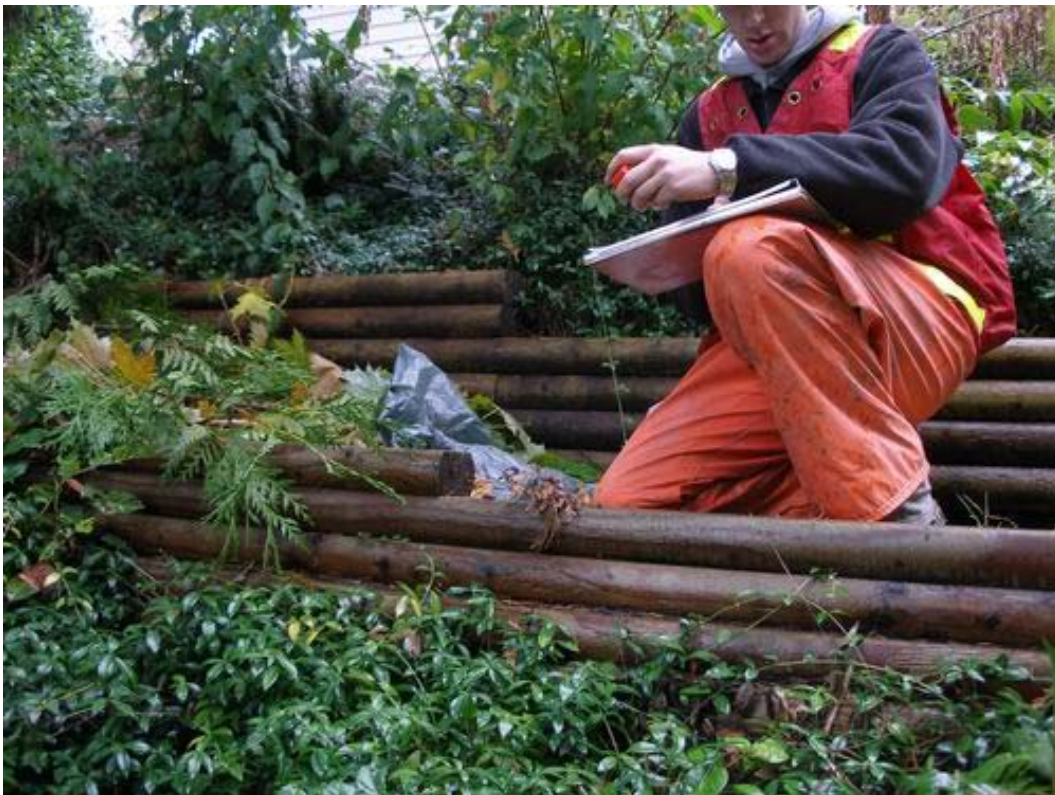
| RETAINING STRUCTURES | YES <input checked="" type="checkbox"/> | NO | HEIGHT= 0.8 m |
|---|---|---|---|
| OBSERVATIONS: No evidence of deformation. | | | |

Figure 2. 2448 Hayseed Close – Timber crib retaining structure

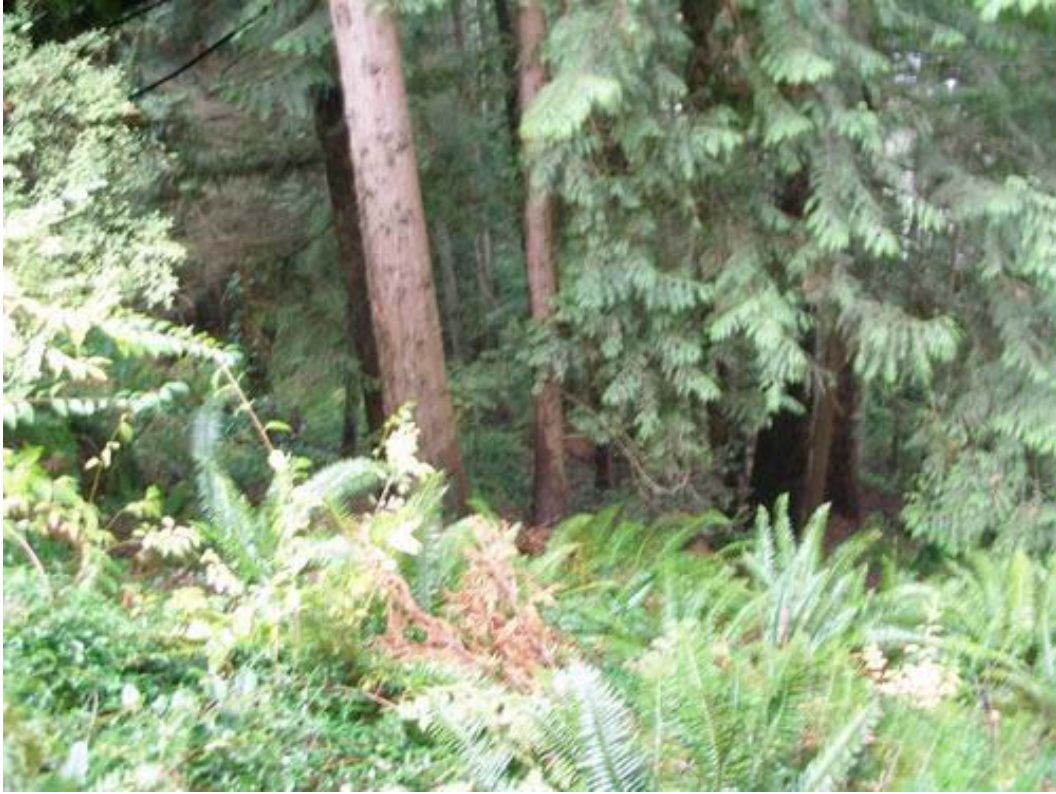
| SLOPE BELOW FENCE/ RETAINING STRUCTURE | SLOPE = 35° | | |
|--|---|---|---|
| OBSERVATIONS: Minor slope erosion observed | | | <input checked="" type="checkbox"/> |

| TREES BELOW FENCE/ RETAINING STRUCTURE | STRAIGHT | PISTOL-BUTT | LEANING |
|--|---|---|---|
| OBSERVATIONS: Slight pistol butting on approximately 50% of trees. | | | |

Figure 3. 2448 Hayseed Close – View down-slope from crest

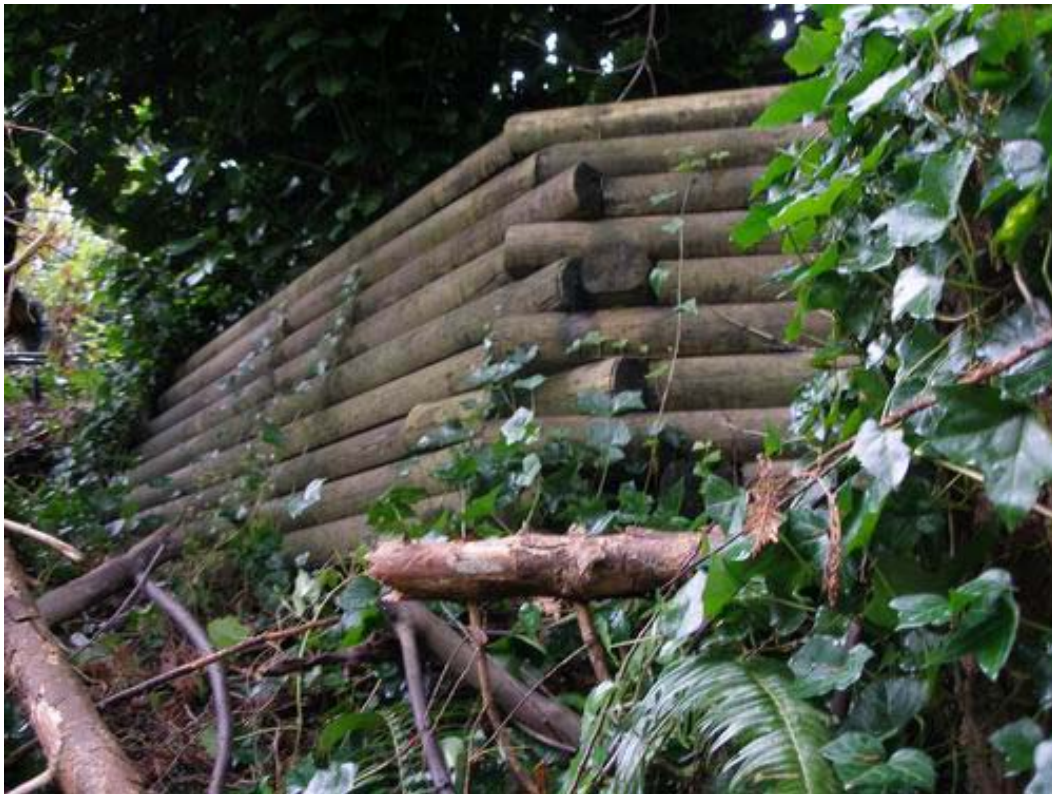
| OBSERVATIONS: Retaining wall consists of 2 steps; both are 1.5m in height. No evidence of deformation. | | | |

Figure 2. 2454 Hayseed Close – Timber crib retaining wall

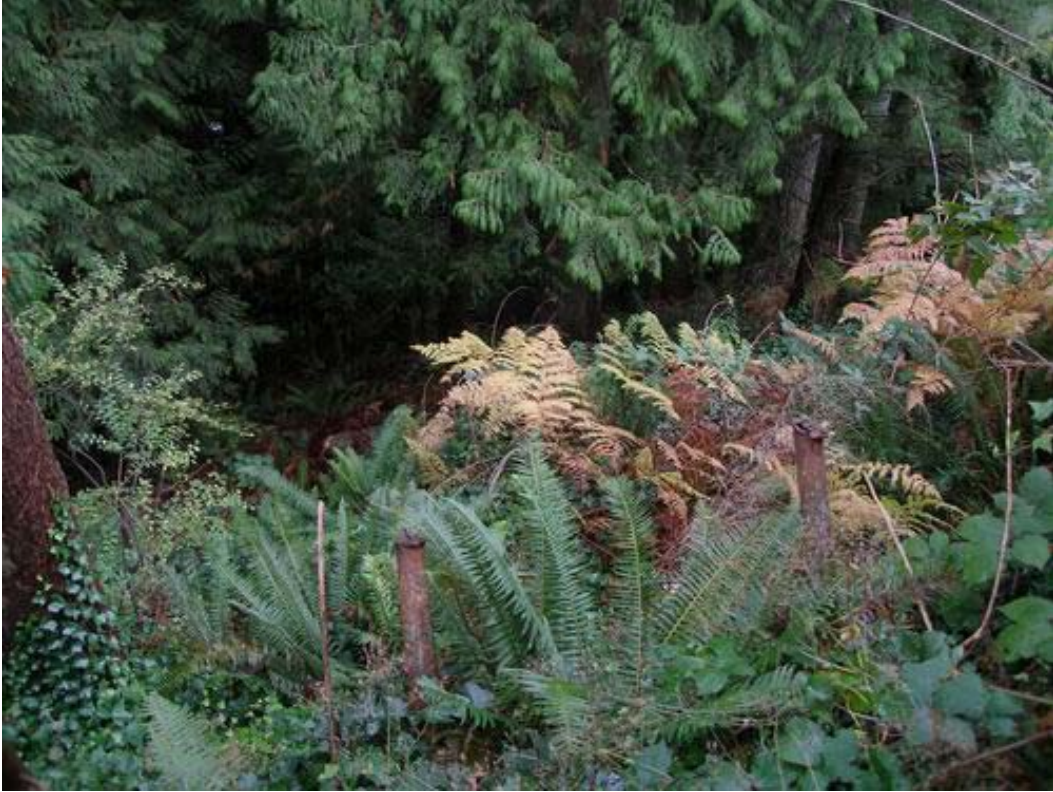
| OBSERVATIONS: Minor slope erosion observed | | | |

Figure 3. 2454 Hayseed Close – View down-slope from south side of property looking NW

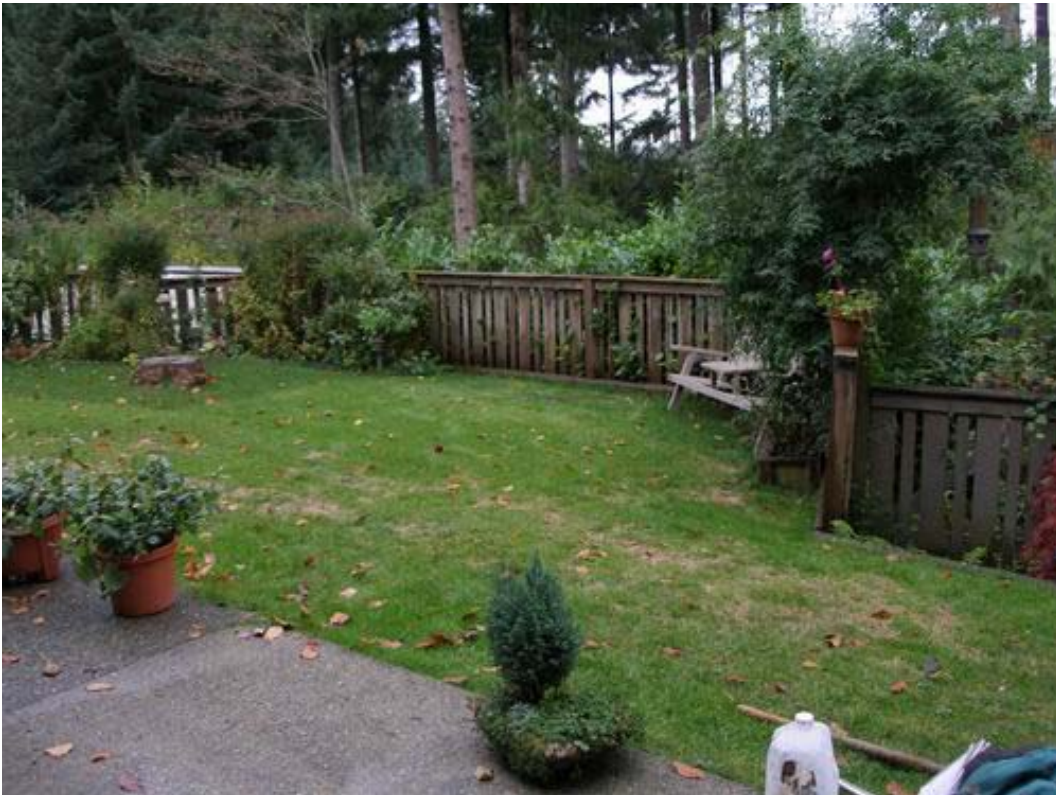
| DESCRIPTION: Backyard dips towards slope. Slight cracks in concrete patio 2 m from house. | | |

Figure 4. 2454 Hayseed Close – Lawn in the backyard dips towards the slope

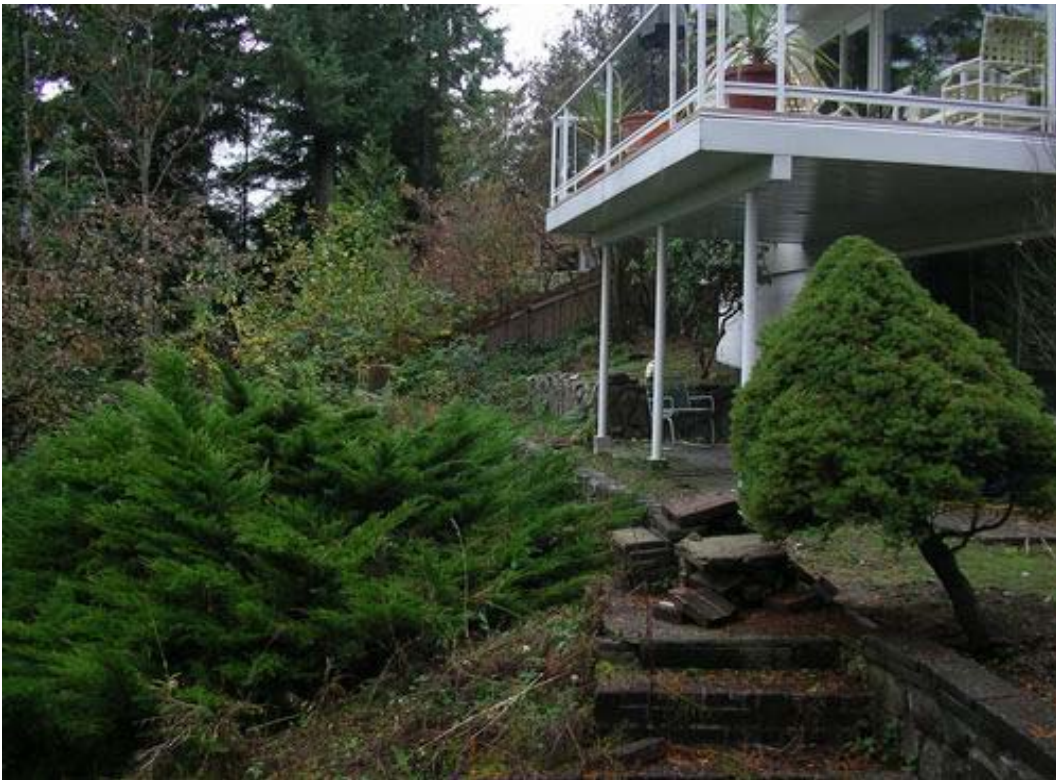
| OBSERVATIONS: 3 terraced retaining walls. All are cracking, leaning or are detached and falling over. | | | |

| DESCRIPTION: Undulating ground, some minor settlement. Owner notes that nothing has changed in last 7-8 years. | | |

Figure 2. 2462 Hayseed Close – View of backyard looking north

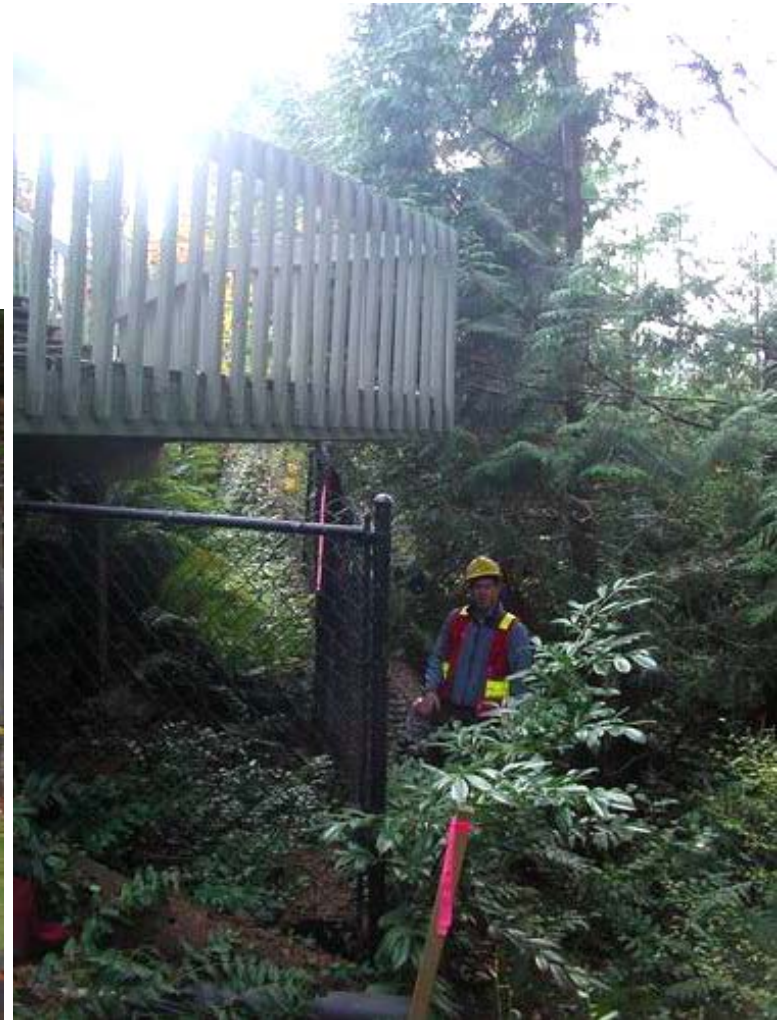
| <ul style="list-style-type: none"> House built on crest, wood deck overhangs crest of slope. Two drainage pipes collect water off the north end of the house and drain below the sundeck Thicknesses of loose materials are estimated since auger holes 1 and 2 reached maximum depths of 0.75m and 0.95m respectively. Both holes refused on gravels in loose materials. |

Figure 2. 2468 Hayseed Close - Back fence line with drain pipe in the foreground

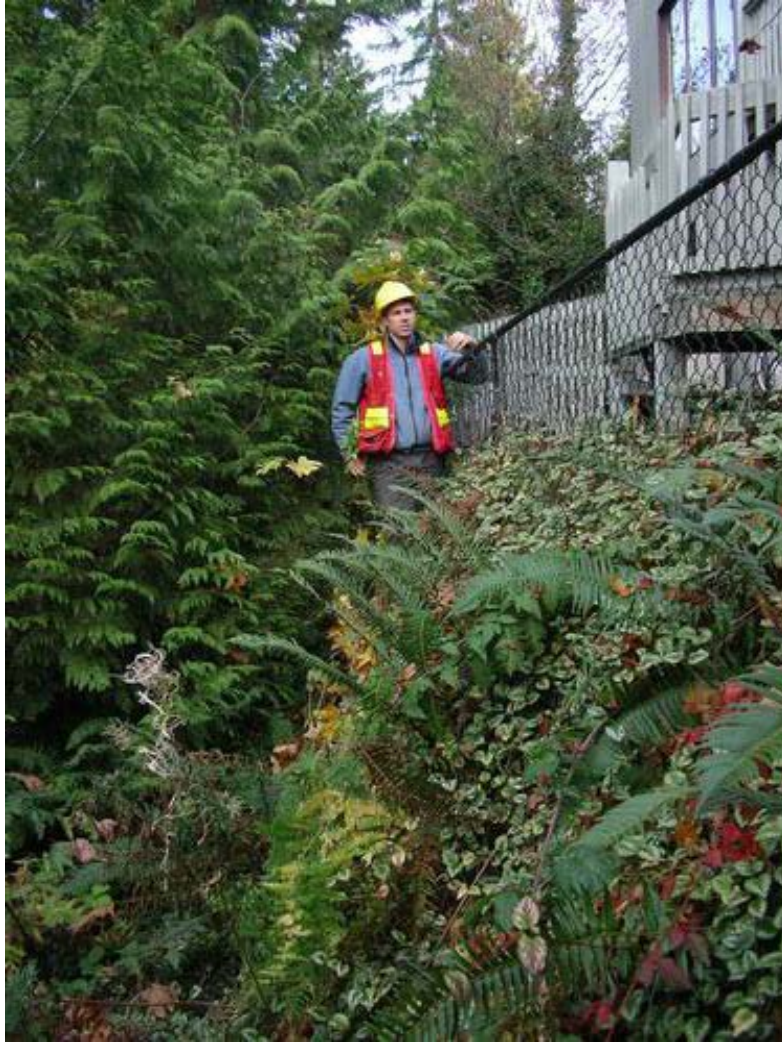
Figure 3. 2468 Hayseed Close – Looking NE along fence line

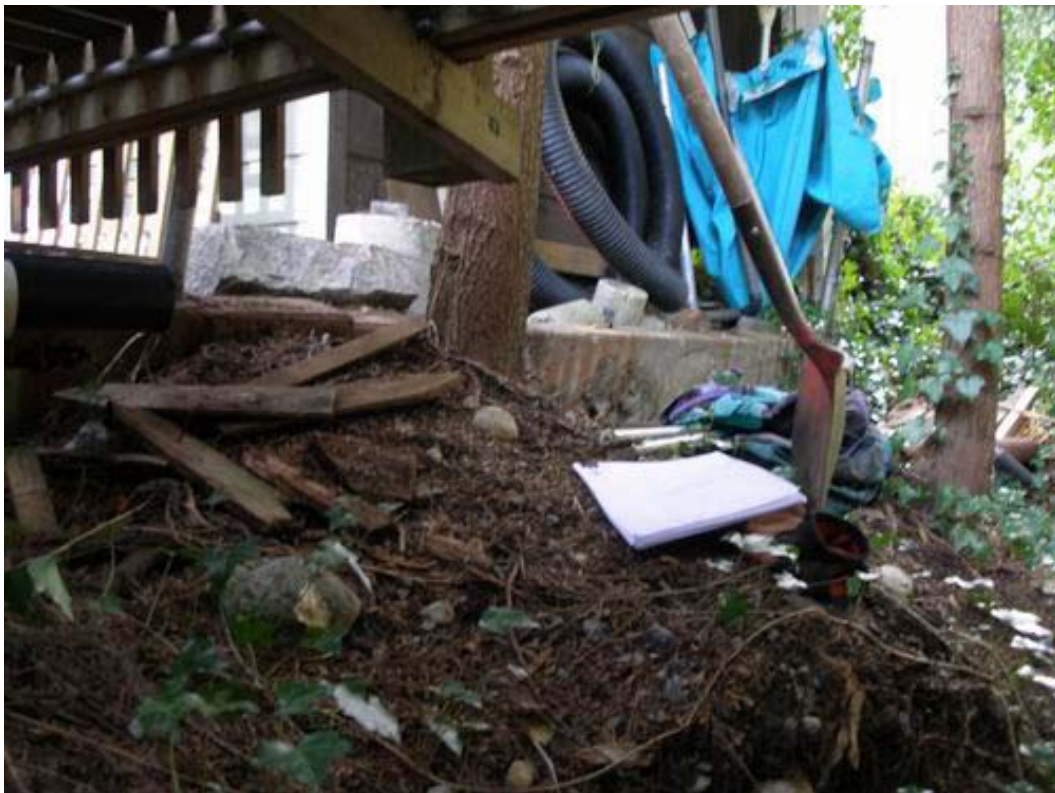
Figure 2. 2474 Hayseed Close – Tilted concrete retaining structure

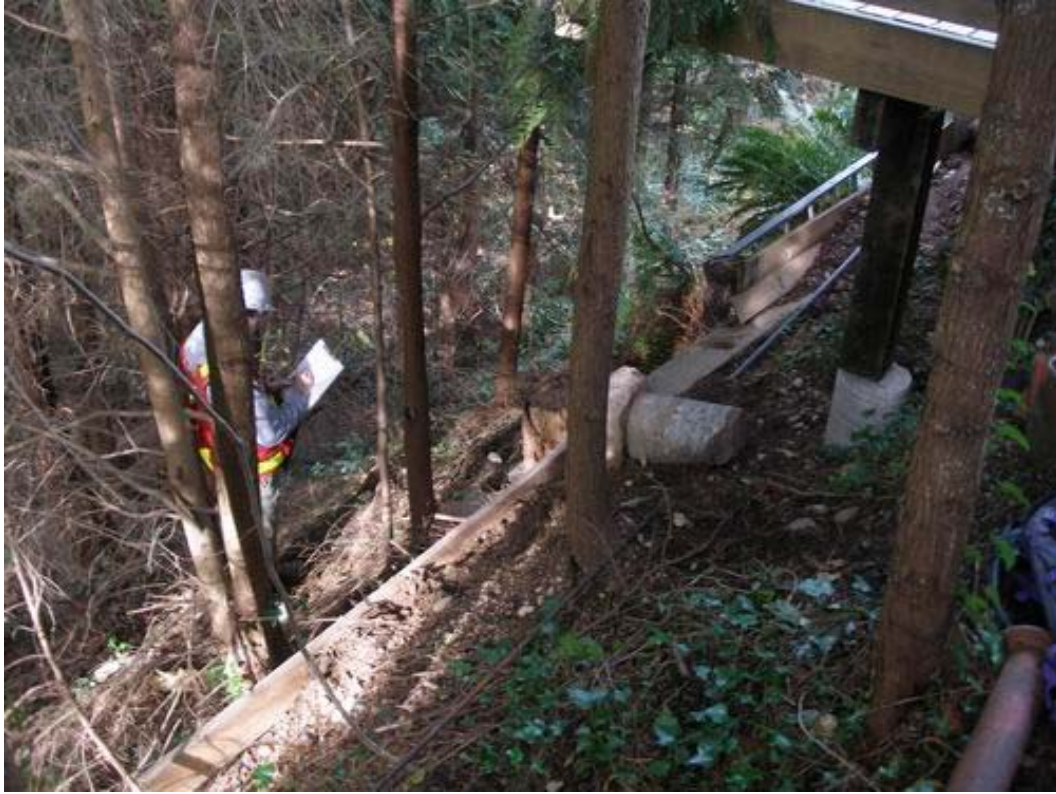
| SLOPE BELOW FENCE/ RETAINING STRUCTURE | SLOPE = 33° | | |
|---|---|---|---|
| OBSERVATIONS: Some erosion observed ~ 10m below deck. | | | <input checked="" type="checkbox"/> |

Figure 3. 2474 Hayseed Close – View from crest looking north down-slope

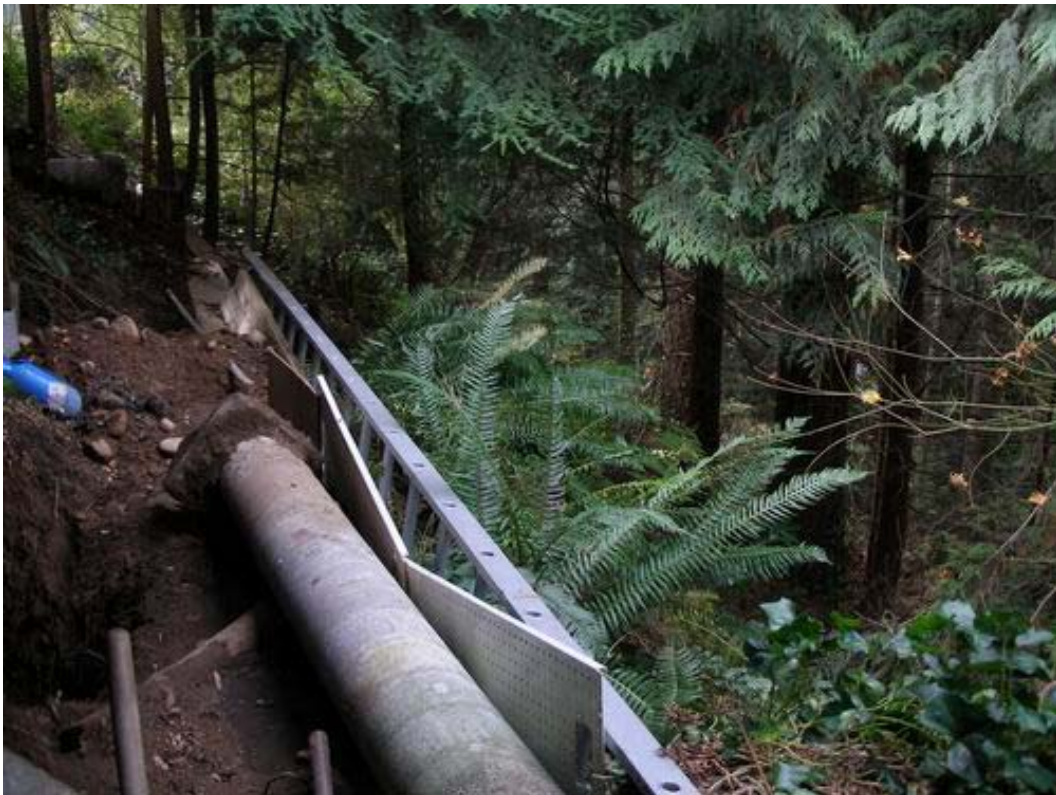
- Sundeck support posts being replaced (evidence of work in progress).
- Patio/deck built at crest of slope.
- Slope thickly vegetated; fallen trees observed.

Figure 4. 2474 Hayseed Close – In-progress renovation of deck supports

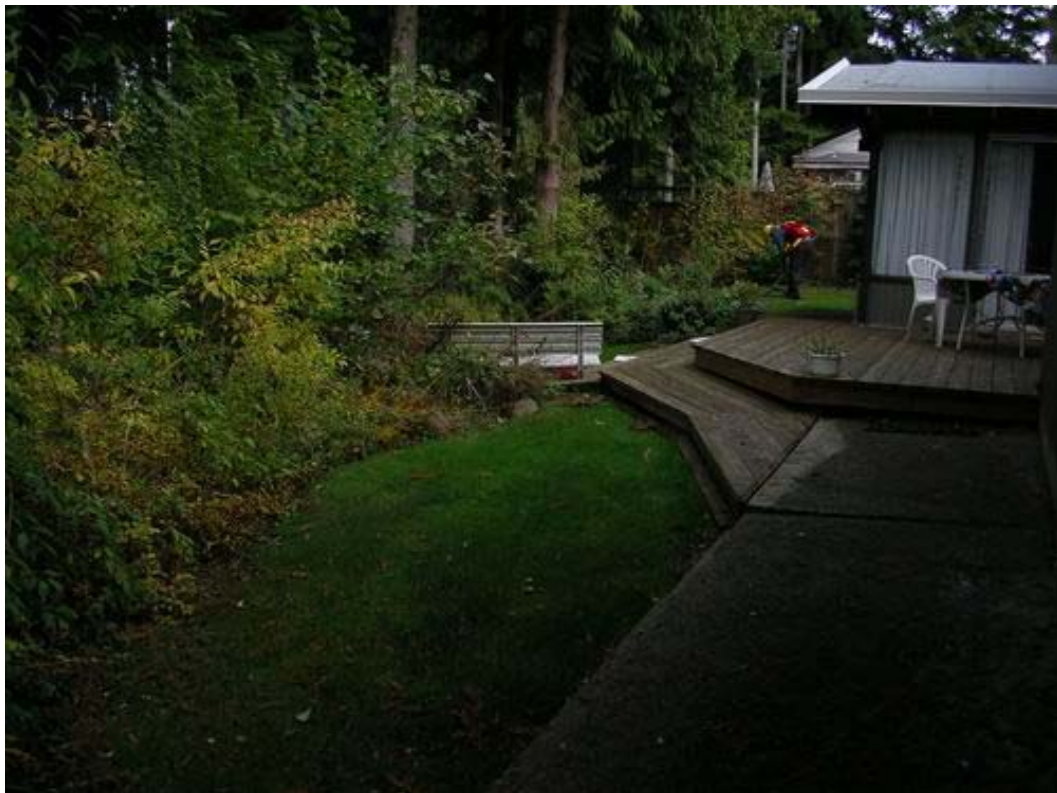
Figure 2. 2480 Hayseed Close – View looking NE along crest

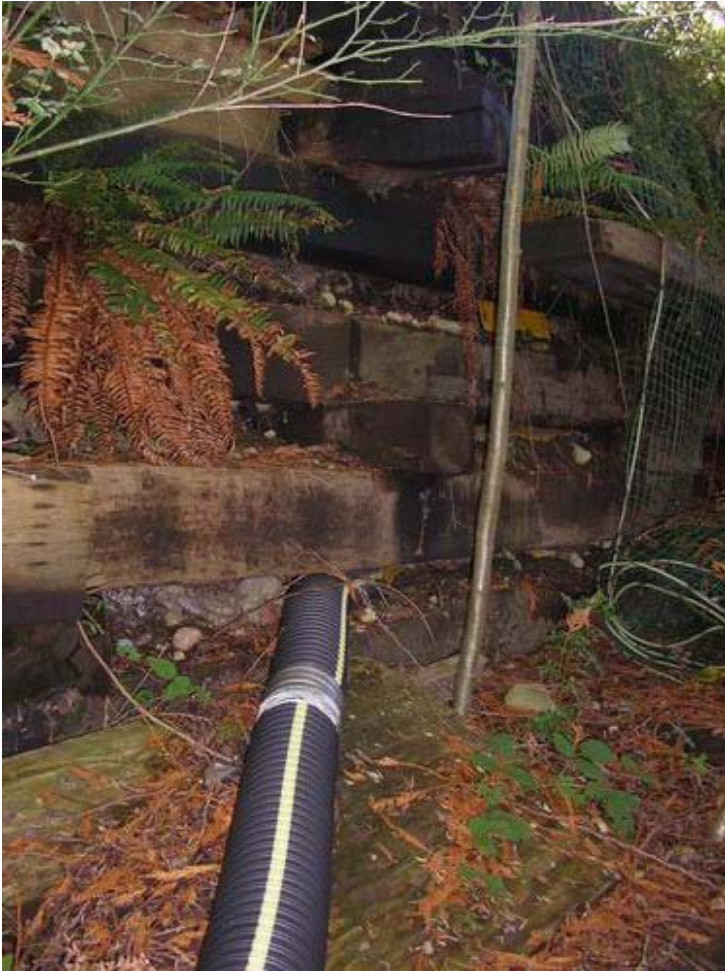
| <ul style="list-style-type: none"> House is 5.4 m from crest of retaining wall and 2.5-3 m from the original crest line as estimated by neighbours yards. Drainage pipe runs from roof, through backyard fill and out near the base of the retaining wall, but not all roof drains are connected Chicken wire holding gravely material behind retaining walls between timbers in upper sections of wall |

Figure 3. 2480 Hayseed Close – Timber crib retaining wall with protruding drainage pipe

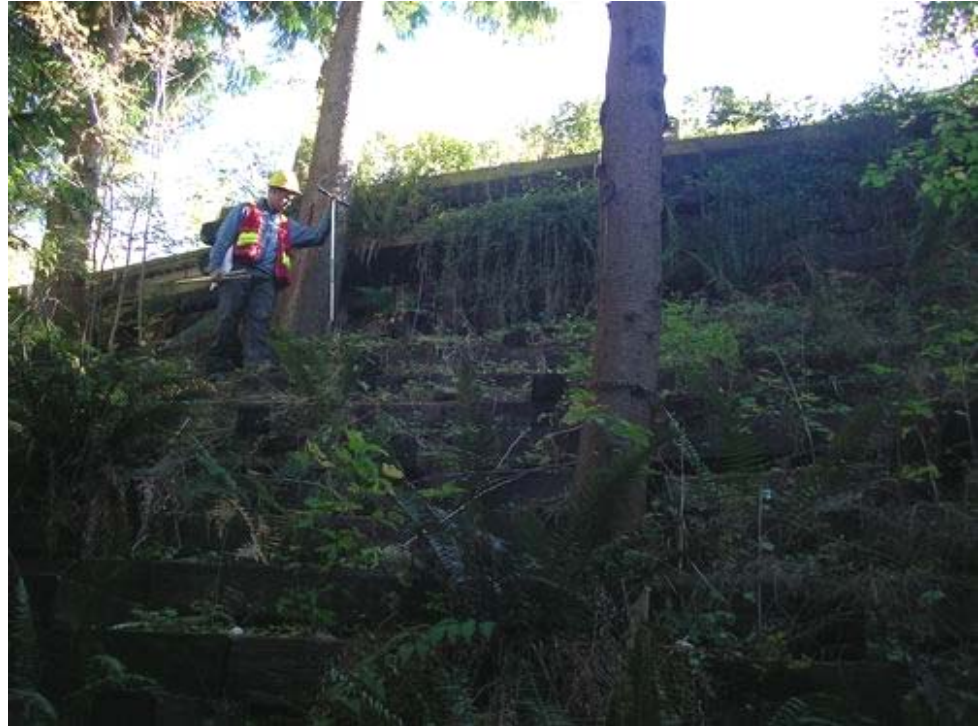
Figure 4. 2480 Hayseed Close – Timber crib retaining wall

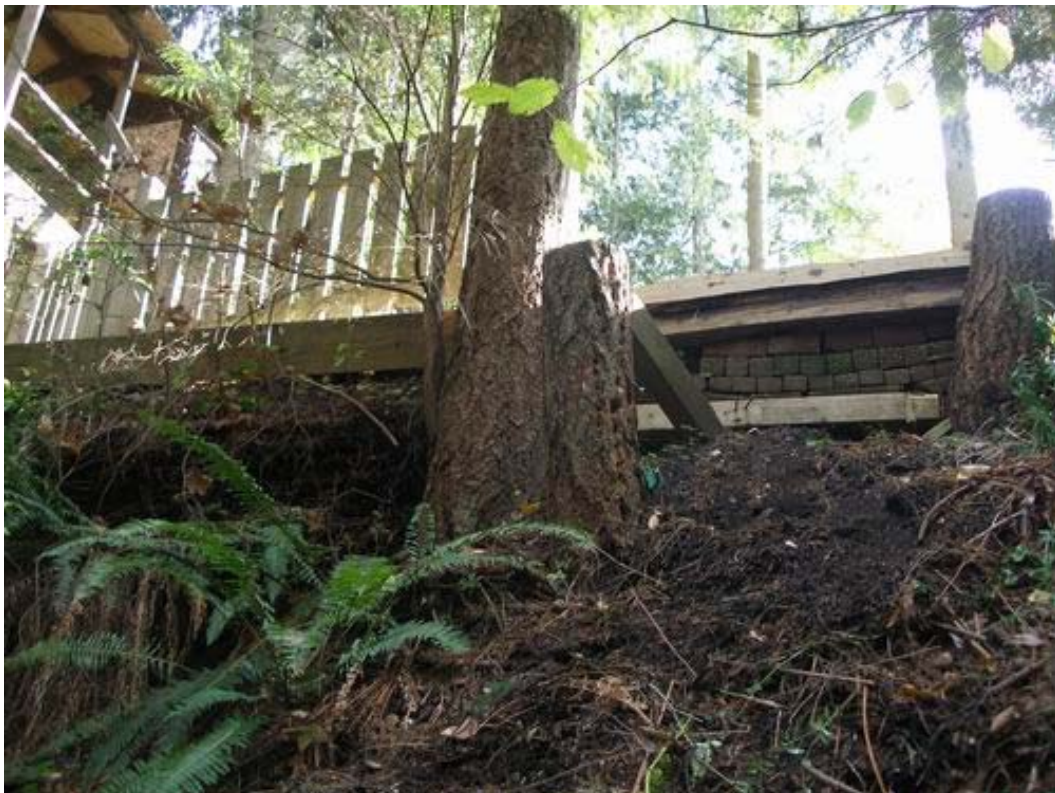
| <ul style="list-style-type: none"> Owner noted slight slumping of soil behind wood/brick retaining wall on east side of backyard within last couple of days Owner notes that 3 trees on west side of backyard fell 10 years ago during a heavy storm Bricks/ logs and pieces of asphalt lying on slope |

Figure 2. 2486 Hayseed Close – View looking south towards a slumping brick retaining wall

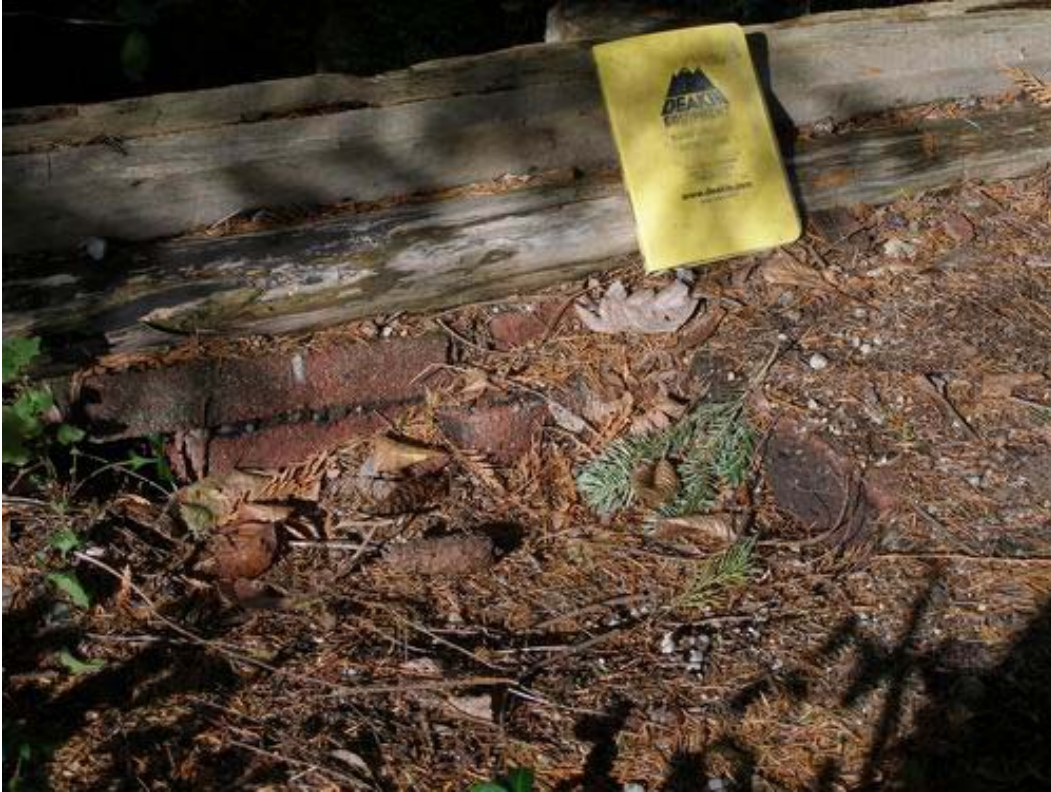
| DESCRIPTION: Settling in backyard at top of retaining structure. | | |

Figure 3. 2486 Hayseed Close – Top view of settling brick retaining wall

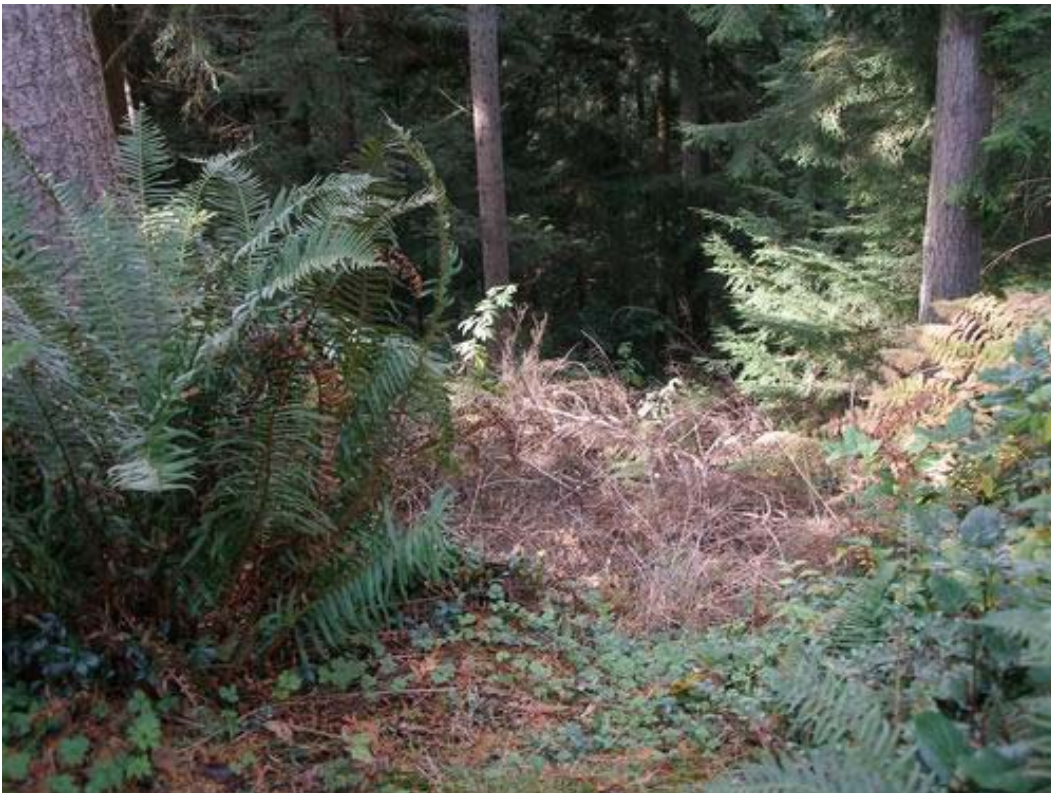
Figure 4. 2486 Hayseed Close – View down-slope on north side of property where 3 trees fell during a heavy storm 10 years ago
