SITE OBSERVATION FORM: DNV Landslide Risk Assessment
LOCATION: 2125 Berkley Avenue
INSPECTION DATE: (mm/dd/yy) 10/27/05
WEATHER: Sunny, clear skies, no rain 1 day prior, heavy rain 2 days prior to visit.

BGC ENGINEERING INC.
 AN APPLIED EARTH SCIENCES COMPANY

Project : DNV Landslide Risk Assessment

Project No. : 0404-002-01

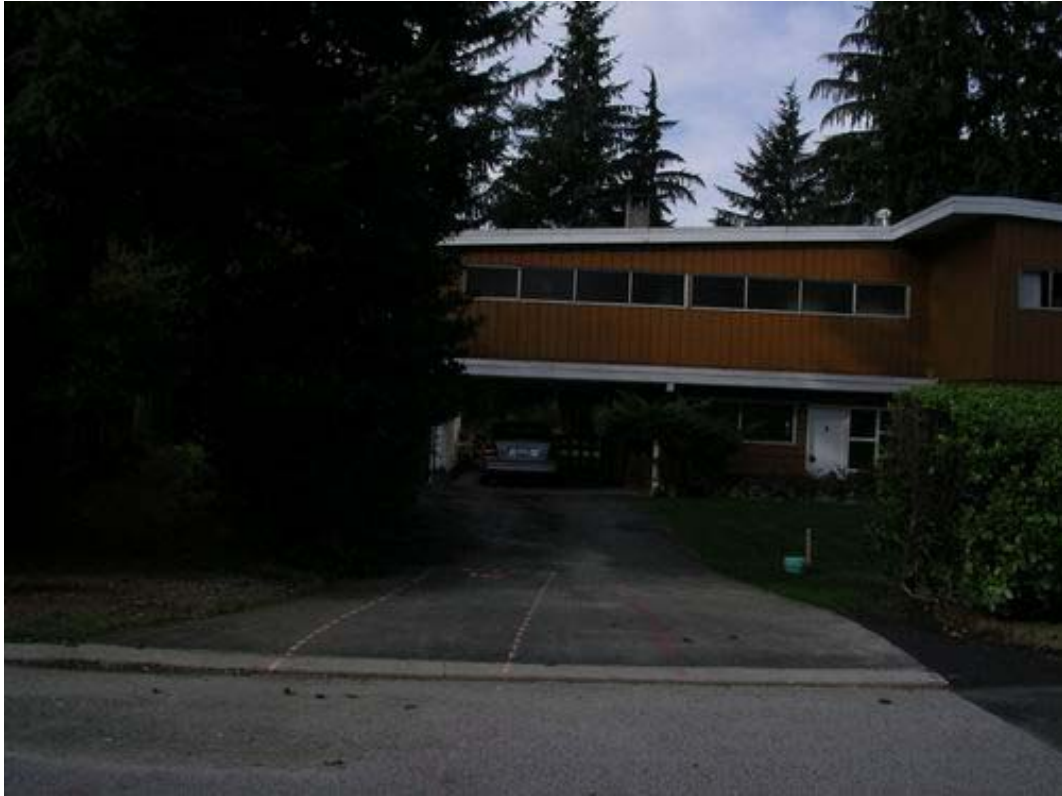
| RECEIVES SURFACE RUNOFF FROM | BACKYARD | 1/2 ROOF | FULL ROOF | FRONT YARD | STREET |
|--|---|---|---|---|---|
| OBSERVATIONS: Drain in the driveway near house. Unsure where roof drains and driveway flow. In a high rainfall event water will likely flow down driveway to drain. (Curb < 10 cm) | | | | | |

Figure 1. 2125 Berkley Avenue – Front of the house and sloping driveway

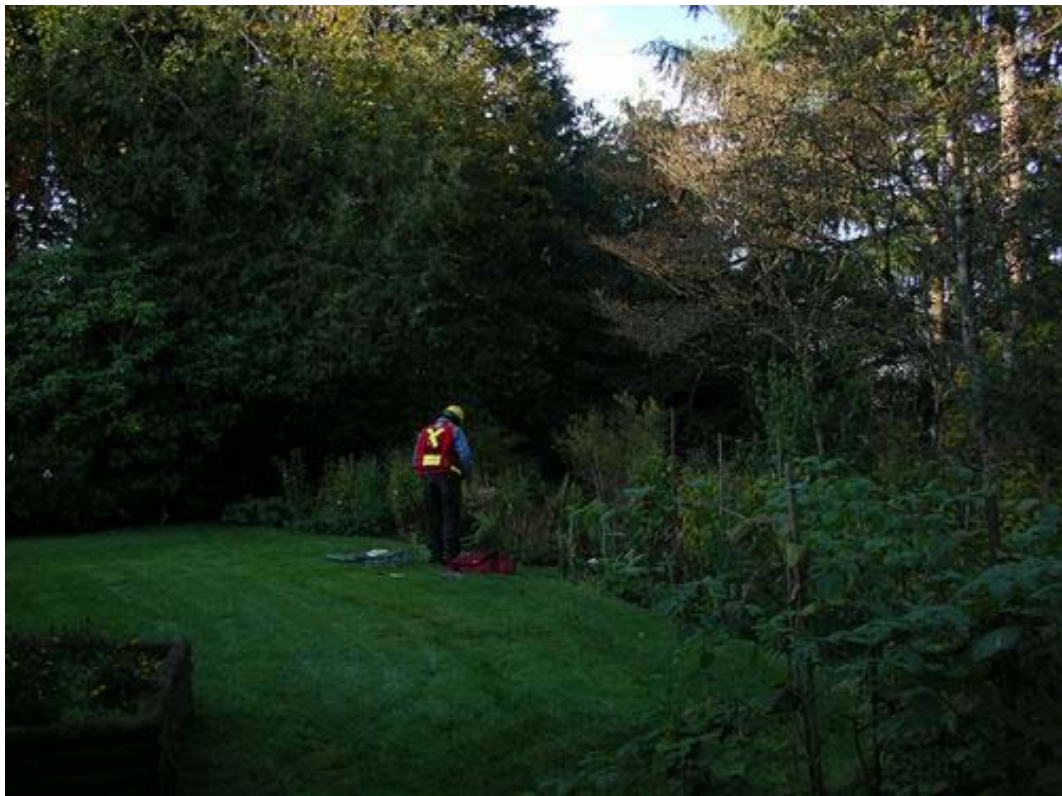
Figure 2. 2125 Berkley Avenue – View south along fence line (backyard)

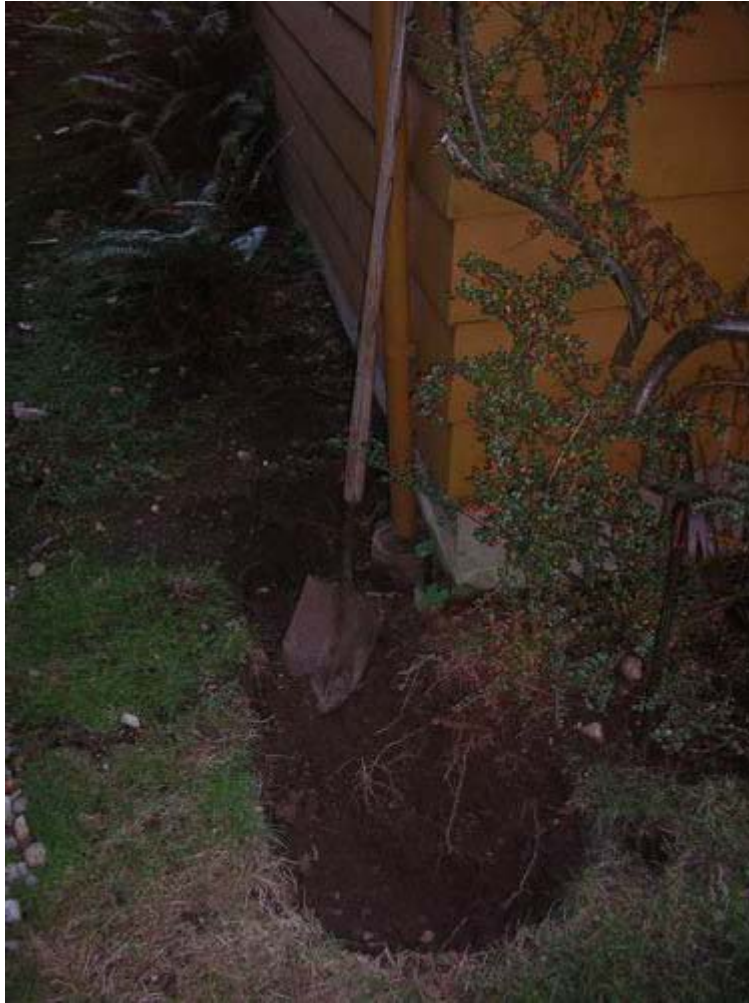
- Old logging road 20 m below crest of slope.
- Debris and compost from garden in area of down slope holes.
- Small excavation at north west corner of house around roof drain where water is directed below the ground surface. No drain outlets observed on slope.

Figure 3. 2125 Berkley Avenue – Pit dug on NW corner of house near roof drain

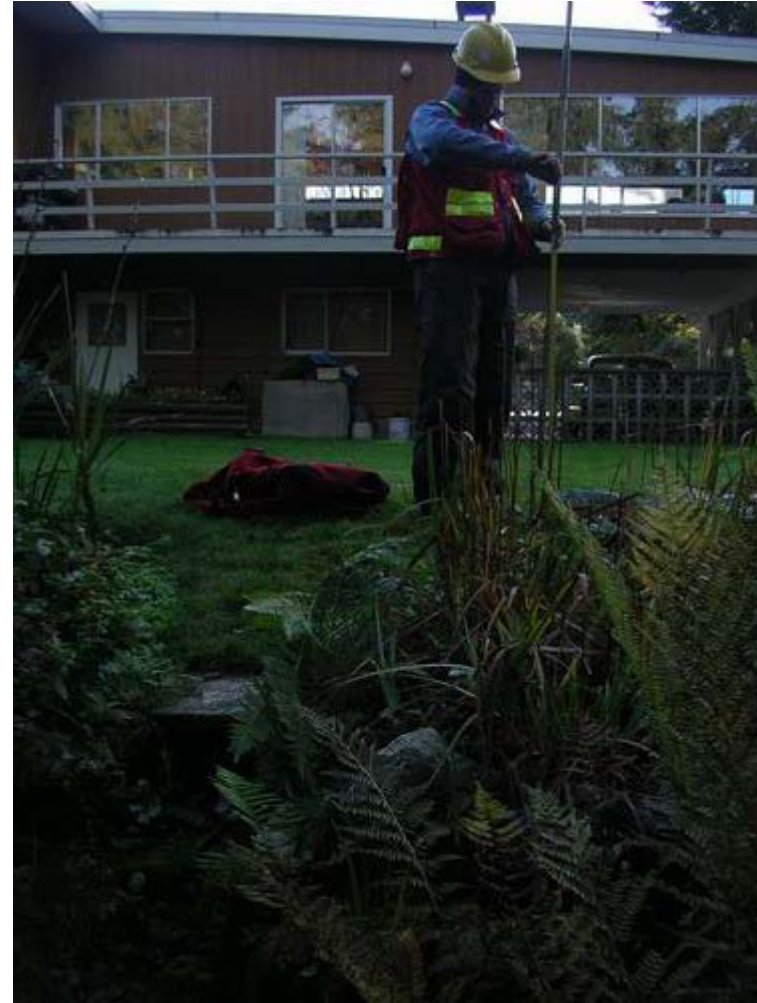
Figure 4. 2125 Berkley Avenue – View from crest to house

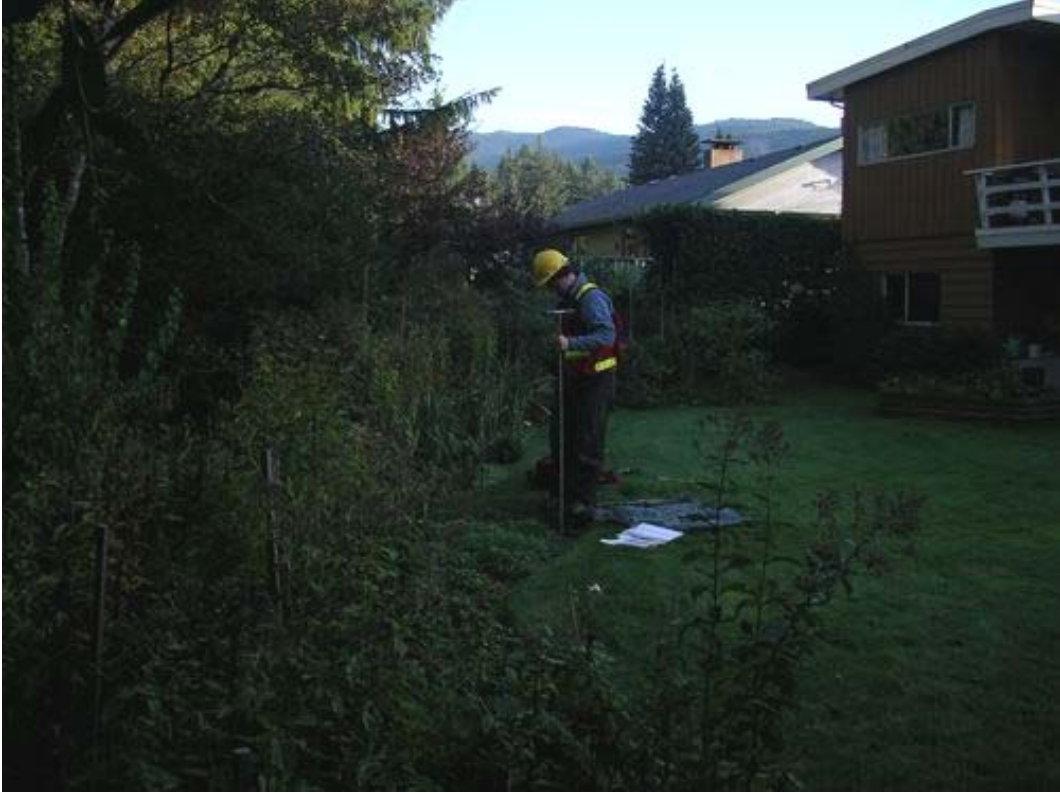
Figure 5. 2125 Berkley Avenue – View north along fence line (backyard)

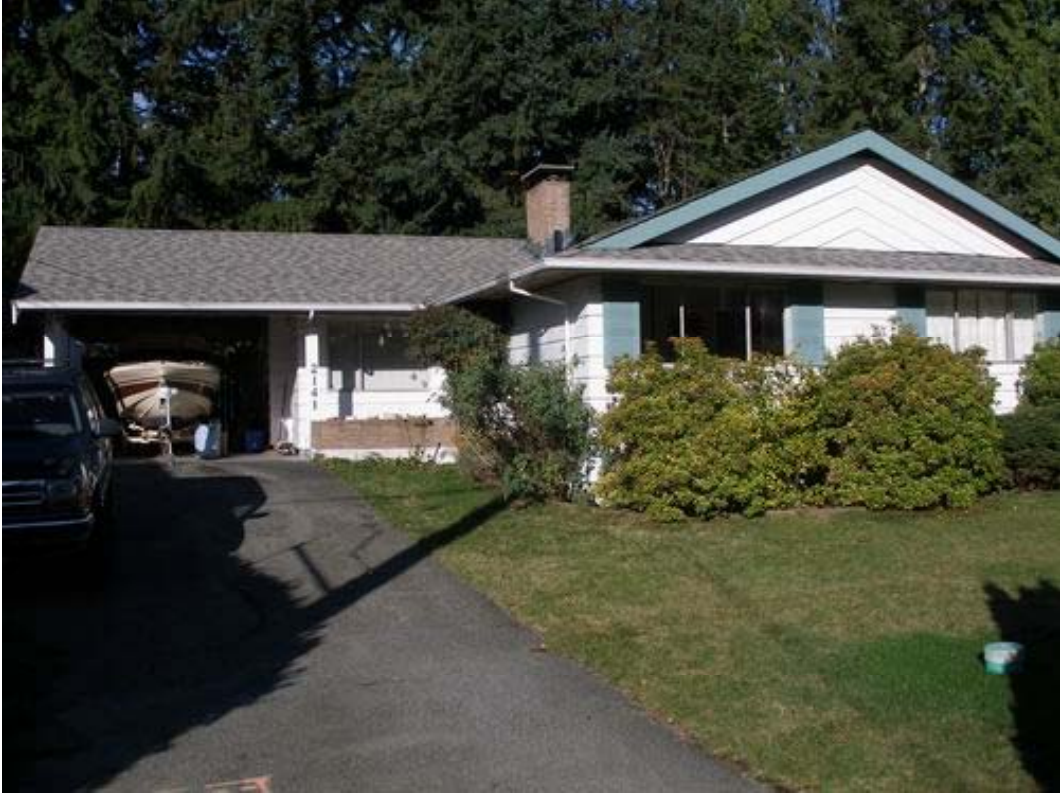
| RECEIVES SURFACE RUNOFF FROM | BACKYARD | ½ ROOF | FULL ROOF | FRONT YARD | STREET |
|---|---|---|---|---|---|
| OBSERVATIONS: Front driveway and front yard slope towards the street. | <input checked="" type="checkbox"/> | <input checked="" type="checkbox"/> | | | |

Figure 1. 2141 Berkley Avenue - Front of the house

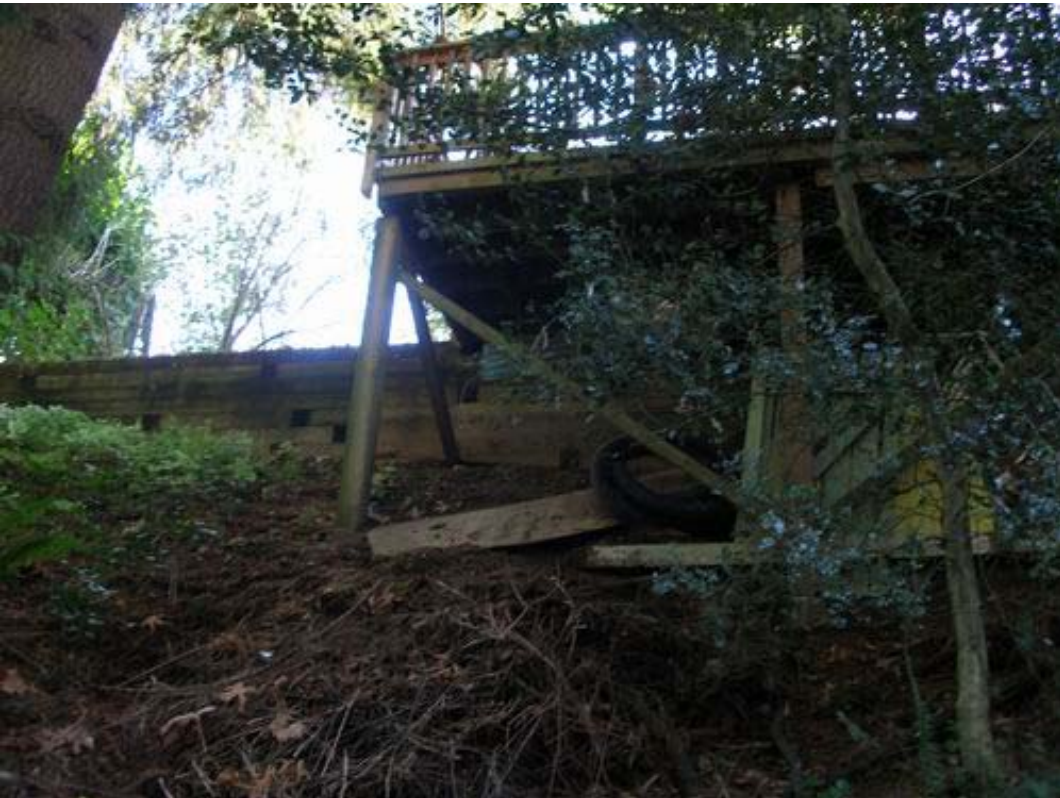
| RETAINING STRUCTURES | YES <input checked="" type="checkbox"/> | NO | HEIGHT= 1.60 m |
|---|--|---|---|
| OBSERVATIONS: Wall spans width of yard. A sun deck extends down slope from the wall structure. No deformation observed. | | | |

Figure 2. 2141 Berkley Avenue - Timber crib retaining wall

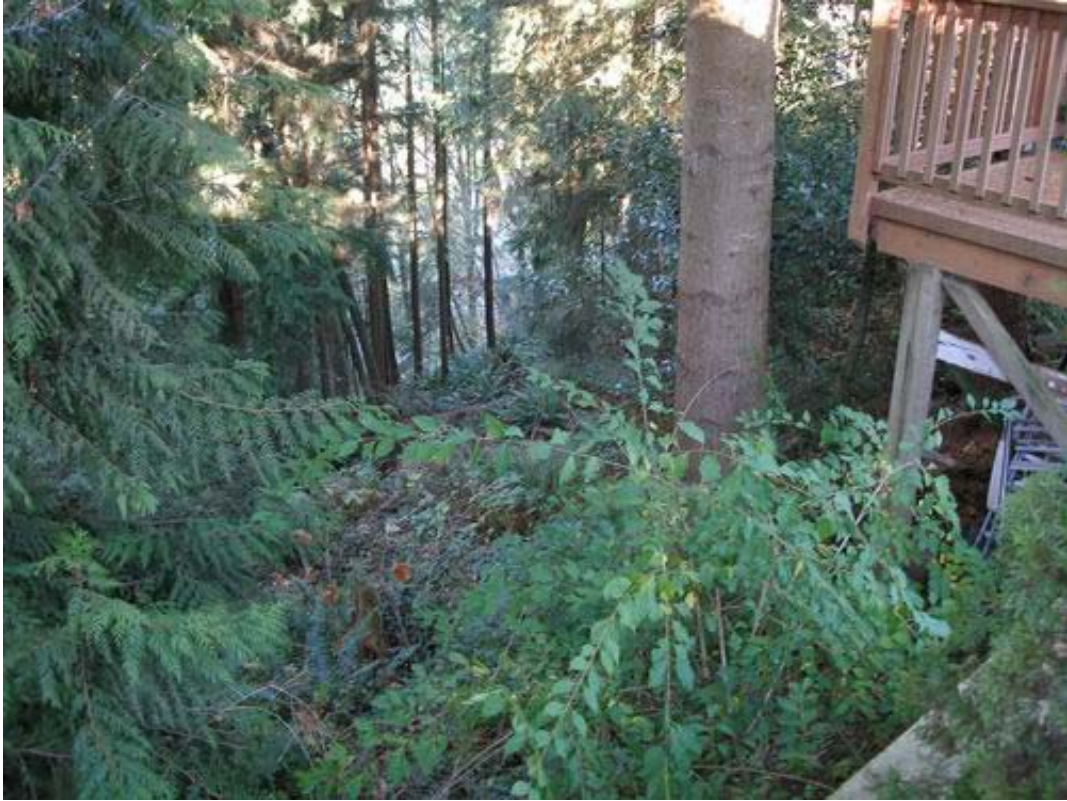
Figure 3. 2141 Berkley Avenue - View down-slope looking NW from south end of property

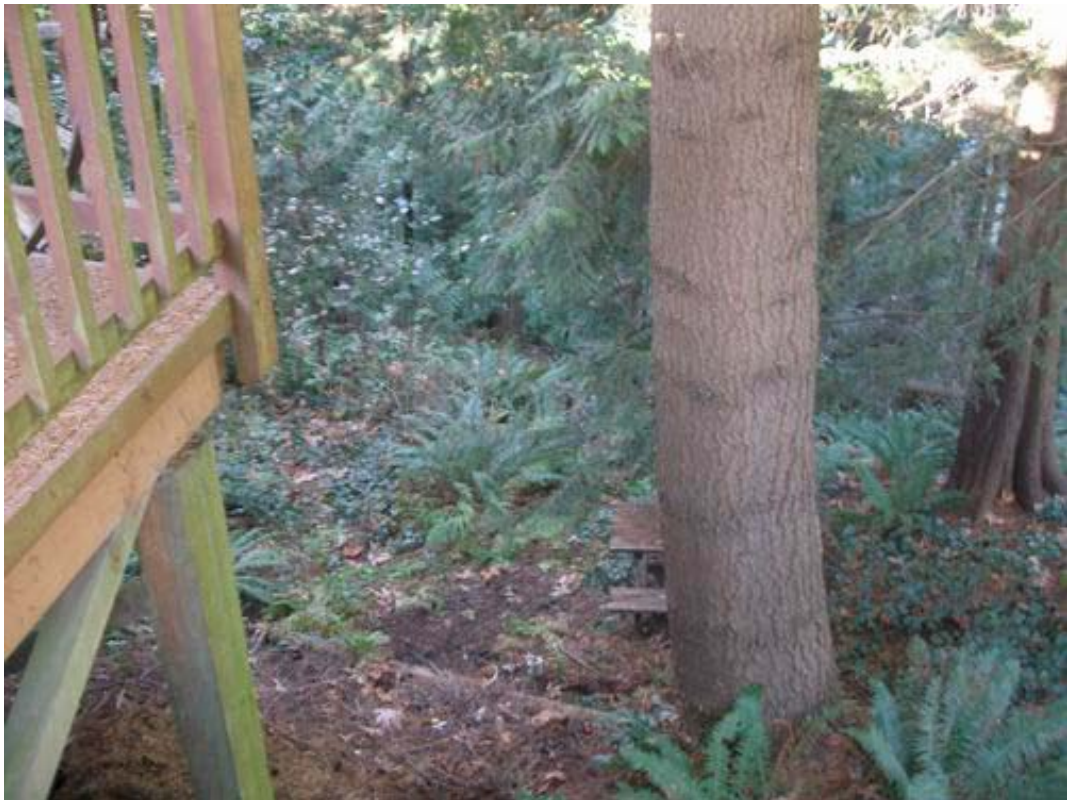
Figure 4. 2141 Berkley Avenue - View down-slope looking SW from north end of property

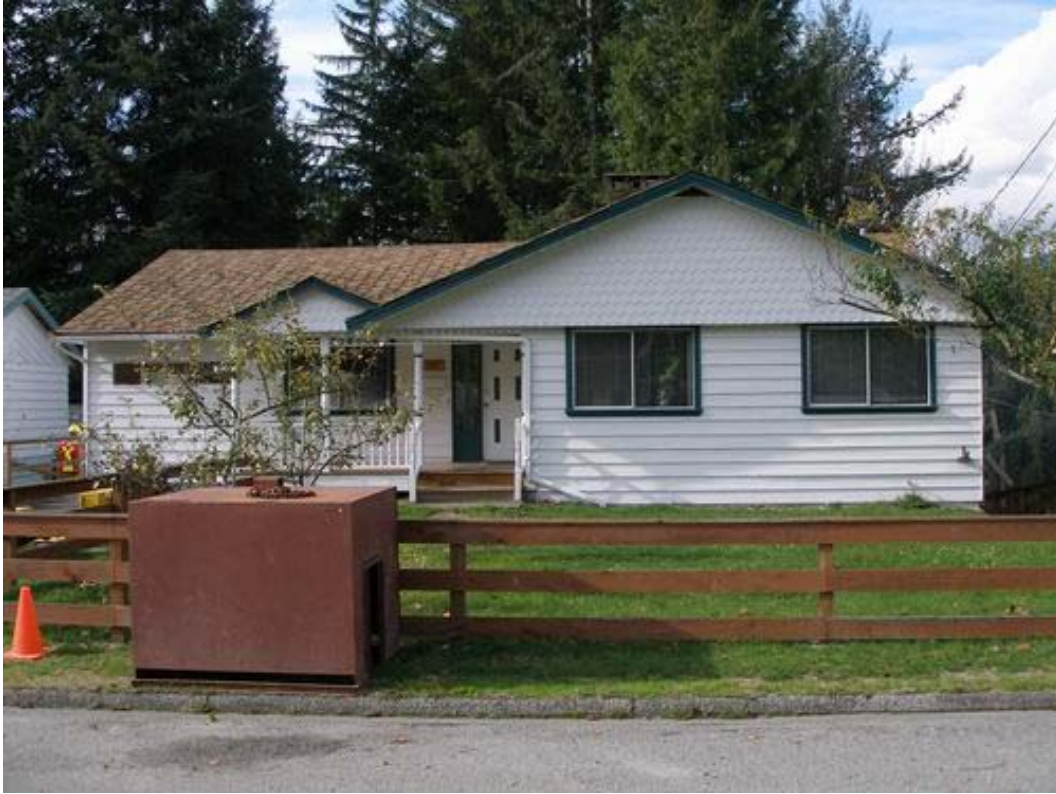
Figure 1. 2157 Berkley Avenue –Front of the house

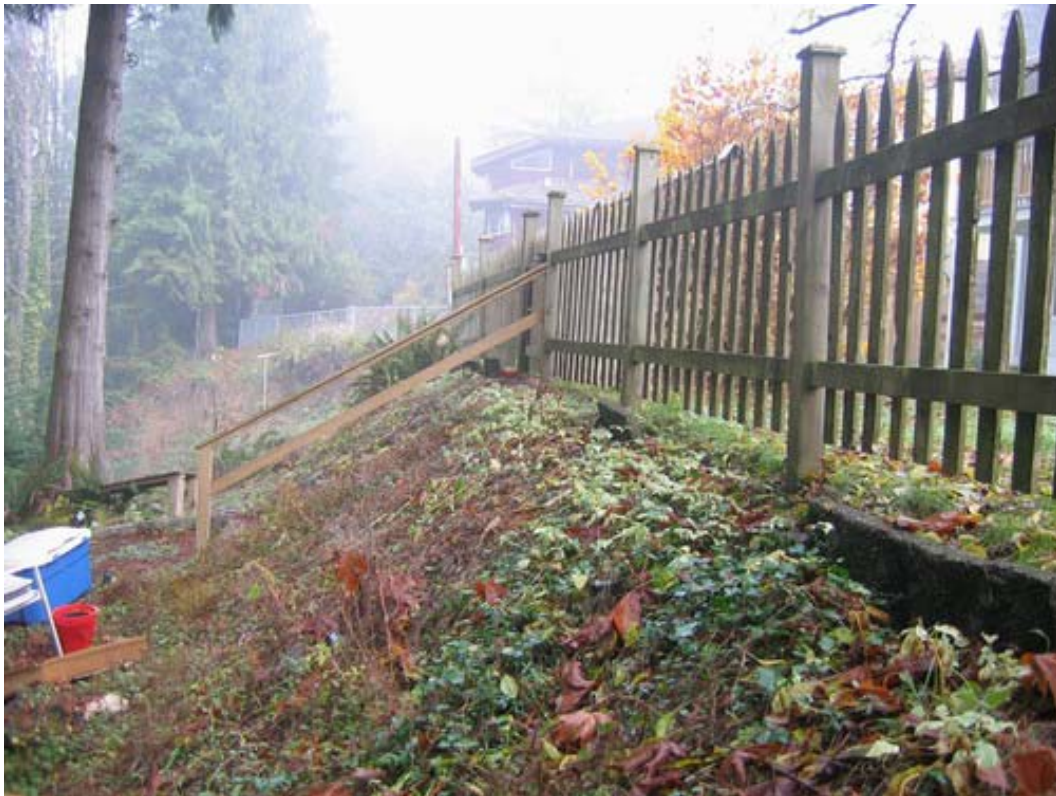
Figure 2. 2157 Berkley Avenue – View looking north along fenceline

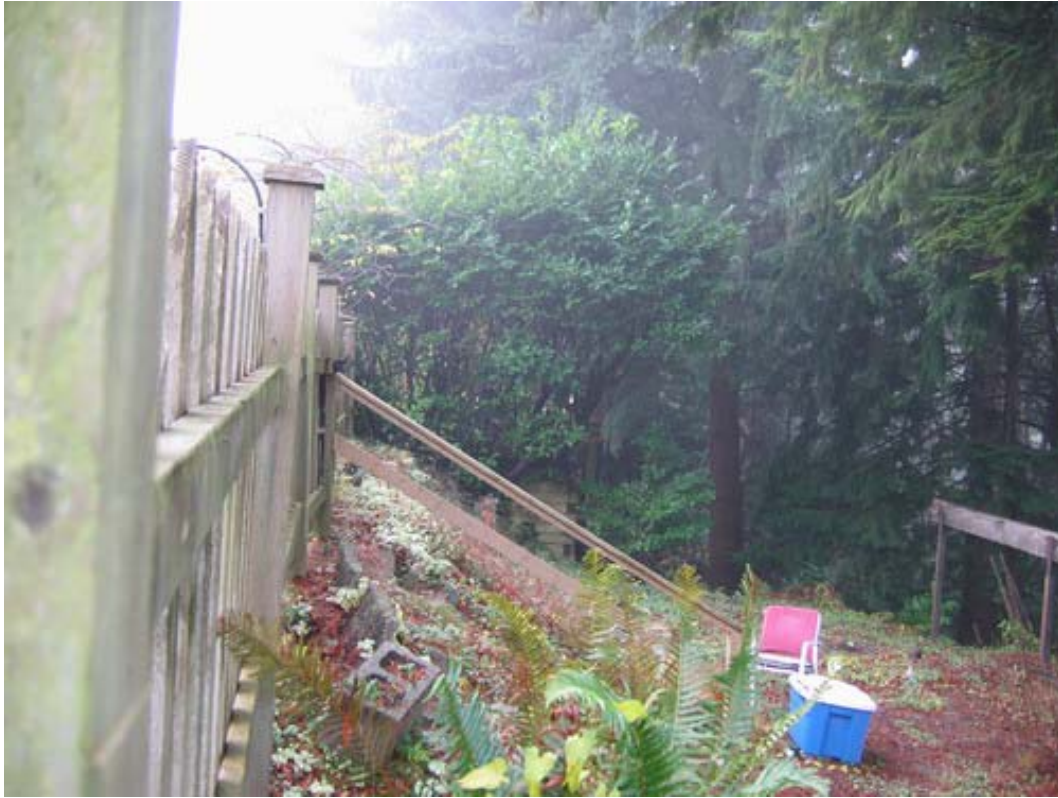
Figure 3. 2157 Berkley Avenue – View looking south along fenceline

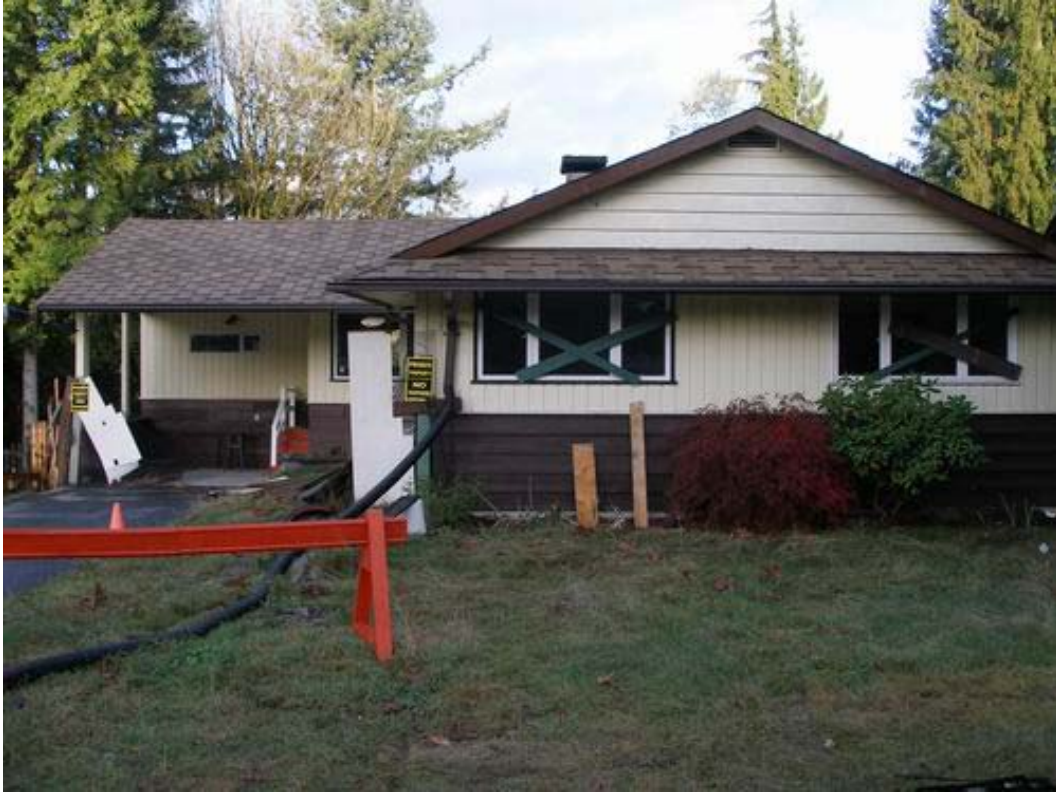
Figure 1. 2175 Berkley Avenue –Front of the house

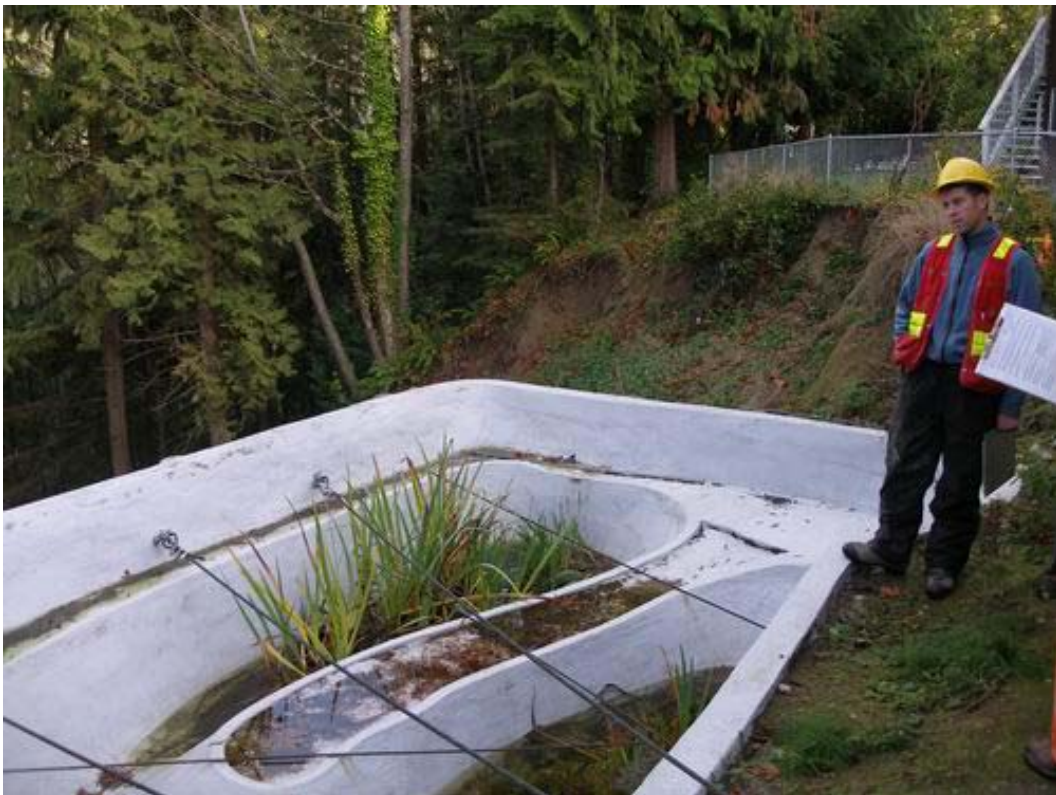
Figure 2. 2175 Berkley Avenue – View looking north from scarp

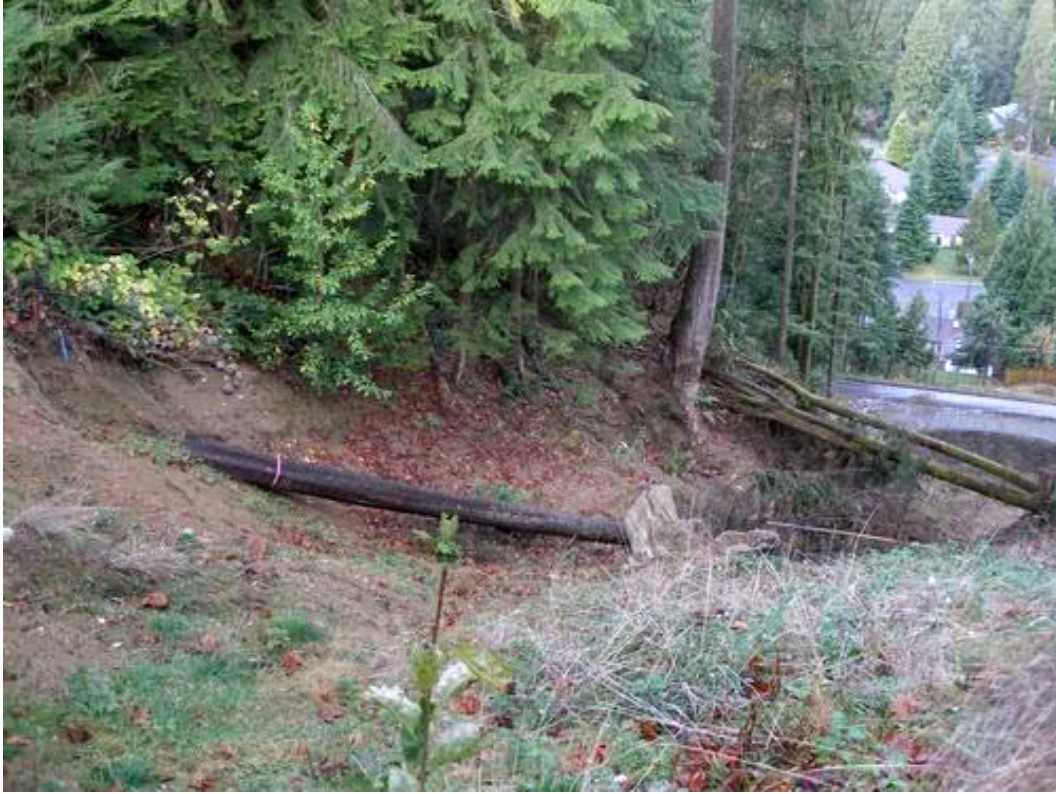
| OBSERVATIONS: Site of January 2005 slide. | | | |

- Site of January 2005 slide.
- No auger hole drilled down slope, no fill remains down slope of headscarp.

Figure 3. 2175 Berkley Avenue – View down-slope of January 2005 slide
