**SITE OBSERVATION FORM:** DNV Landslide Risk Assessment  
**LOCATION:** 2191 Berkley Avenue  
**INSPECTION DATE:** (mm/dd/yy) 10/26/05  
**WEATHER:** Sunny, clear skies, no rain 1 day prior, heavy rain 2 days prior to visit.

**Project :** DNV Landslide Risk Assessment

**Project No. :** 0404-002-01

*Client: District of North Vancouver*

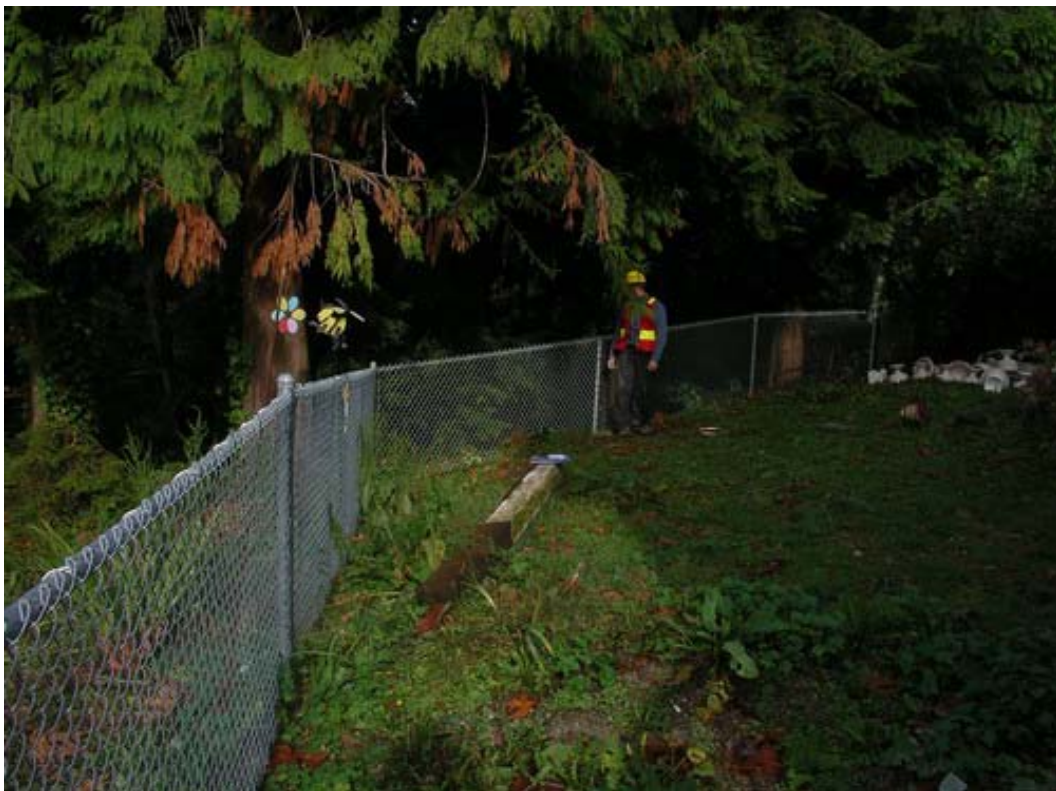
RETAINING STRUCTURES	YES <input checked="" type="checkbox"/>	NO	HEIGHT= 0.5 m
TYPE	CONCRETE <input checked="" type="checkbox"/>	TIMBER CRIB	OTHER:
DEFORMATION	CRACKED <input checked="" type="checkbox"/>	SETTLED <input checked="" type="checkbox"/>	BULGING
<b>OBSERVATIONS:</b> Slightly cracked, bulging slightly. Tilted, rotating at base approximately 20°.

DEFORMATION IN BACKYARD	YES <input checked="" type="checkbox"/>	NO
LOCATION: South side of backyard at fence line.		
DESCRIPTION: Surficial tension cracks near January 2005 slide site.

Figure 2. 2191 Berkley Avenue – View looking NW along fence line

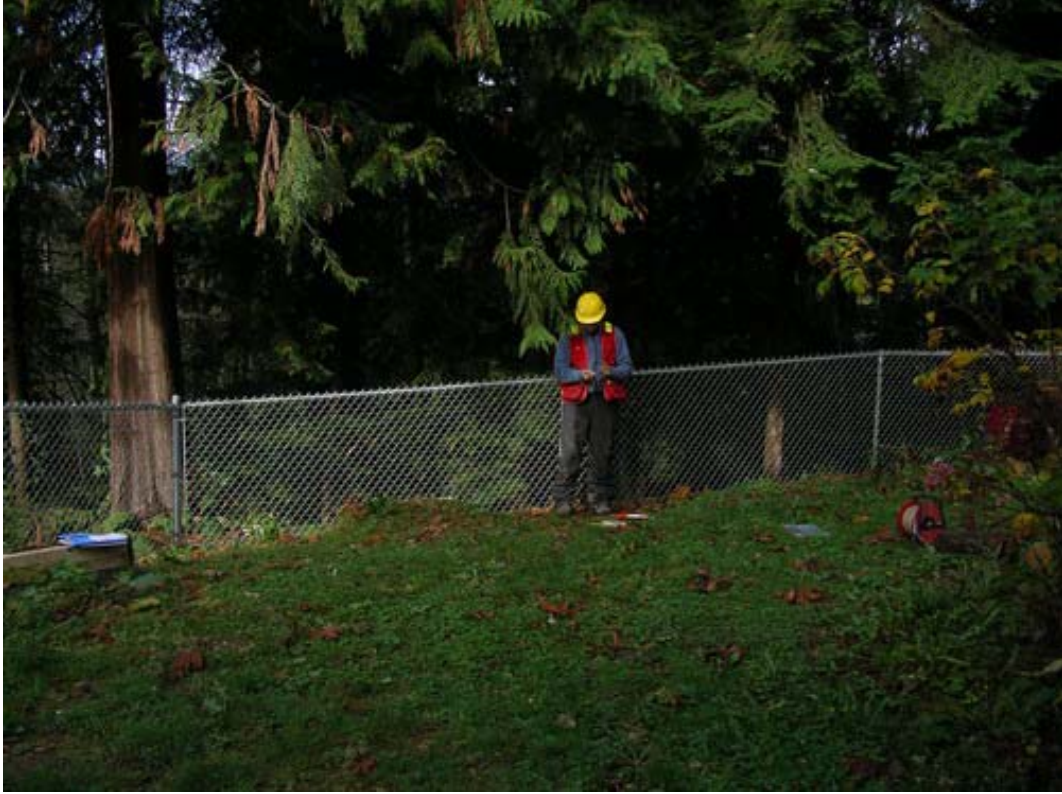
Figure 3. 2191 Berkley Avenue – View from house to crest

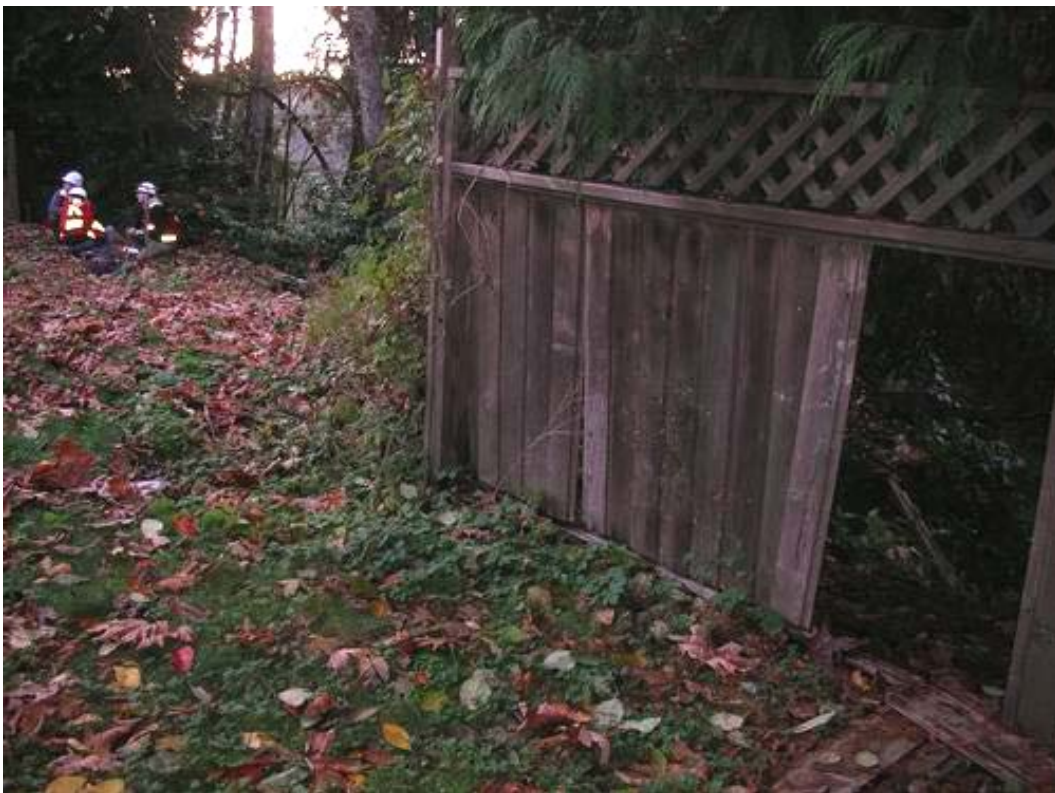
Figure 2. 2205 Berkley Avenue – View along crest of slope

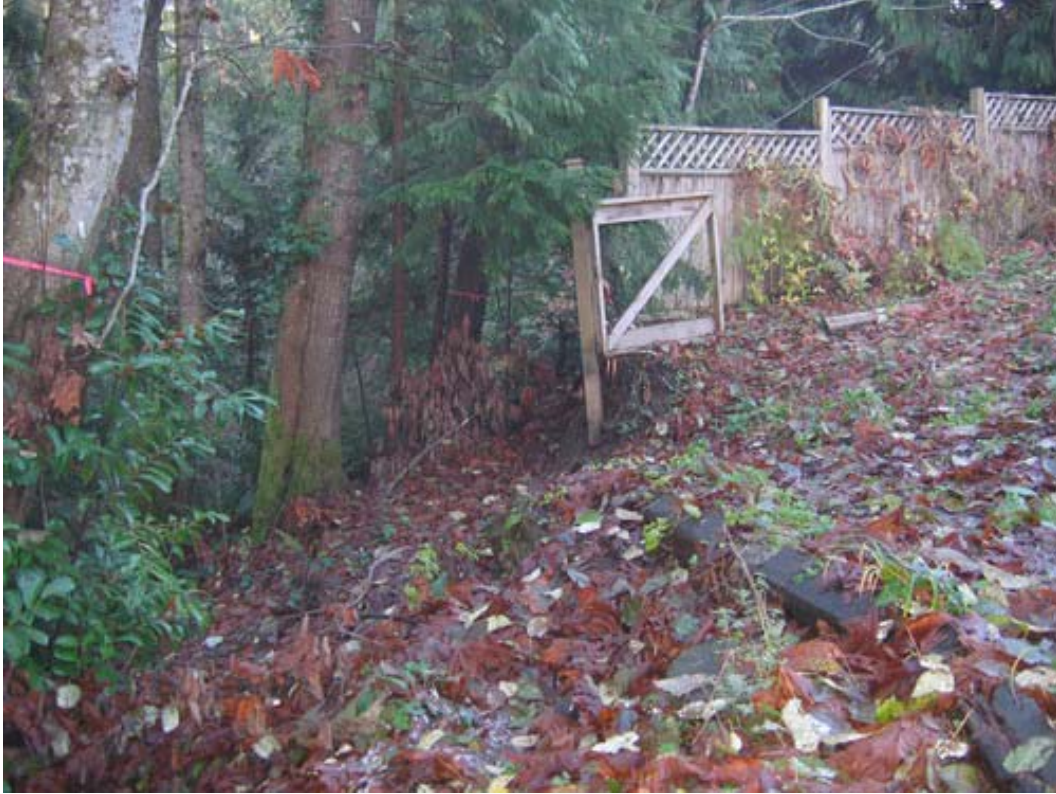
SLOPE BELOW FENCE/ RETAINING STRUCTURE	SLOPE = 35°		
	CRACKS	SLIDES	EROSION
		<input checked="" type="checkbox"/>	
<b>OBSERVATIONS:</b> No slope deformation observed directly below west fence line. Adjacent property (to the north) is the site of a slide in 1979, a portion of the scarp is at the north end of the 2205 Berkley fence line.

Figure 3. 2205 Berkley Avenue - View looking north along crest

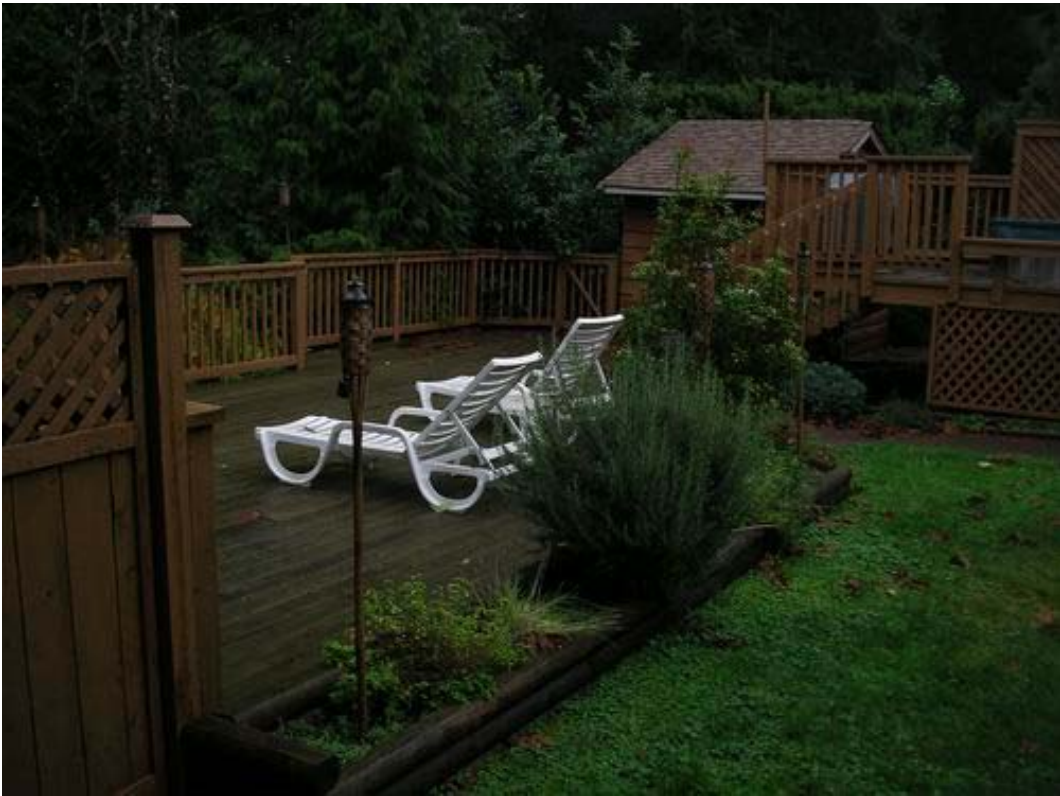
Figure 2. 2217 Berkley Avenue – View of backyard looking NW

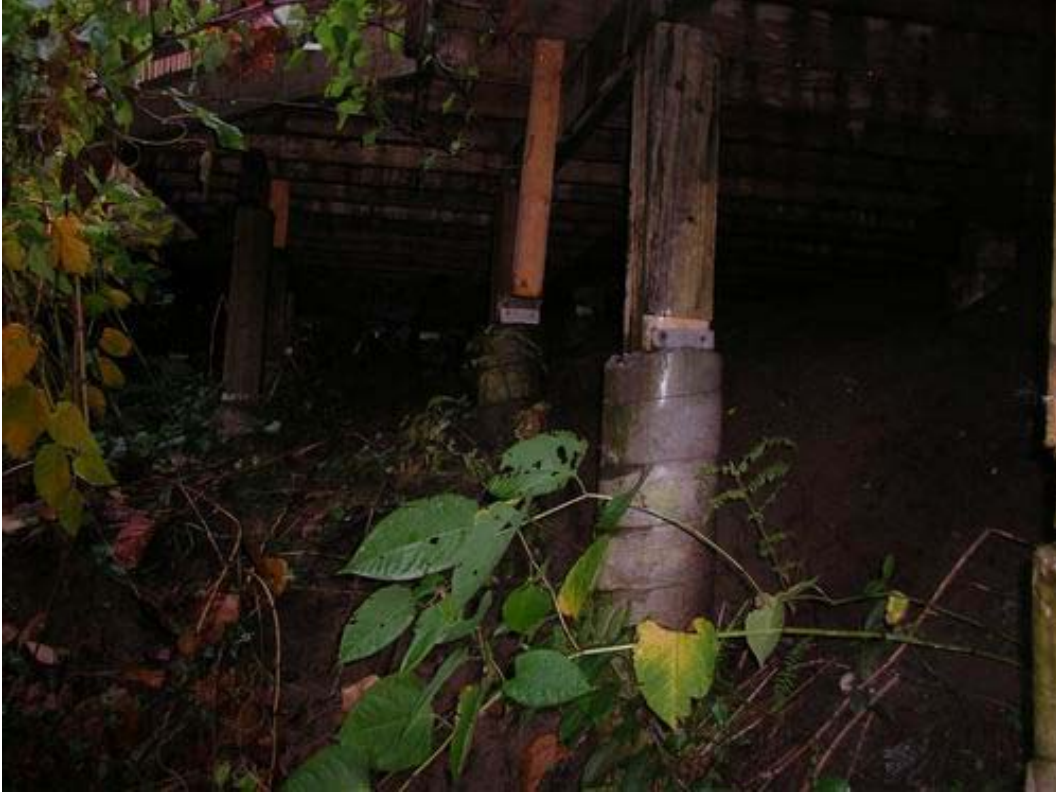
SLOPE BELOW FENCE/ RETAINING STRUCTURE	SLOPE = 44°		
	CRACKS	SLIDES	EROSION
		<input checked="" type="checkbox"/>	
<b>OBSERVATIONS:</b> 1979 landslide scarp on south portion of slope below the fence line. Wood deck built over headscarp, several foundations are placed below crest of the scarp.

Figure 3. 2217 Berkley Avenue – Deck supports

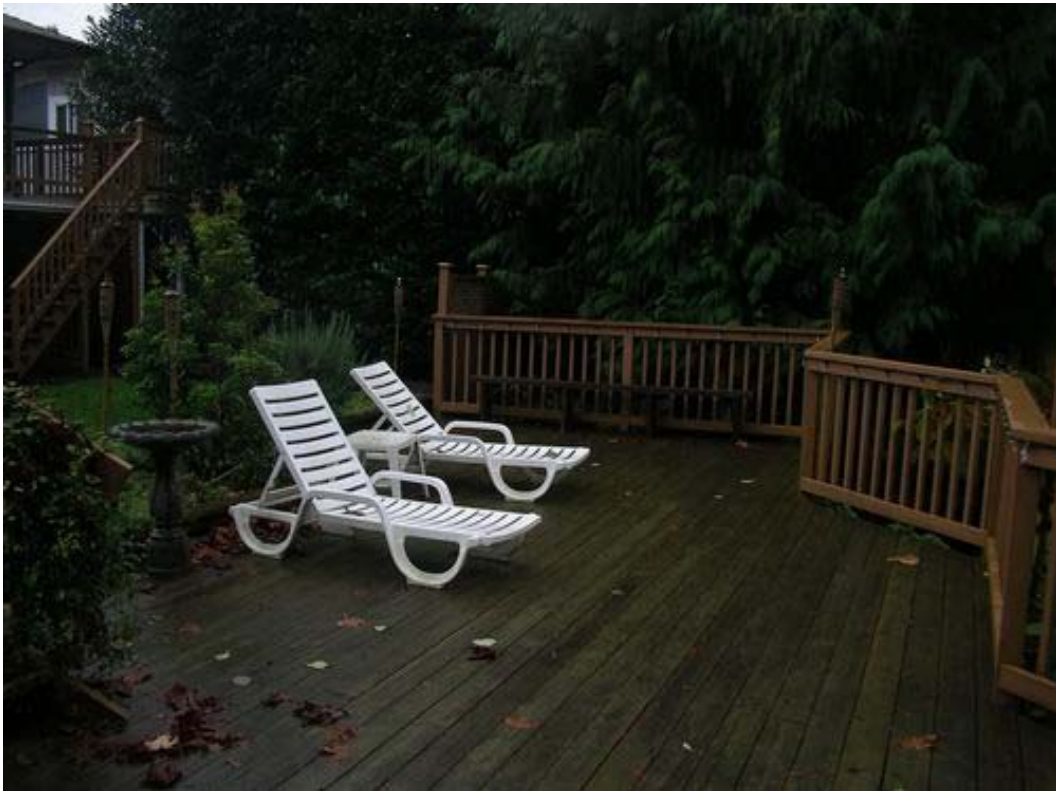
- The south portion of this slope is the site of a slide in 1979.
- Large coniferous tree on south side of headscarp has been undercut by landslide.
- Seepage appears to be at the contact between Glaciomarine and colluvium in landslide scarp.

Figure 4. 2217 Berkley Avenue – View of backyard looking south

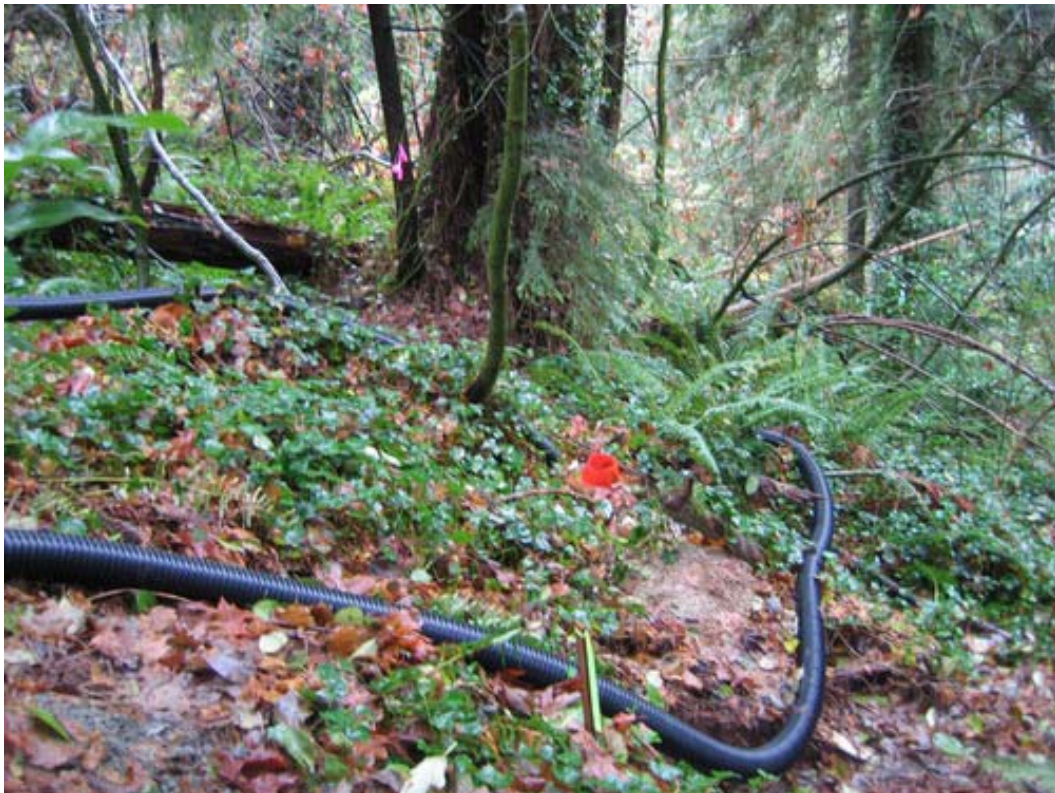
- Owner notes that a DNV geotechnical engineer has been doing work on this property. A deep test pit and a piezometer (installed in lawn) remain on site.
- Three corrugated pipes lead down slope. Rain is directed by a tarp on the back lawn to flow down these pipes. Installed after January 2005 slide.

Figure 2. 2223 Berkley Avenue - End of drainage pipes down-slope

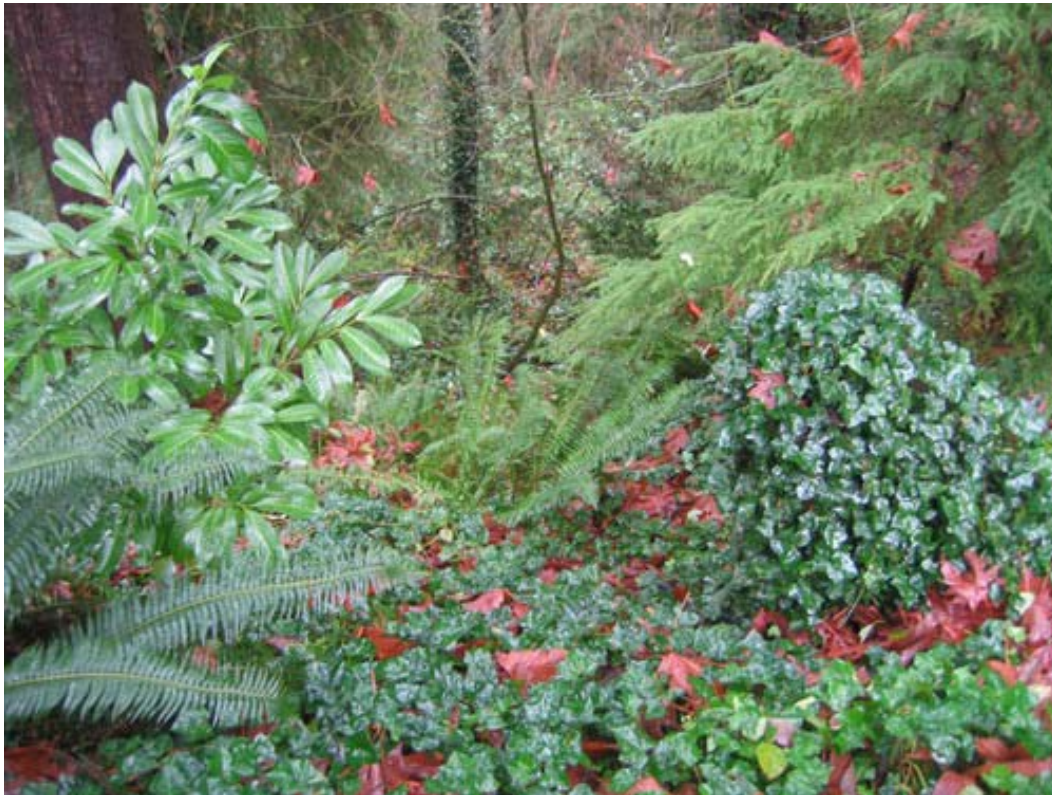
<b>SLOPE BELOW FENCE/ RETAINING STRUCTURE</b>	SLOPE = 33°		
	CRACKS	SLIDES	EROSION
			<input checked="" type="checkbox"/>
<b>OBSERVATIONS:</b> Minor erosion below trees.

Figure 3. 2223 Berkley Avenue - View down-slope from crest

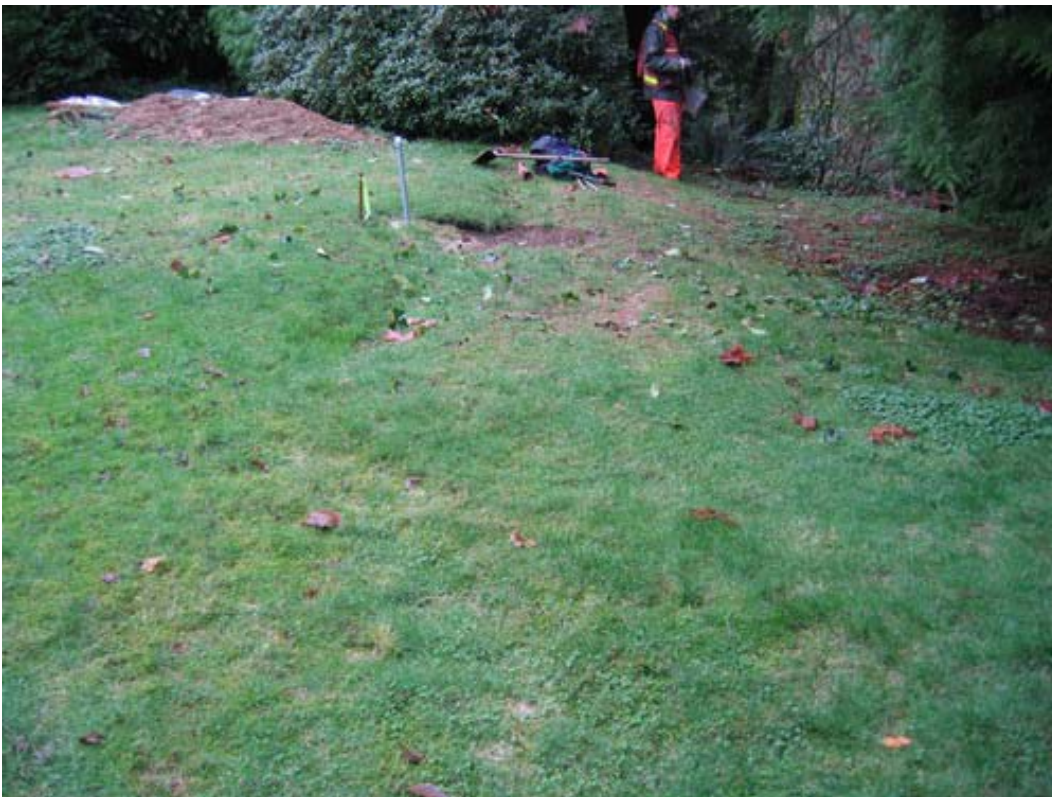
<b>DEFORMATION IN BACKYARD</b>	YES <input checked="" type="checkbox"/>	NO
<b>LOCATION:</b> Backyard		
<b>DESCRIPTION:</b> Slumping observed near crest of slope.

Figure 4. 2223 Berkley Avenue – Slumping in backyard
