**SITE OBSERVATION FORM:** DNV Landslide Risk Assessment  
**LOCATION:** 2249 Berkley Avenue  
**INSPECTION DATE:** (mm/dd/yy) 11/09/05  
**WEATHER:** Overcast

**BGC ENGINEERING INC.**  
 AN APPLIED EARTH SCIENCES COMPANY

**Project :** DNV Landslide Risk Assessment

**Project No. :** 0404-002-01

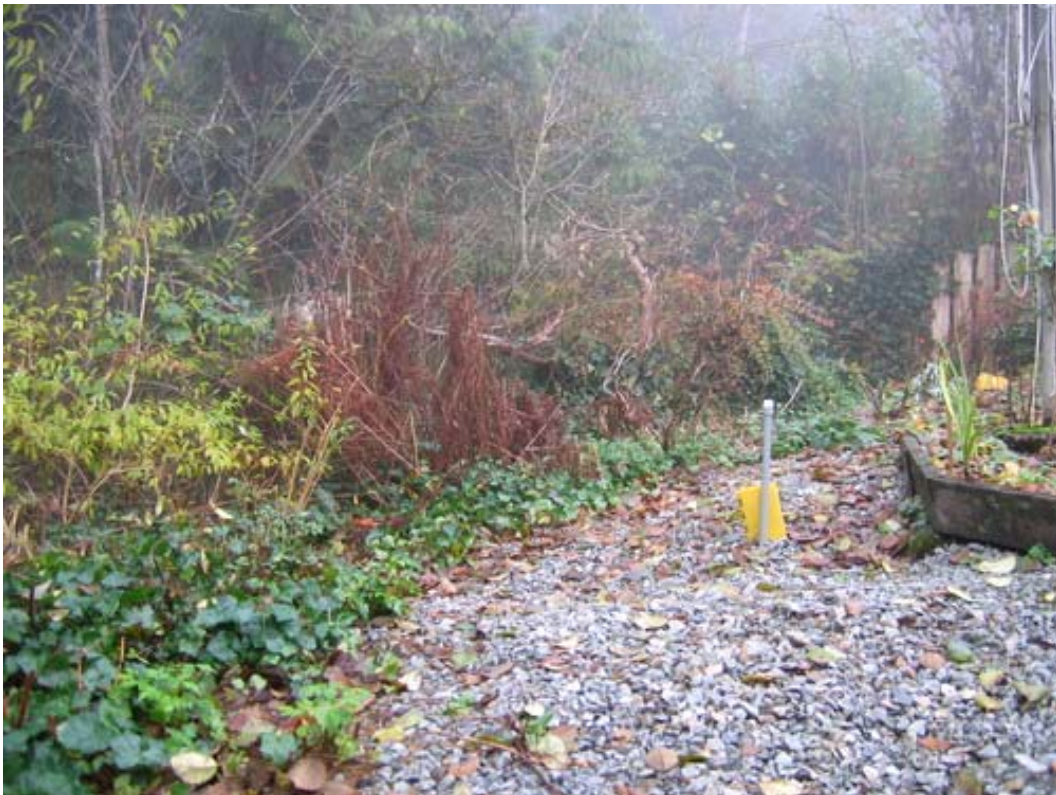
- Crack on south side of property reported in the 1980 Klohn report is not observed
- Seepage all year round approximately 50 m down slope according to owner
- According to owner, site inspected by an engineer. Test pits and piezometer observed.

Figure 2. 2249 Berkley Avenue – View looking north along crest with marked piezometer

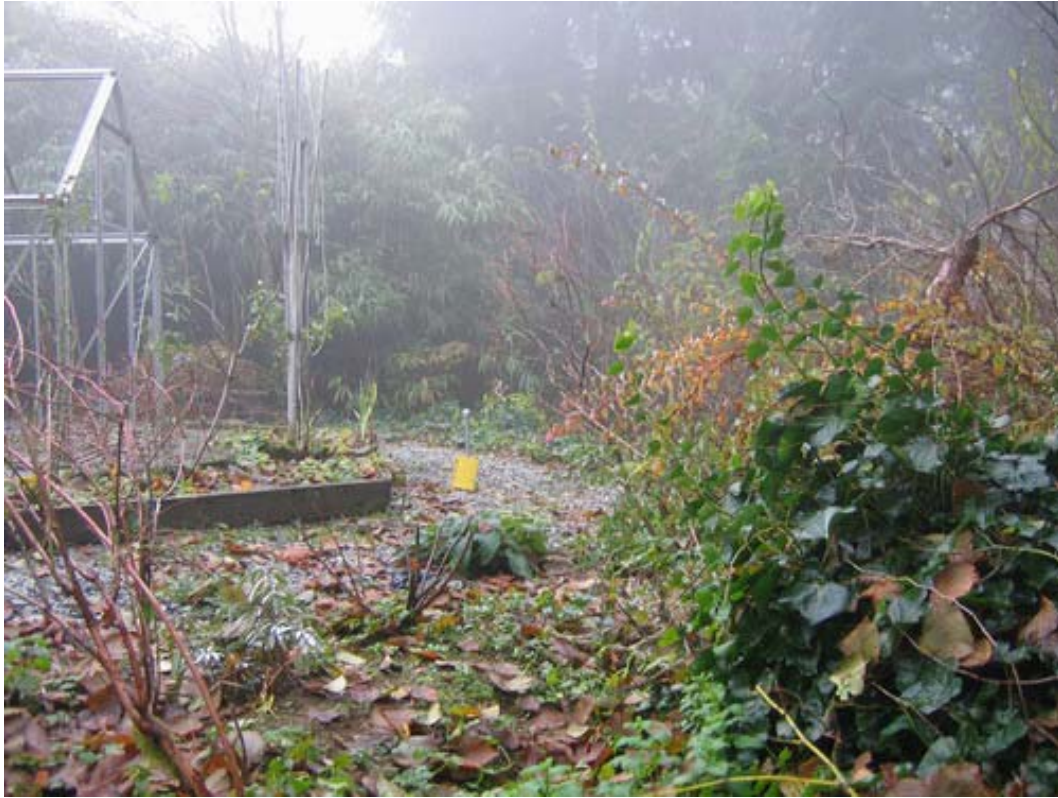
Figure 3. 2249 Berkley Avenue – View looking south along crest with marked piezometer

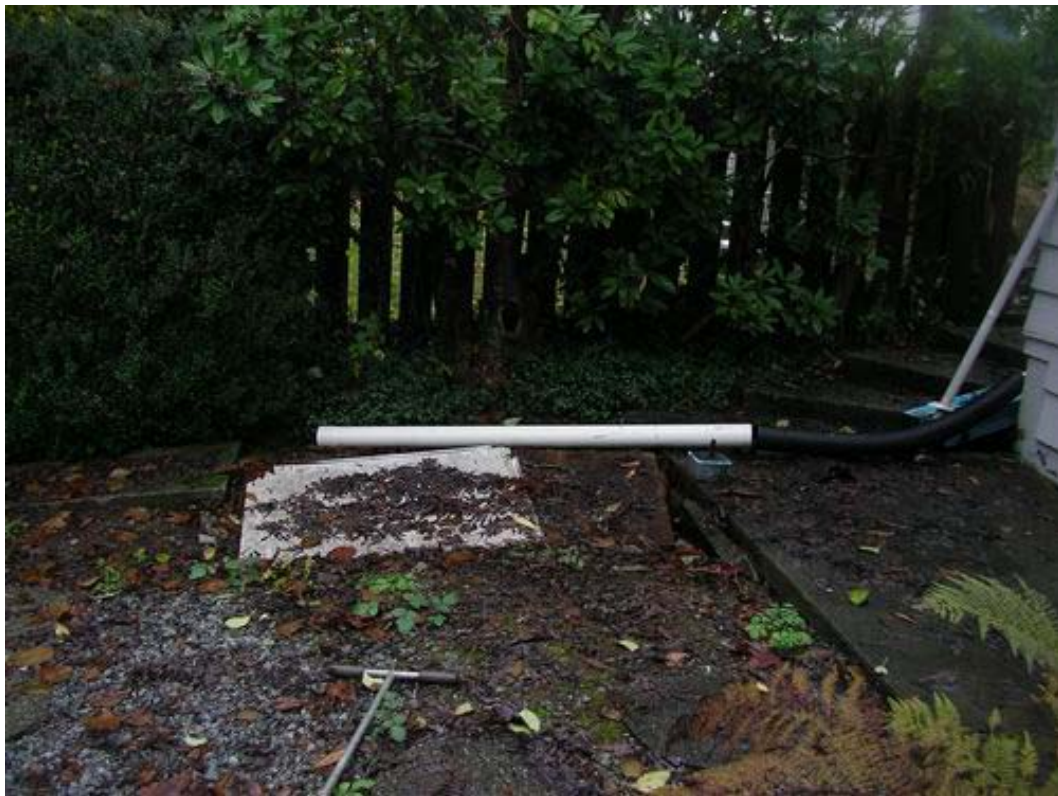
Figure 4. 2249 Berkley Avenue – Drainage pipe exit

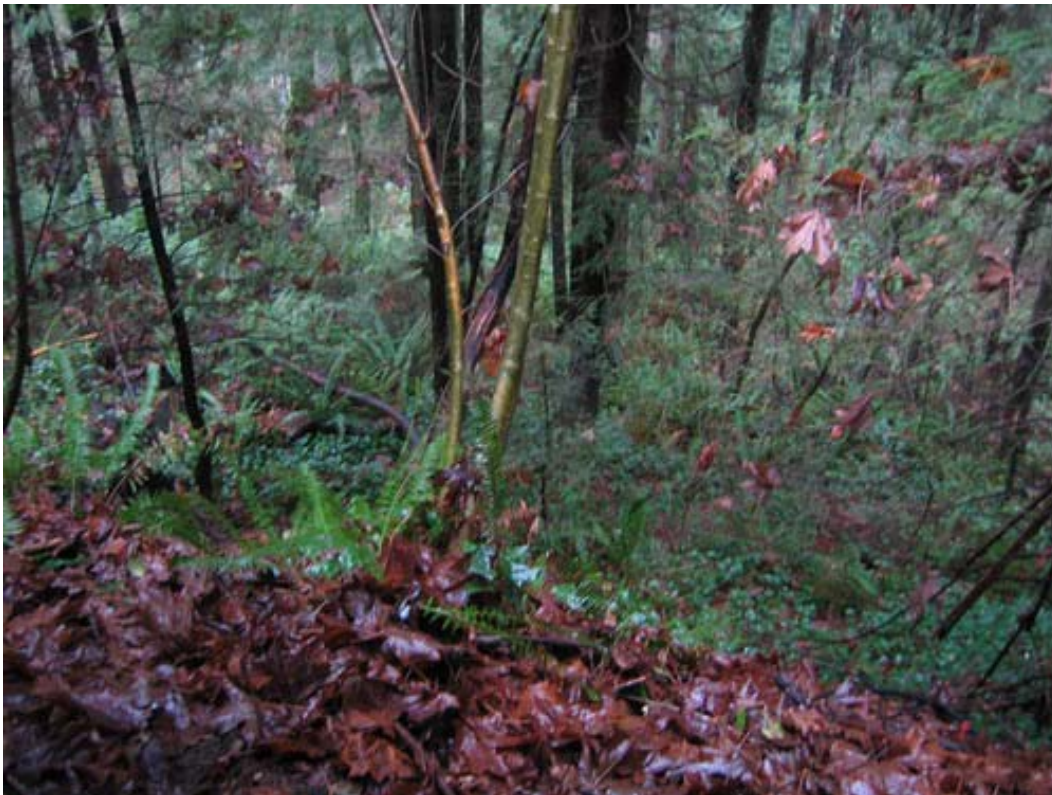
<b>SLOPE BELOW CREST/ RETAINING STRUCTURE</b>	<b>SLOPE = 34°</b>		
	<b>CRACKS</b>	<b>SLIDES</b>	<b>EROSION</b>
			<input checked="" type="checkbox"/>
<b>OBSERVATIONS:</b> Some erosion immediately below fence at slope crest, soil oversteepened.

<b>GENERAL OBSERVATIONS</b>
<ul style="list-style-type: none"> <li>• Drainage pipe discharges at the top of the slope on the north side of the lawn, erosion below.</li> <li>• Compost and debris dumped over the crest of the slope.</li> <li>• Deck distance to crest is 12.1 m.</li> </ul>

Figure 2. 2251 Berkley Avenue – View down-slope from crest

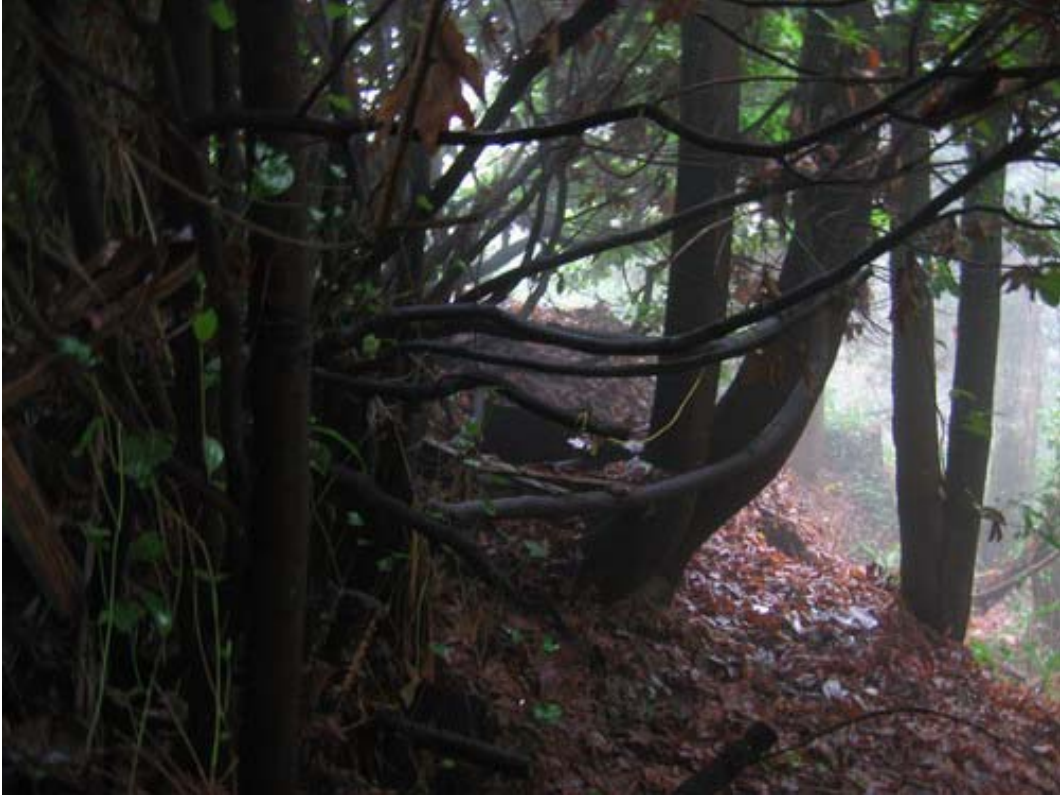
Figure 3. 2251 Berkley Avenue – View looking south along crest

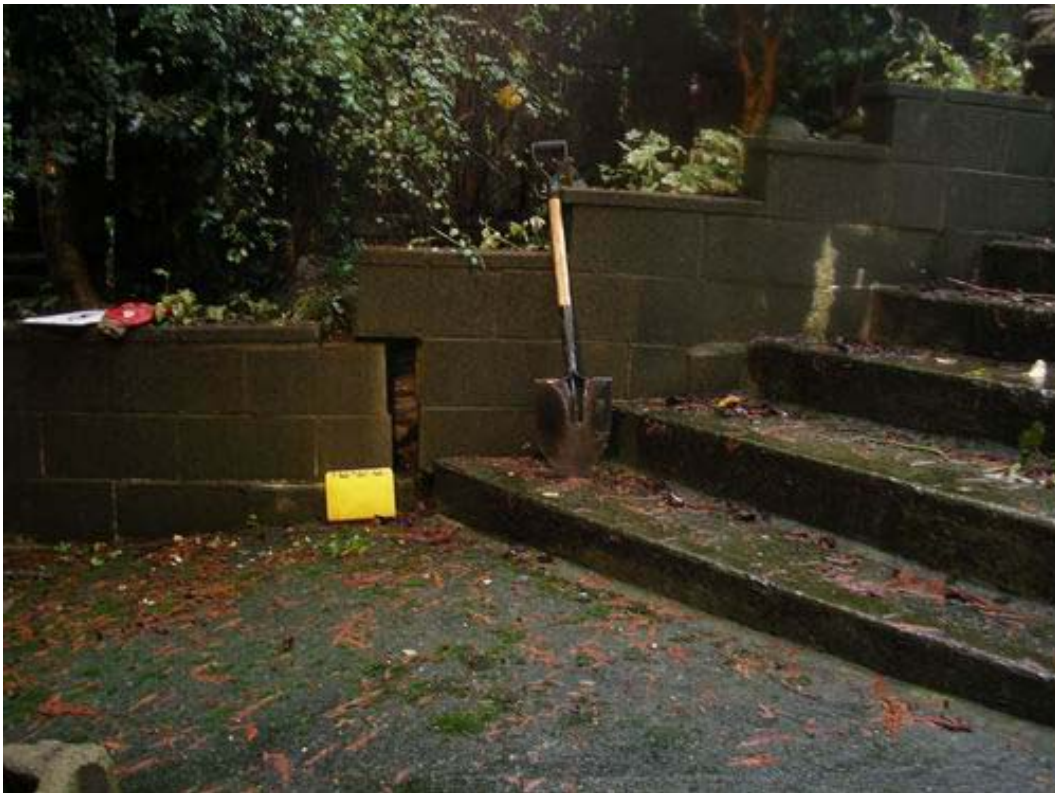
<b>RETAINING STRUCTURES</b>	YES <input checked="" type="checkbox"/>	NO	HEIGHT= 0.7 m –0.8 m
TYPE	BLOCKS	CONCRETE	TIMBER CRIB
DEFORMATION	UNDEFORMED	CRACKED	SETTLED
OBSERVATIONS: Timber crib appears intact, it was constructed after the concrete retaining wall/ patio cracked and fell. Owner notes that concrete slab broke off after an earthquake approximately 20 years ago.

Figure 2. 2265 Berkley Avenue – Large crack in retaining wall

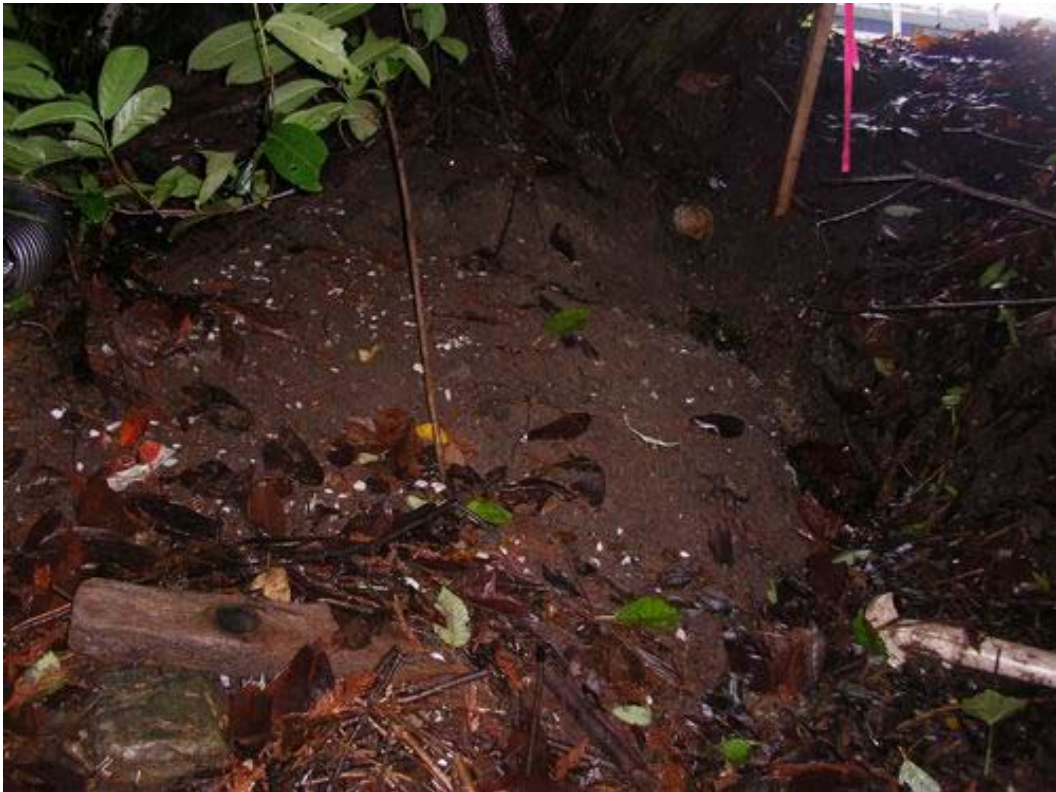
- GENERAL OBSERVATIONS**
- Unable to place AH02 closer than 25 m down slope from crest due to concrete and debris from broken patio.
  - Crest line AH01 is estimated due to refusal on gravel fill.
  - Drainage from the roof drains onto slope 3 m from crest at south side of property. Property to south has a drain causing slope erosion.

Figure 3. 2265 Berkley Avenue – Significant erosion from pipe draining at crest

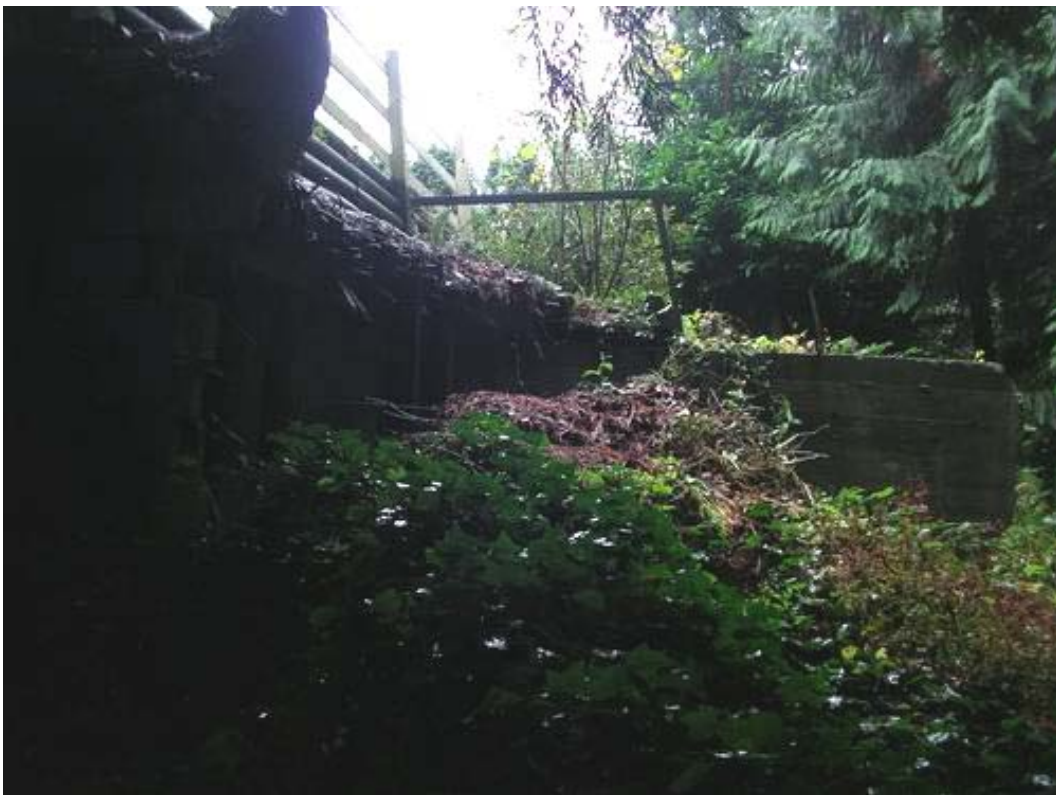
Figure 4. 2265 Berkley Avenue – Concrete retaining wall

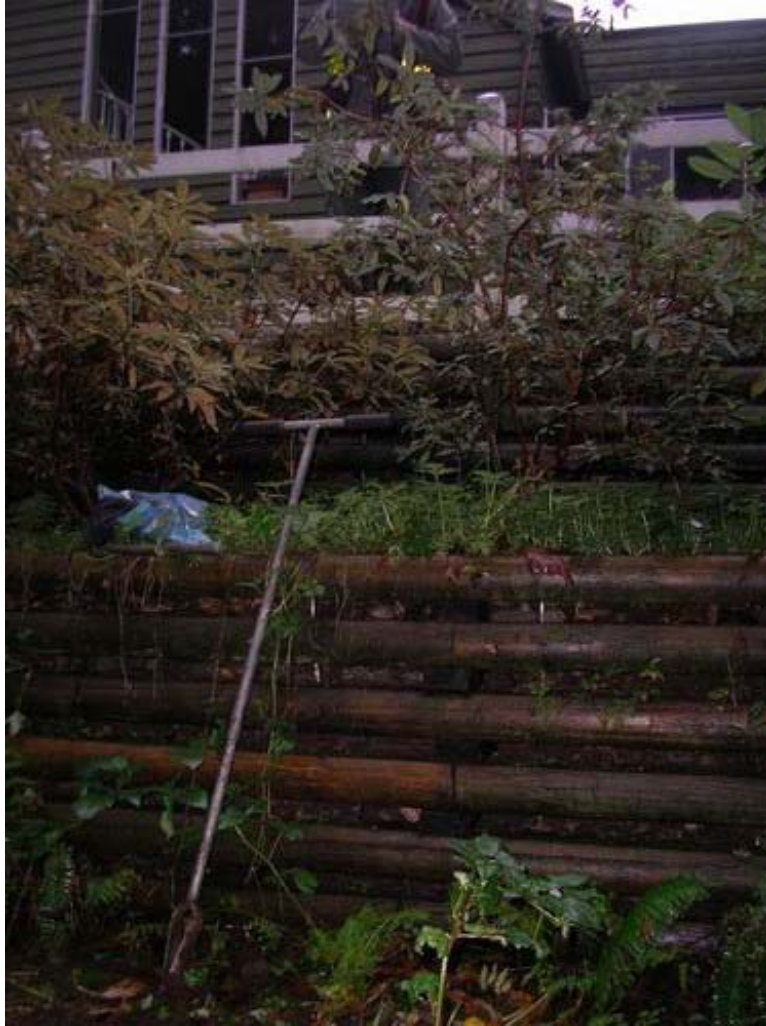
<b>SLOPE BELOW FENCE/ RETAINING STRUCTURE</b>	SLOPE = 36° to inflection point and 20° after inflection		
	CRACKS	SLIDES	EROSION
OBSERVATIONS: Slope angle taken from below the fallen retaining wall/patio for 15 m then slope changes to 20°. 4 tiers of crib wall 0.7-0.8 m high on the south side of property.			<input checked="" type="checkbox"/>

Figure 5. 2265 Berkley Avenue – Two tiers of a four tiered timber crib retaining wall

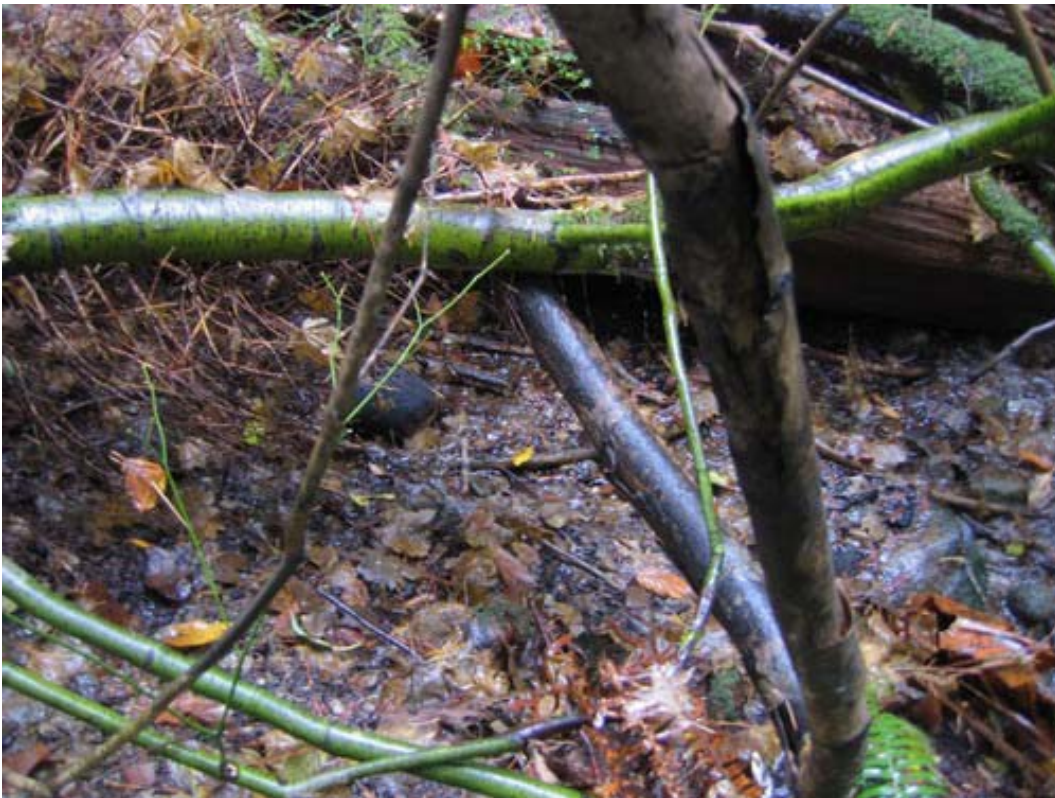
<b>SEEPAGE/ SPRINGS IN OR BELOW FILL</b>	YES <input checked="" type="checkbox"/>	NO
OBSERVATIONS: Running water is pooling at inflection point in the slope.

Figure 2. 2279 Berkley Avenue – Seepage zone down-slope

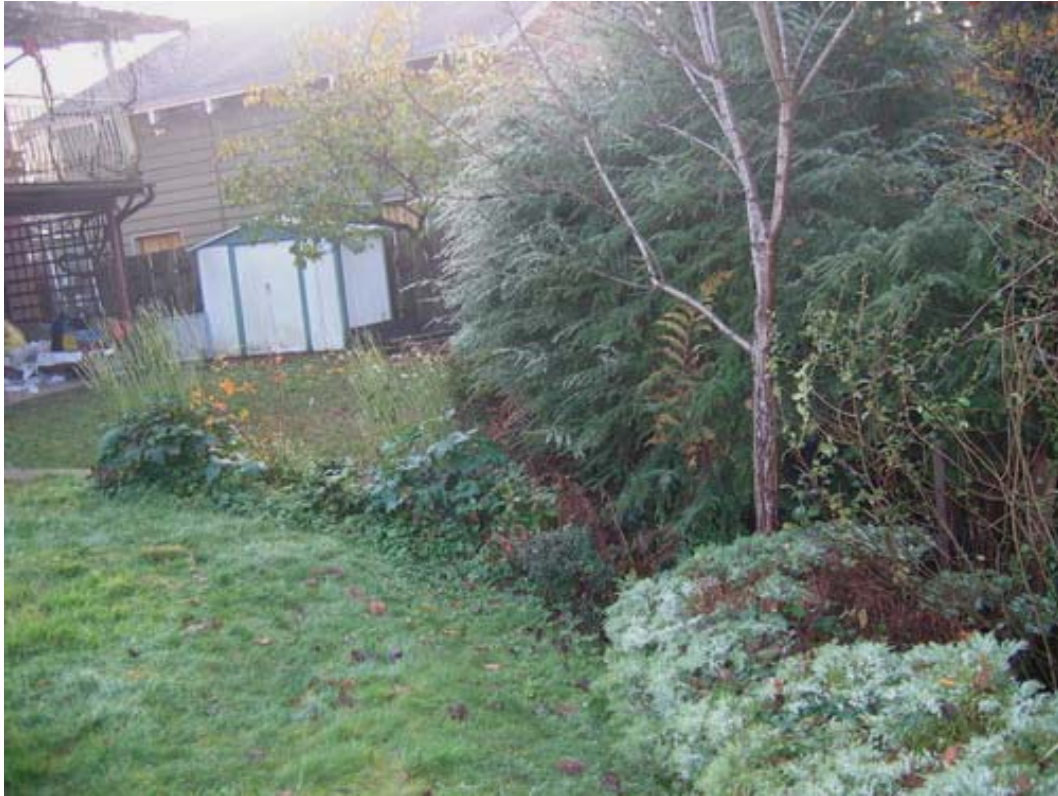
Figure 3. 2279 Berkley Avenue – View looking south along crest

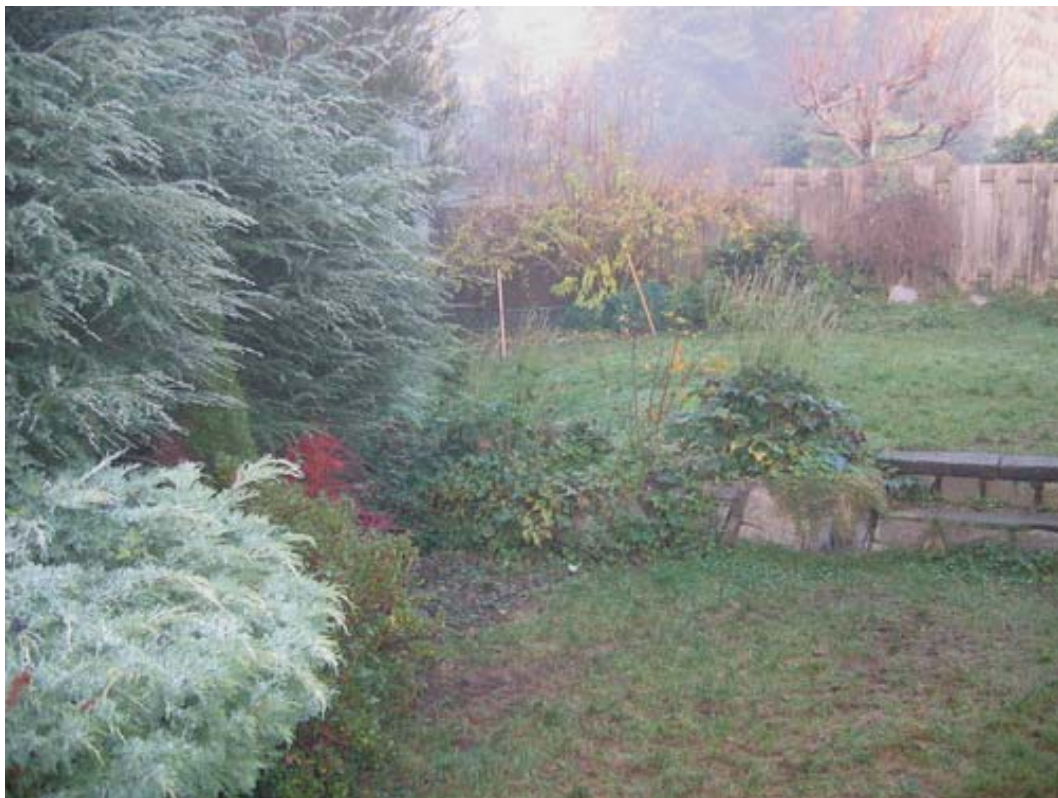
Figure 4. 2279 Berkley Avenue – View looking north along crest

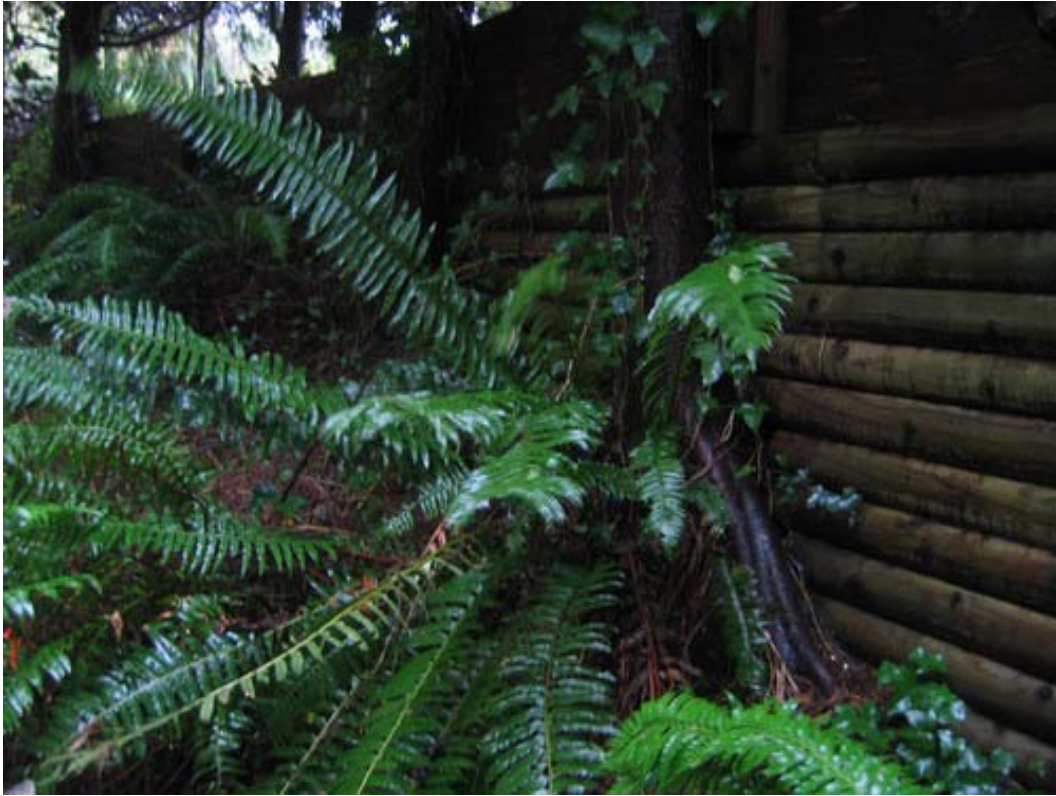
<b>RETAINING STRUCTURES</b>	YES <input checked="" type="checkbox"/>	NO	HEIGHT= 2.50 m
TYPE	BLOCKS	CONCRETE	TIMBER CRIB
			OTHER: Landscape ties and planks
DEFORMATION	UNDEFORMED	CRACKED	SETTLED
	<input checked="" type="checkbox"/>		BULGING
OBSERVATIONS: Terraced retaining walls in 2 steps. Wall at crest is 1.4 m high and second wall with pathway on terrace is 1.1 m high.

Figure 5. 2279 Berkley Avenue – Timber crib retaining wall

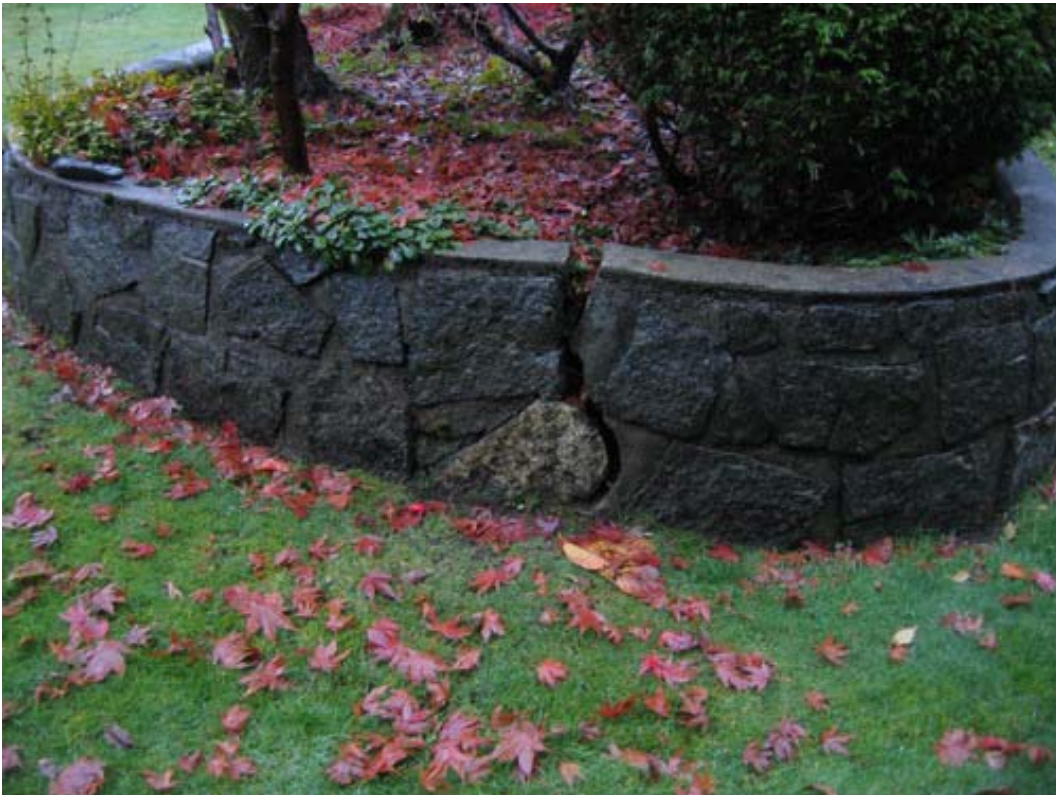
DEFORMATION IN BACKYARD	YES	NO <input checked="" type="checkbox"/>
LOCATION:		
DESCRIPTION:	Cracked stone planter

Figure 2. 2293 Berkley Avenue - Cracked planter near slope crest

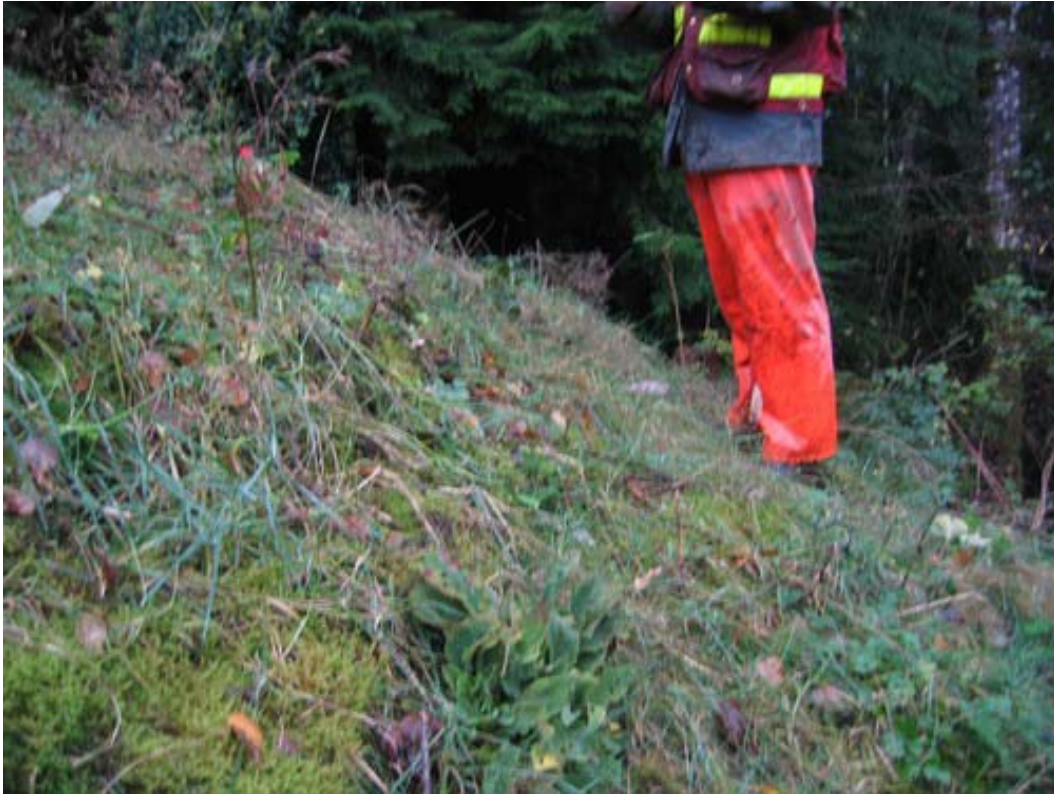
SLOPE BELOW FENCE/ RETAINING STRUCTURE	SLOPE = 35°		
	CRACKS	SLIDES	EROSION
		<input checked="" type="checkbox"/>	
<b>OBSERVATIONS:</b> Most of slope covered by branches/fallen logs. A series of 2 m wide slump features is located 4 m downslope from crest on south end of yard.

Figure 3. 2293 Berkley Avenue – Slumping near crest of slope
