SITE OBSERVATION FORM: DNV Landslide Risk Assessment
LOCATION: 2307 Berkley Avenue
INSPECTION DATE: (mm/dd/yy) 11/09/05
WEATHER: Raining, heavy rain for several days prior to visit.

BGC ENGINEERING INC.
 AN APPLIED EARTH SCIENCES COMPANY

Project : DNV Landslide Risk Assessment

Project No. : 0404-002-01

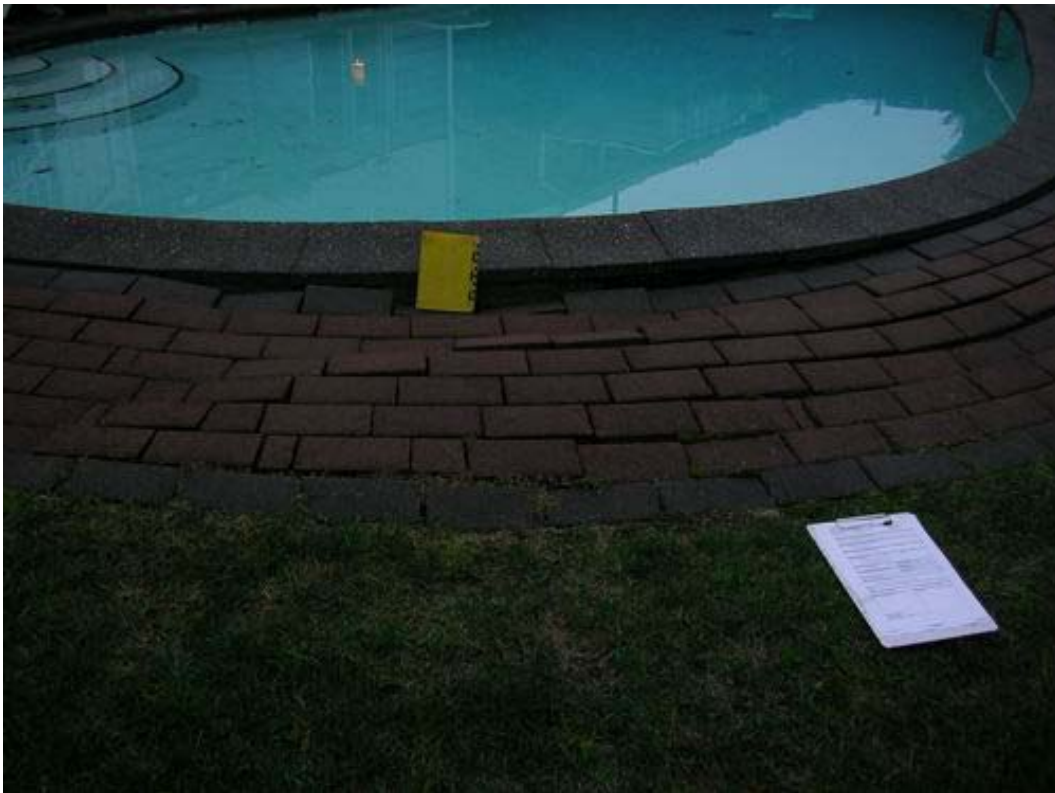
| POOLS | YES <input checked="" type="checkbox"/> | NO |
|--|---|---|
| DESCRIPTION: Settlement around pool, cracked pool deck | | |

Figure 2. 2307 Berkley Avenue – Settling around pool deck

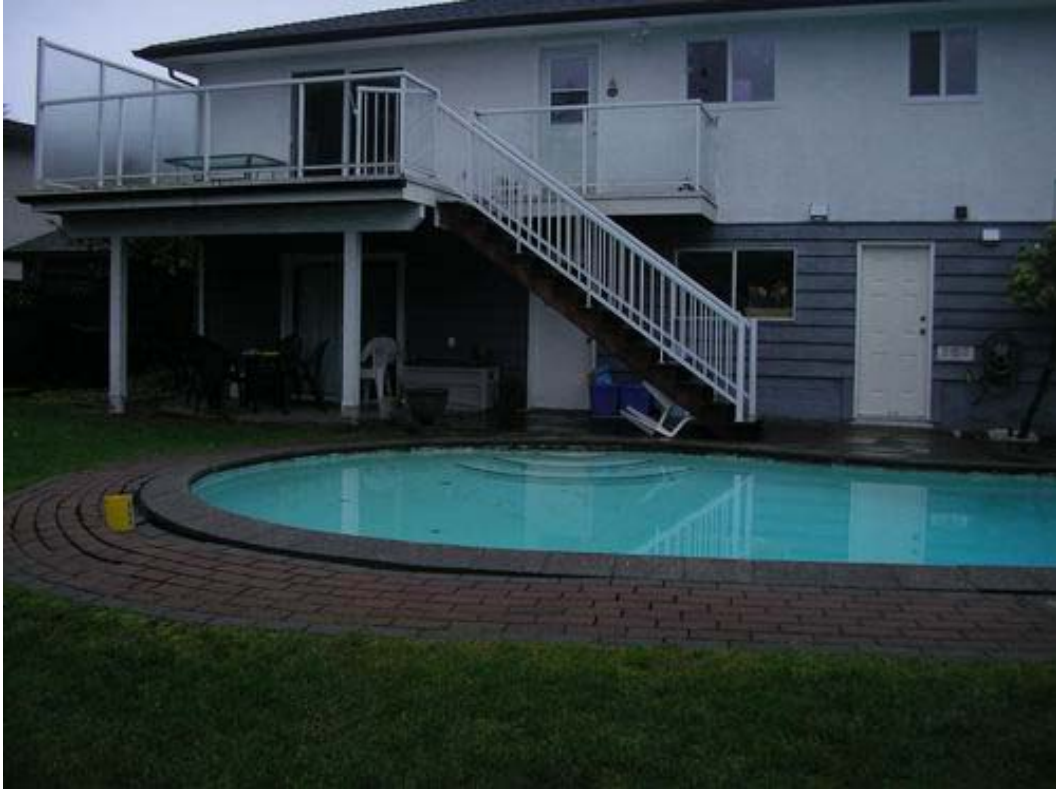
Figure 3. 2307 Berkley Avenue – Backyard and settlement around pool

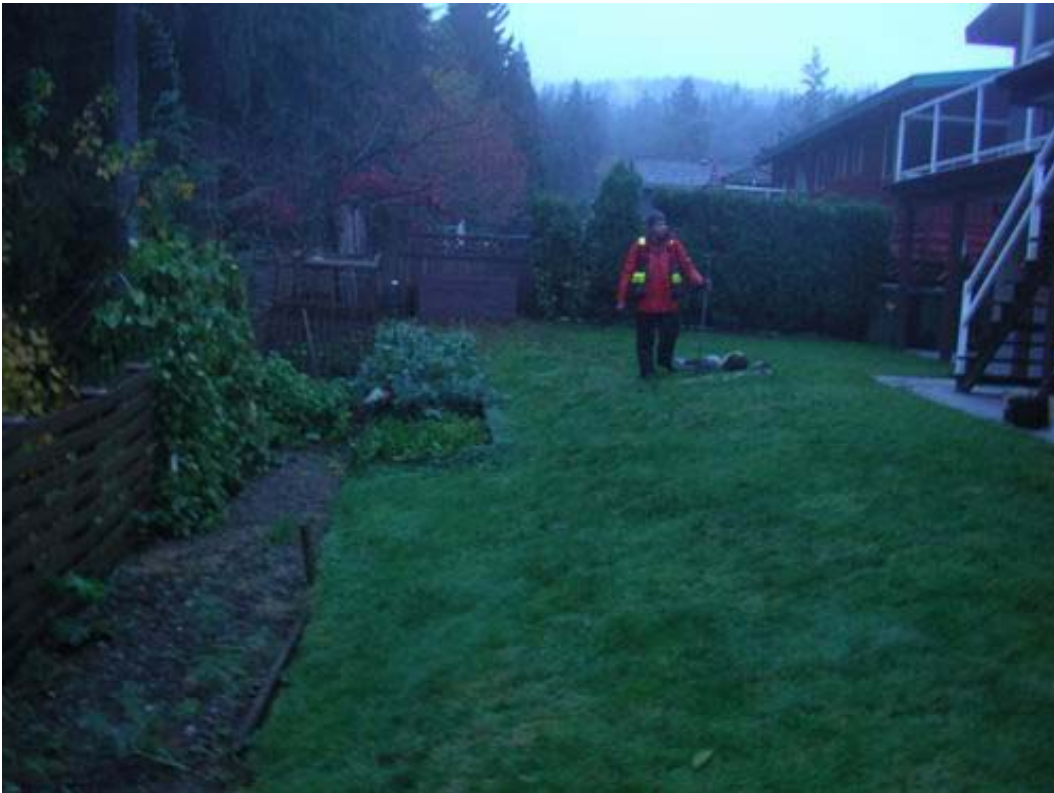
| DEFORMATION IN BACKYARD | YES <input checked="" type="checkbox"/> | NO |
|--|---|---|
| LOCATION: North end of crest line. | | |
| DESCRIPTION: Shallow slump in lawn sloping 12° towards garden. | | |

Figure 2. 2321 Berkley Avenue – View looking north along crest

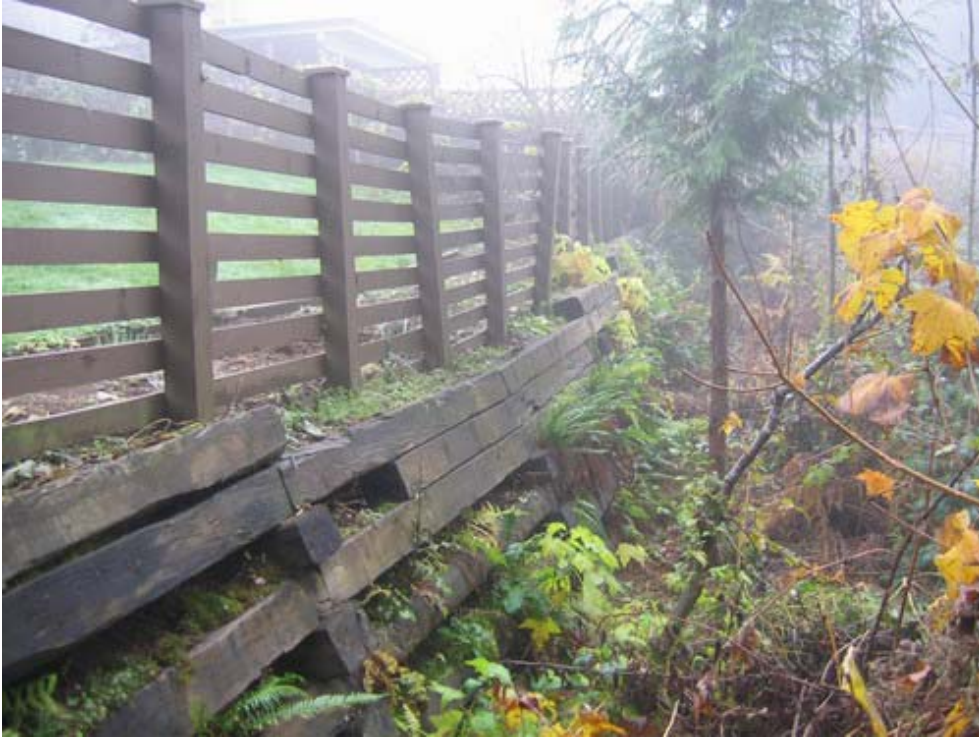
| RETAINING STRUCTURES | YES <input checked="" type="checkbox"/> | NO | HEIGHT= 1.3 m |
|--|---|---|--|
| OBSERVATIONS: Part of retaining wall is slightly sagging. Possible older retaining wall down slope of existing wall (covered by brush) | | | |

Figure 3. 2321 Berkley Avenue – Settled retaining wall

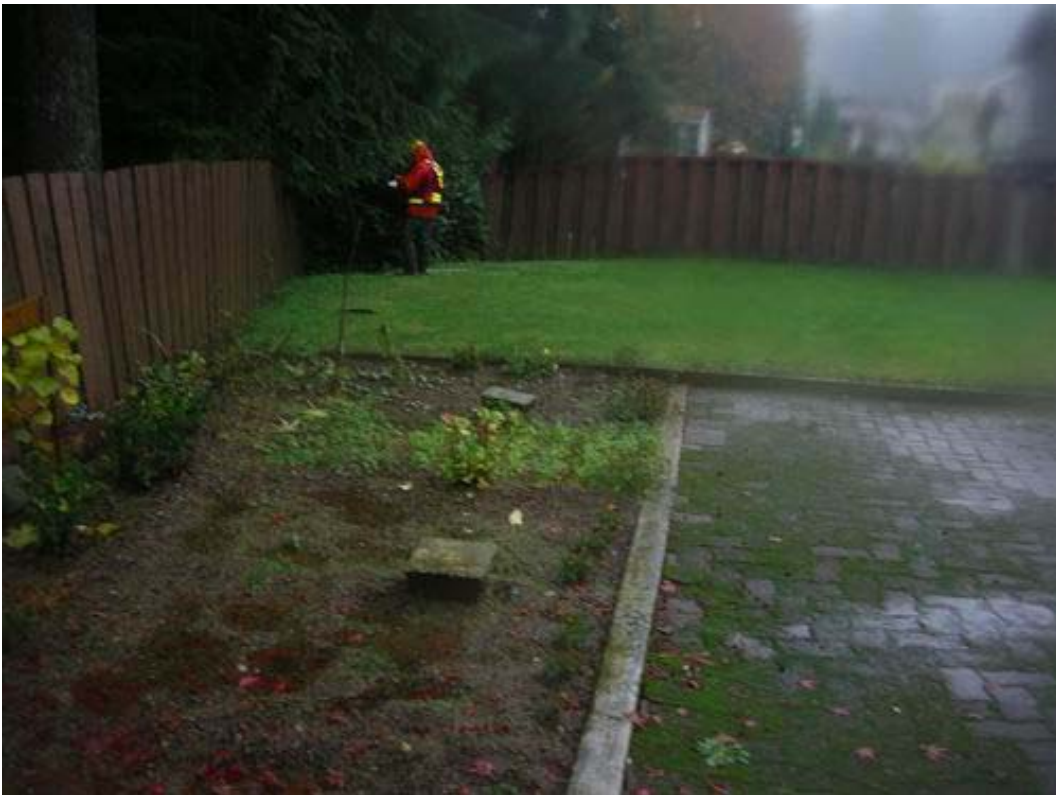
- Water dripping from deck causes lawn to be saturated near house.
- Minor settlement in tiles by garden and lawn by house.
- Compost and garden waste deposited on crest and behind fence.

Figure 2. 2335 Berkley Avenue – View looking north along fenceline

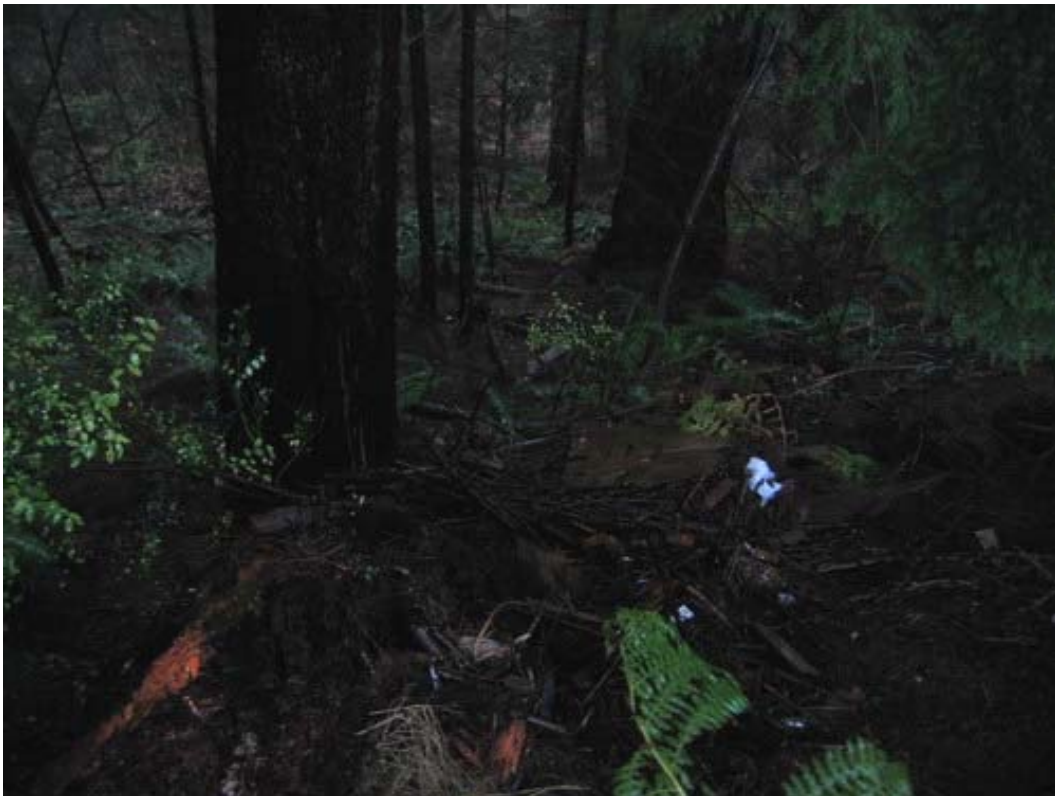
| SLOPE BELOW FENCE/ RETAINING STRUCTURE | SLOPE = 35° | | |
|--|---|---|---|
| OBSERVATIONS: Evidence of erosion below trees | | | <input checked="" type="checkbox"/> |

- Large amount of compost/debris pushed over edge of crest

Figure 2. 2349 Berkley Avenue – View down-slope from crest

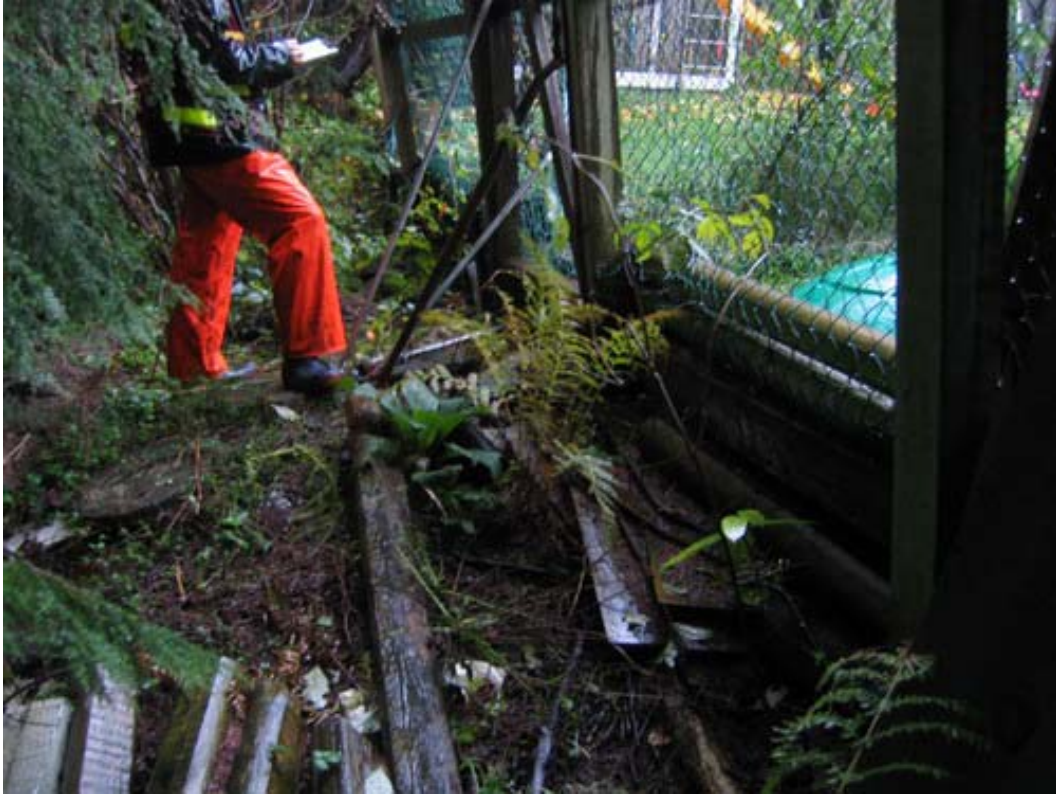
| RETAINING STRUCTURES | YES <input checked="" type="checkbox"/> | NO | HEIGHT = 0.45 m |
|---|---|---|---|
| OBSERVATIONS: Fence above the retaining structure is tilted downslope. | | | |

Figure 3. 2349 Berkley Avenue – Retaining wall/fence near crest

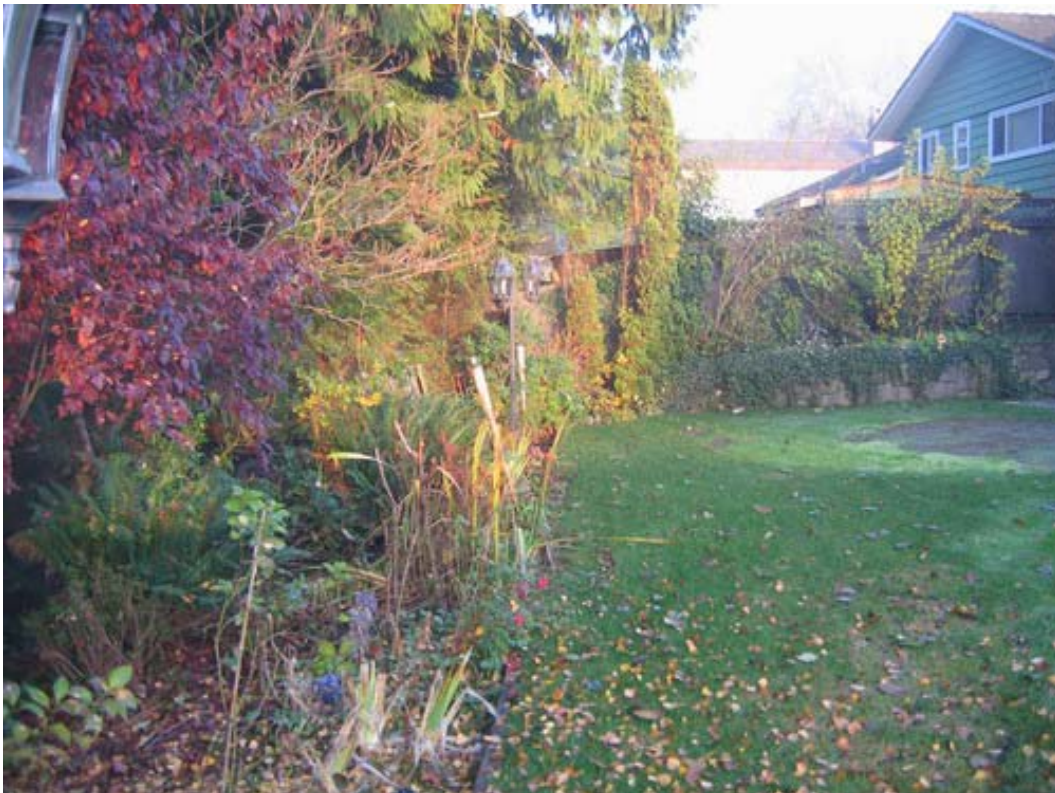
| SLOPE BELOW FENCE/ RETAINING STRUCTURE | SLOPE = 38° | | |
|--|---|---|---|
| OBSERVATIONS: Site of previous landslide. Considerable surficial erosion. | | | |

Figure 2. 2363 Berkley Avenue – View looking north along crest

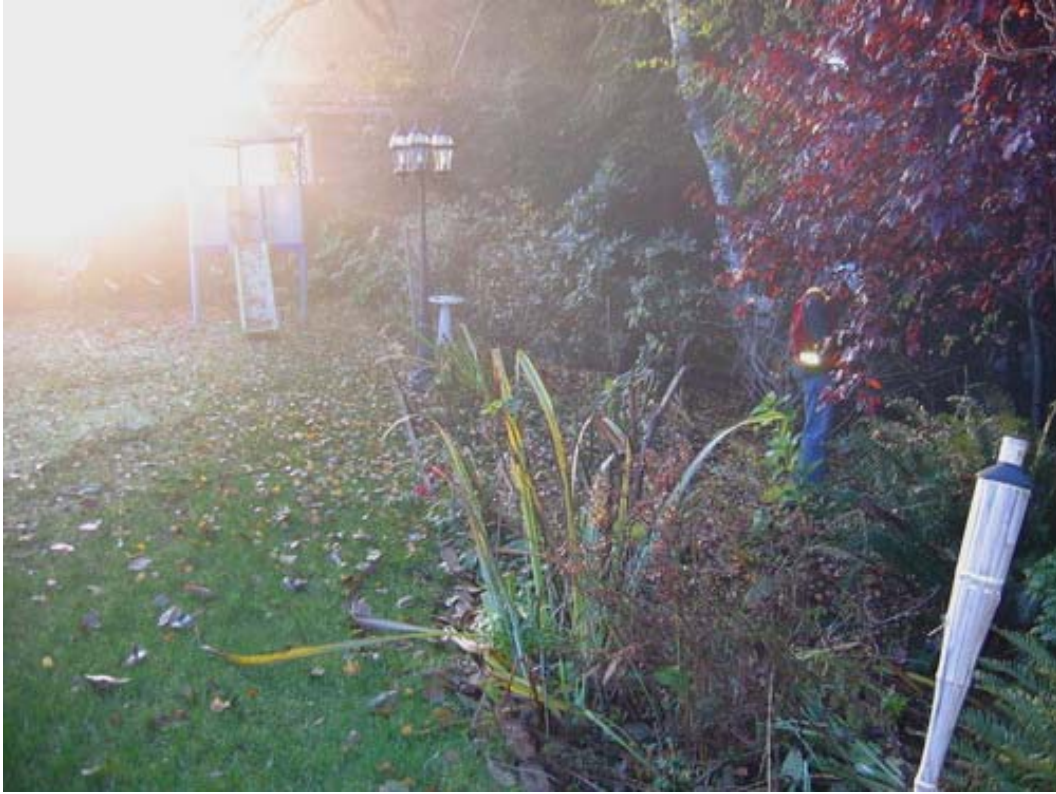
- A high-flow drainage pipe empties on to top of slope at south end of yard.
- Site of a recent landslide between 2363 and 2349 Berkley Road.
- Balcony to crest distance is 9.8 m

Figure 3. 2363 Berkley Avenue – View looking south along crest
