**SITE OBSERVATION FORM:** DNV Landslide Risk Assessment  
**LOCATION:** 2377 Berkley Avenue  
**INSPECTION DATE:** (mm/dd/yy) 11/10/05  
**WEATHER:** Raining, heavy rain for several days prior to visit.

**Project :** DNV Landslide Risk Assessment

**Project No. :** 0404-002-01

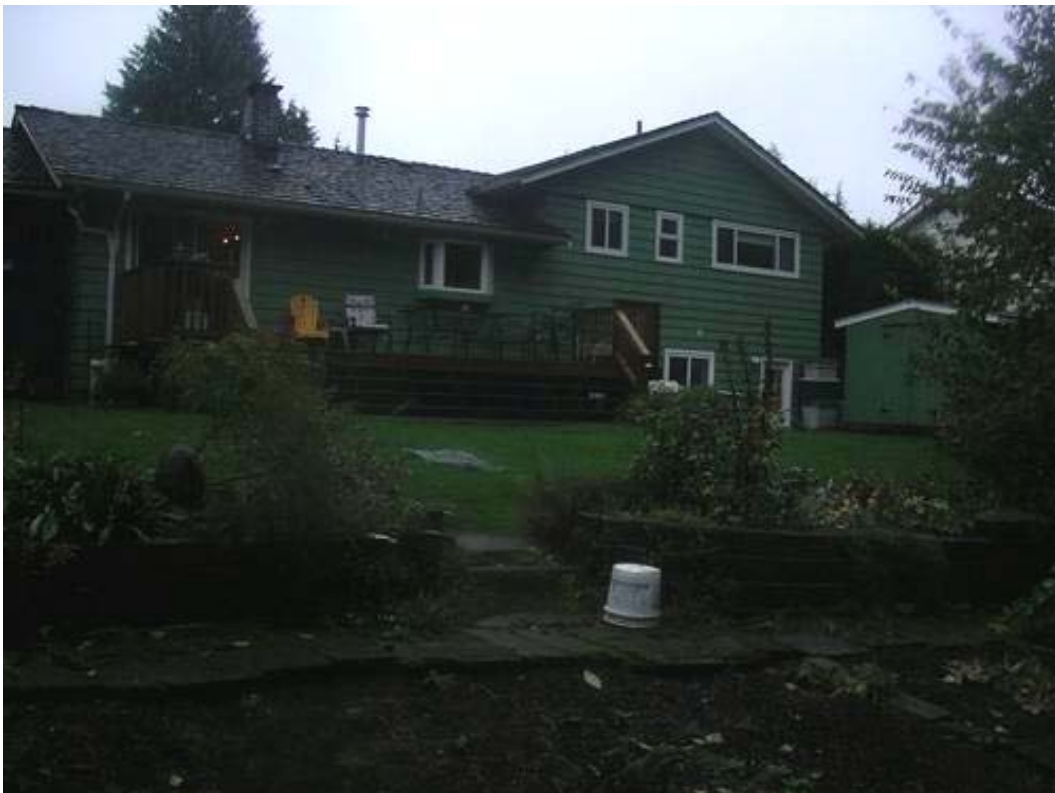
DEFORMATION IN BACKYARD	YES <input checked="" type="checkbox"/>	NO
LOCATION: Backyard garden at crest.		
DESCRIPTION: Minor circular settlement on lawn near deck. Garden retaining wall is cracks and displaced, causing some settlement in garden.

Figure 2. 2377 Berkley Avenue – View of backyard

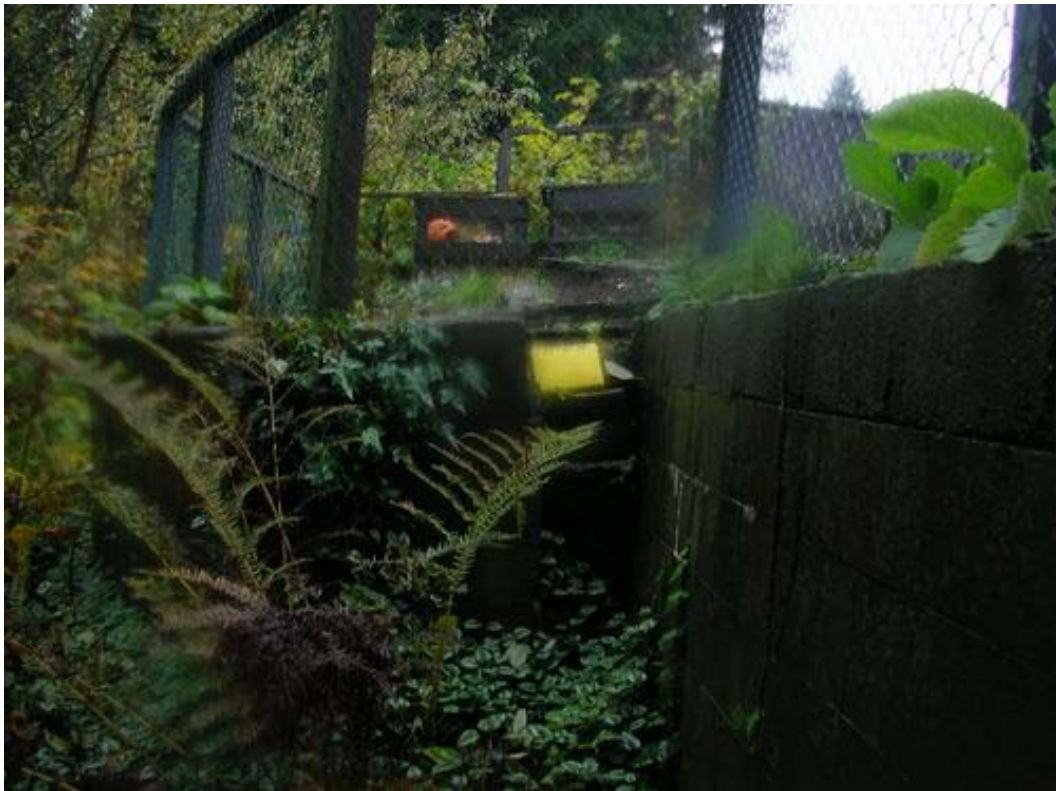
RETAINING STRUCTURES	YES <input checked="" type="checkbox"/>	NO	HEIGHT= 1.6 m
TYPE	BLOCKS	CONCRETE	TIMBER CRIB
	<input checked="" type="checkbox"/>	<input checked="" type="checkbox"/>	
DEFORMATION	UNDEFORMED	CRACKED	SETTLED
		<input checked="" type="checkbox"/>	BULGING
<b>OBSERVATIONS:</b> 8" crack in concrete block wall retaining garden and approx. 1/2 the yard. Wall is tilted down slope..

Figure 4. 2377 Berkley Avenue – Concrete retaining wall

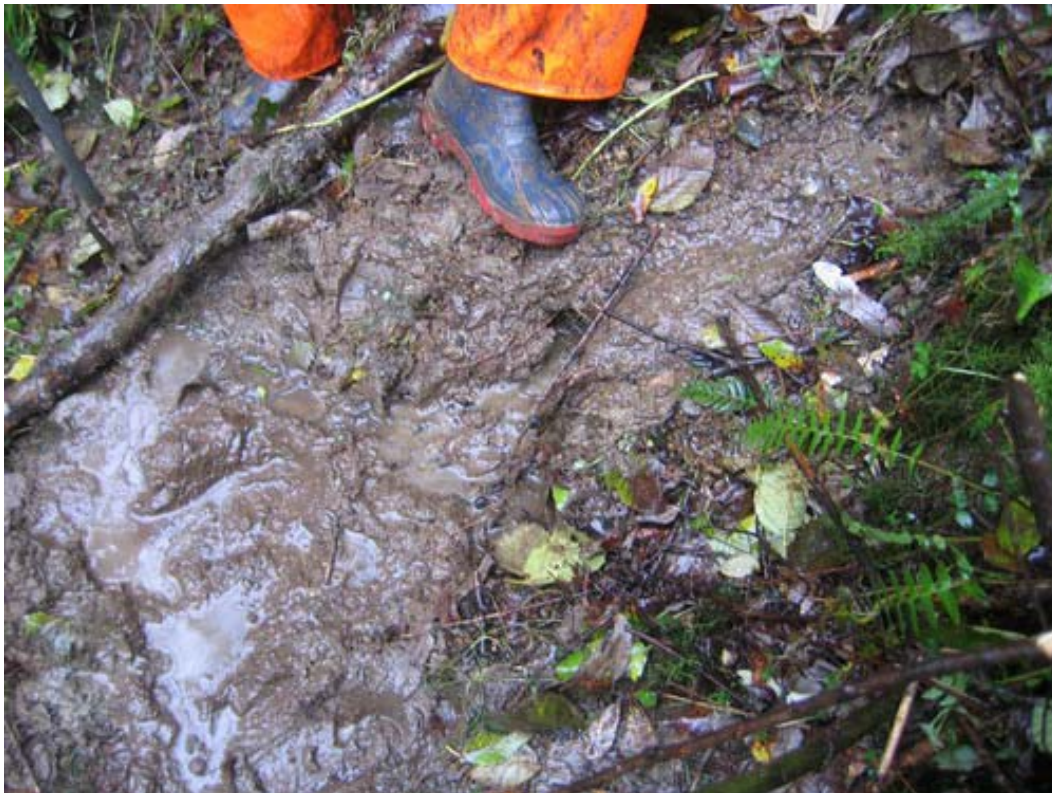
SEEPAGE/ SPRINGS IN OR BELOW FILL	YES <input checked="" type="checkbox"/>	NO
OBSERVATIONS: Considerable seepage evident at slope inflection point 10 m down slope from crest and below.

Figure 2. 2391 Berkley Avenue – Ponding of water from seepage

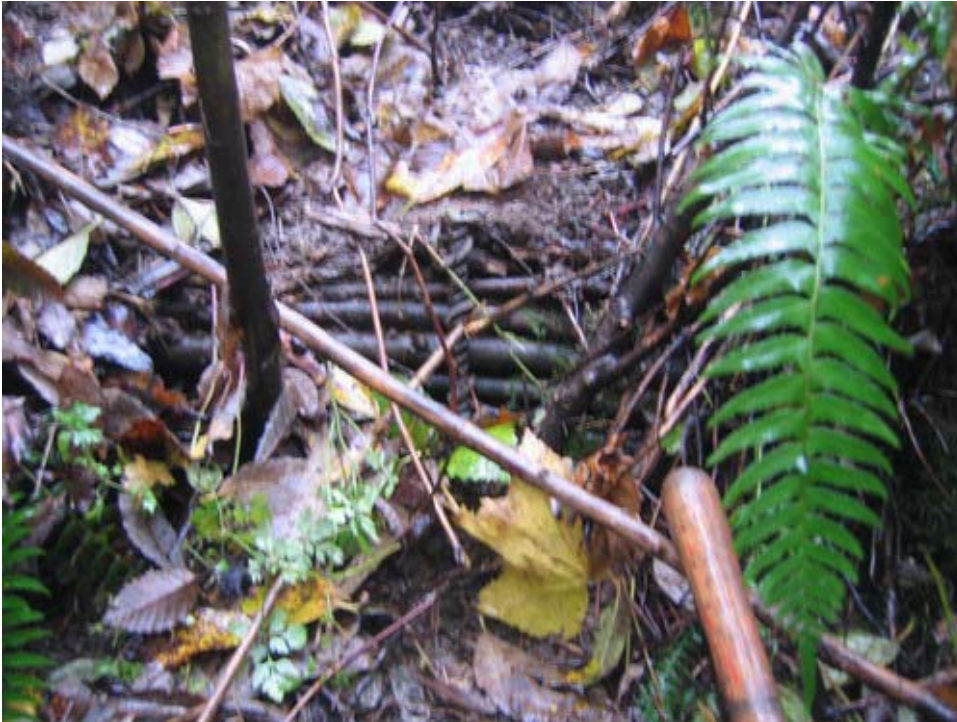
RETAINING STRUCTURES	YES <input checked="" type="checkbox"/>	NO	HEIGHT= 0.2 m	
TYPE	BLOCKS	CONCRETE	TIMBER CRIB	OTHER: Rebar & small branches
DEFORMATION	UNDEFORMED	CRACKED	SETTLED	BULGING
<b>OBSERVATIONS:</b> Many small retaining structures present throughout slope. All structures made of rebar and 1" diameter branches.

Figure 3. 2391 Berkley Avenue – Close up of rebar and stick retaining structure

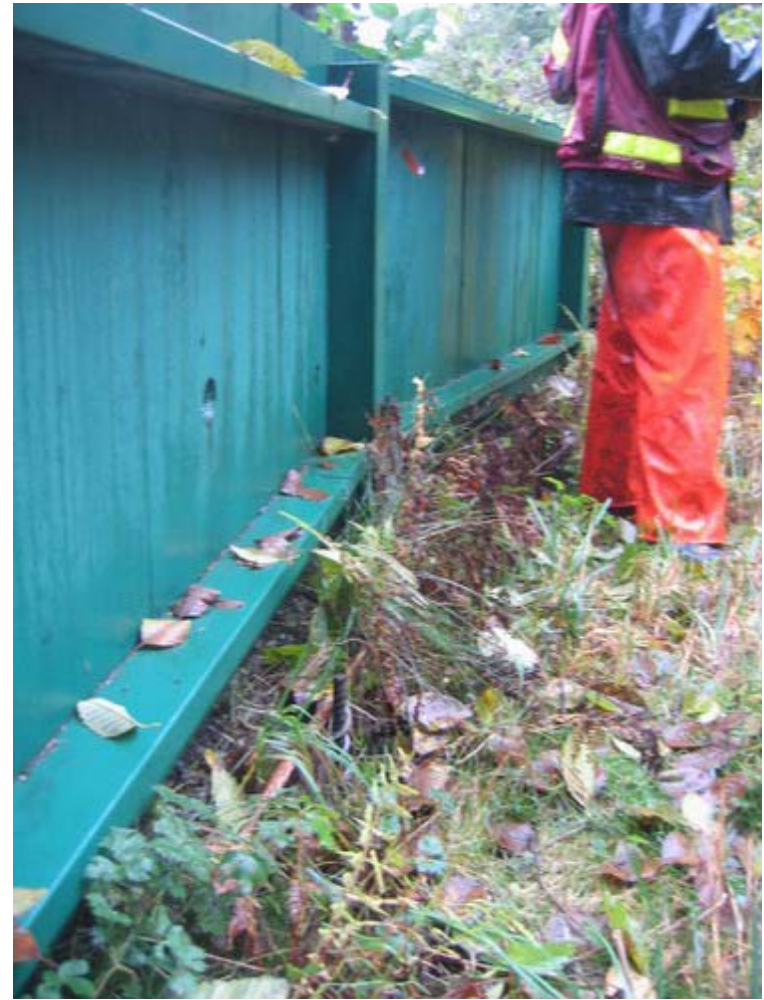
Figure 4. 2391 Berkley Avenue – Retaining wall/fence line and small retaining structures made of rebar and small sticks

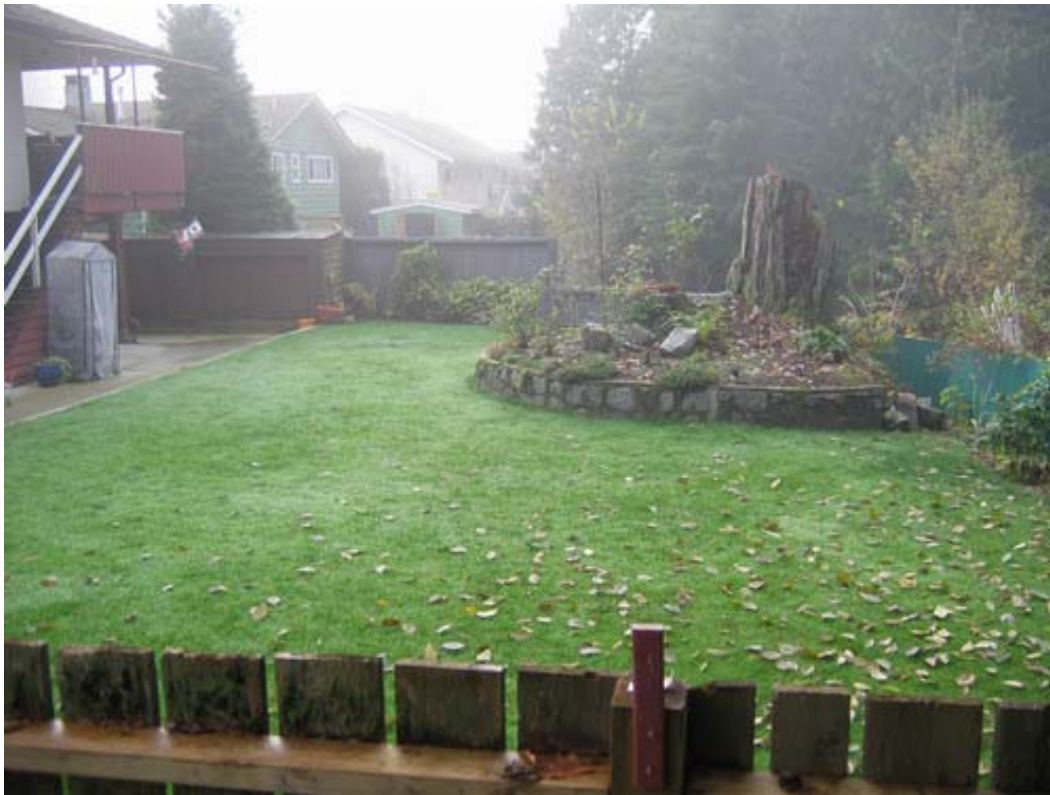
- Site of January 1999 slide
- A large 12' diameter rock and concrete planter (previously a complete circle) is now 2/3 of a circle. Planter is broken at crest of slope

Figure 5. 2391 Berkley Avenue – View looking south of backyard

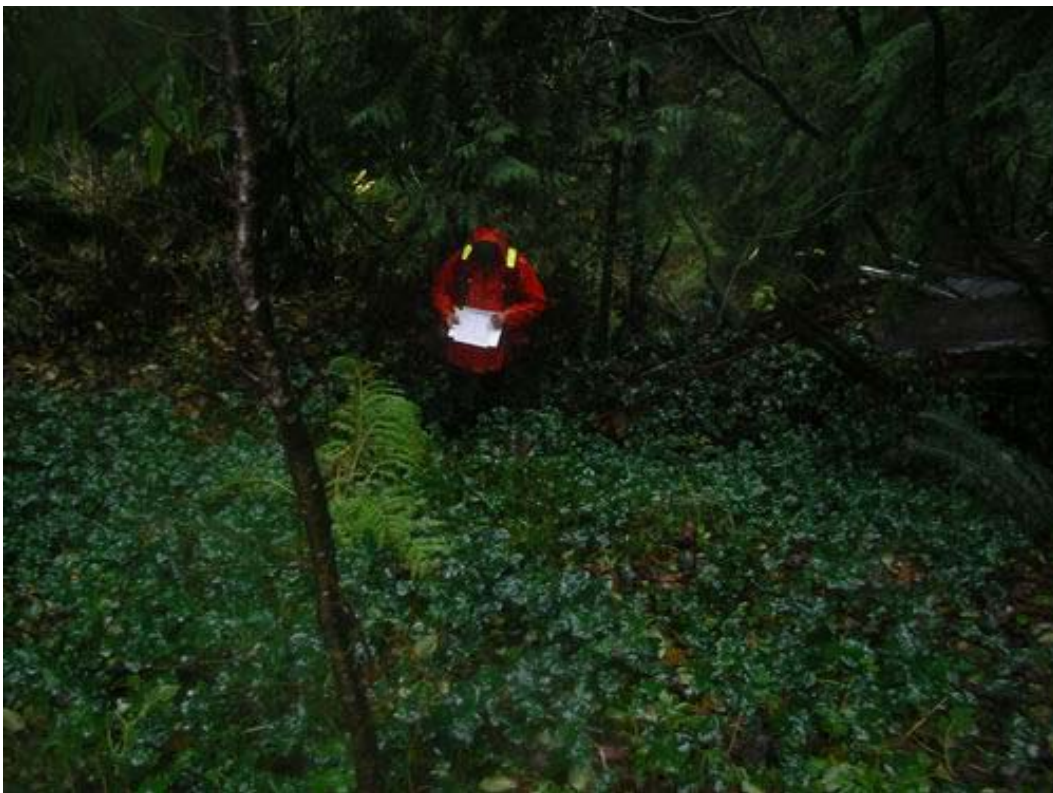
<b>SLOPE BELOW FENCE/ RETAINING STRUCTURE</b>	SLOPE = 22° from crest to 15m down slope, 37° below 15m		
	CRACKS	SLIDES	EROSION
	<input checked="" type="checkbox"/>		
OBSERVATIONS: Evidence of slumping just below crest.

Figure 4. 2409 Berkley Avenue – View down-slope from crest

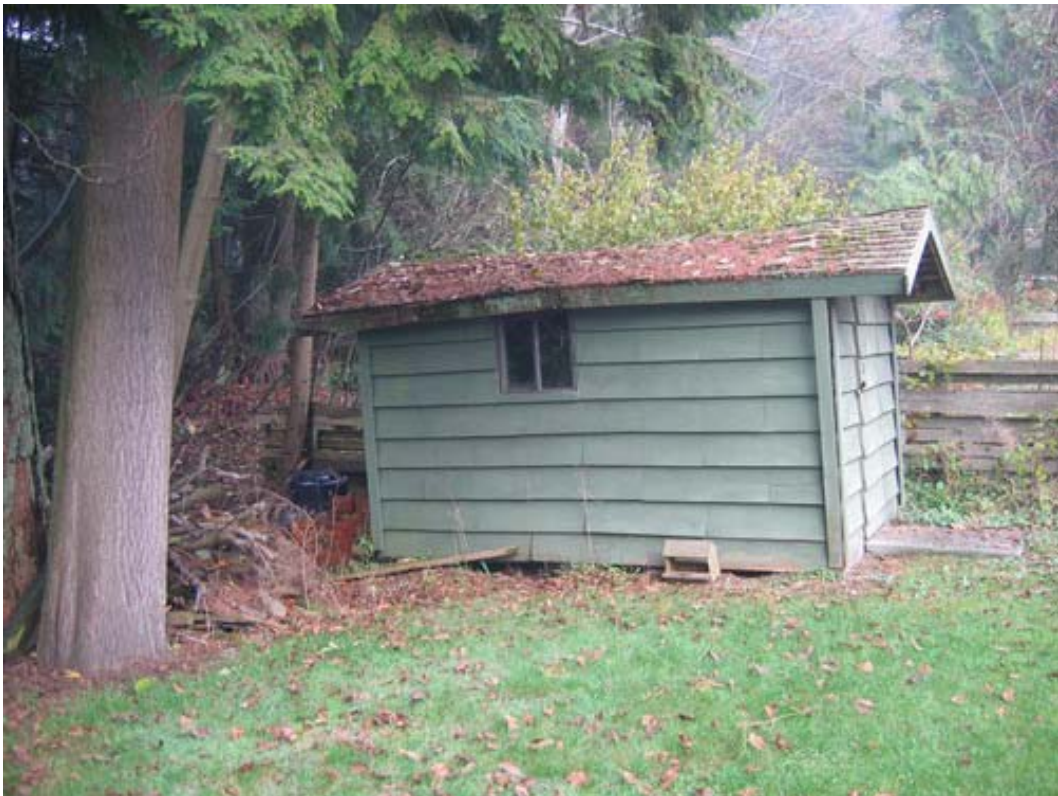
DEFORMATION IN BACKYARD	YES <input checked="" type="checkbox"/>	NO
<b>LOCATION:</b> Northwest corner of yard at crest.		
<b>DESCRIPTION:</b> Shed is bending due to settlement.

Figure 4. 2425 Berkley Avenue – Shed settling on west side
