<b>SITE OBSERVATION FORM:</b>	<b>DNV Landslide Risk Assessment</b>
<b>LOCATION:</b>	<b>2477 Berton Place</b>
<b>INSPECTION DATE:</b> (mm/dd/yy)	<b>11/08/05</b>
<b>WEATHER:</b>	<b>Raining</b>

**Project :** DNV Landslide Risk Assessment

**Project No. :** 0404-002-01

*Client: District of North Vancouver*

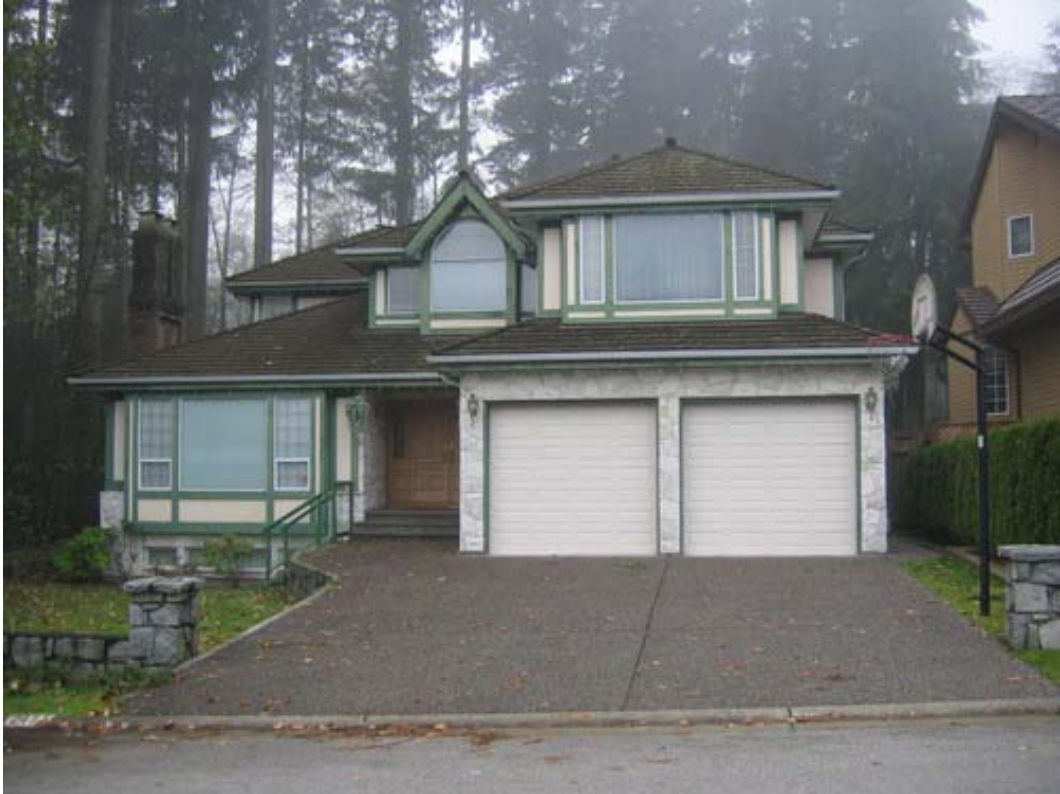
Figure 1. 2477 Berton Place – Front of the house

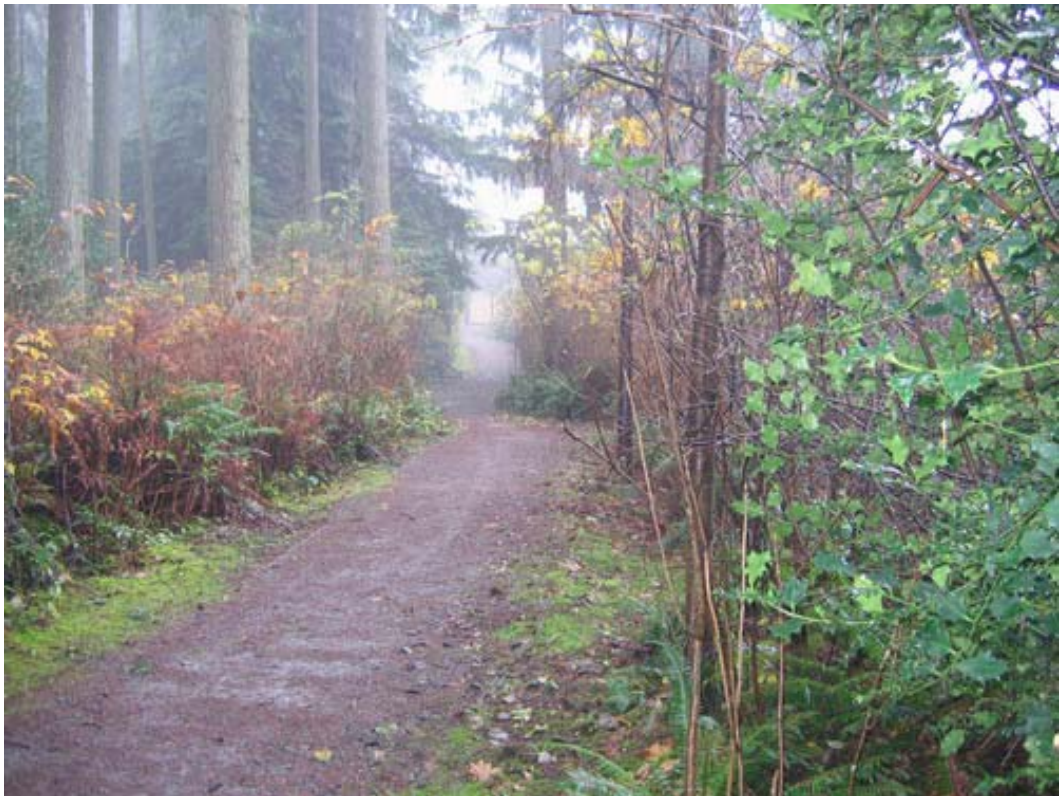
Figure 2. 2477 Berton Place – View of path on west side of house looking north

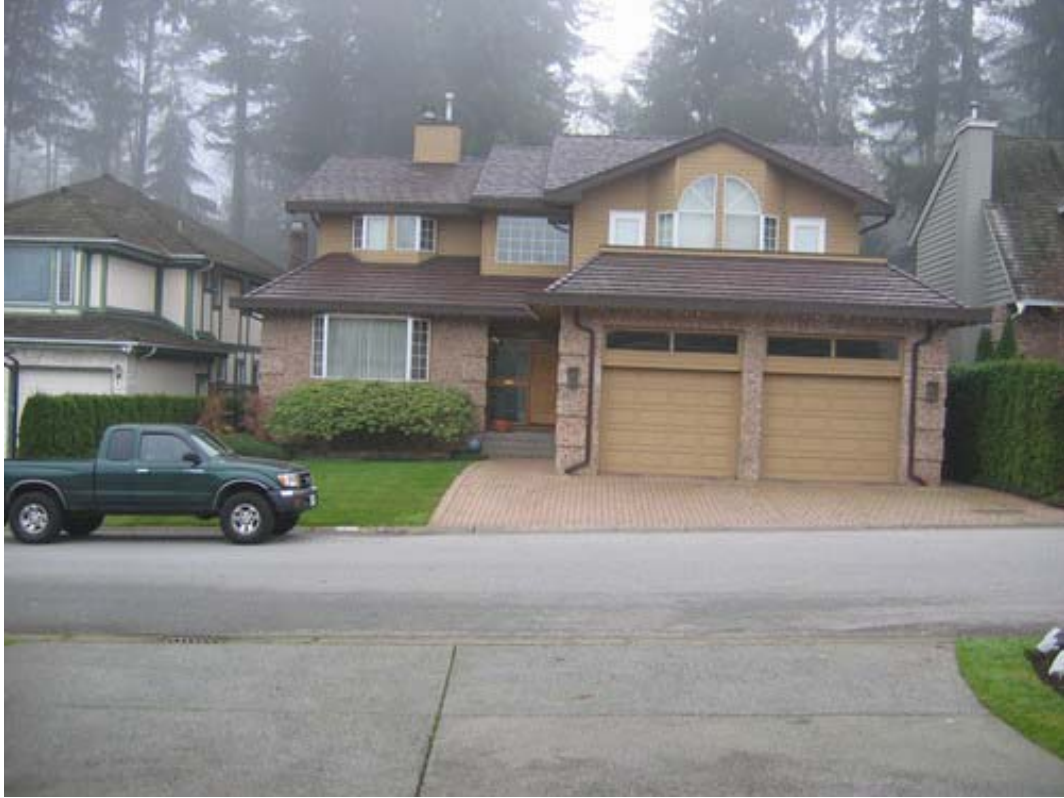
Figure 1. 2475 Berton Place – Front of the house

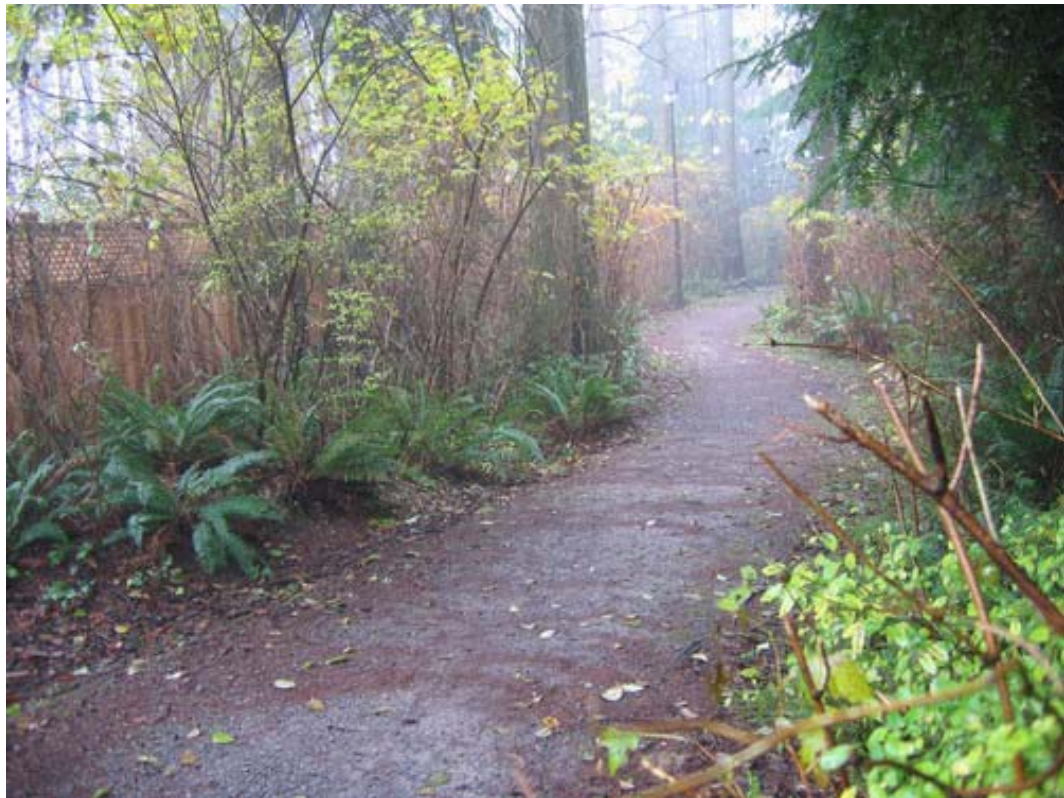
Figure 2. 2475 Berton Place – View of path on west side of house looking south

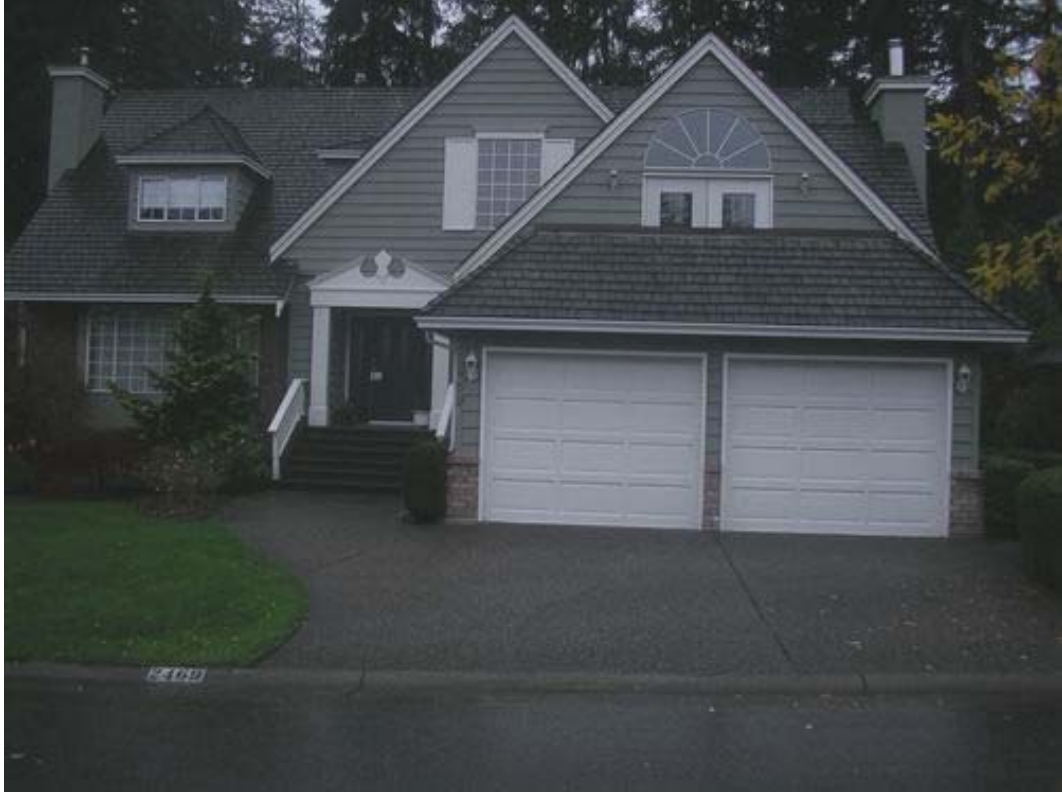
Figure 1. 2469 Berton Place – Front of the house

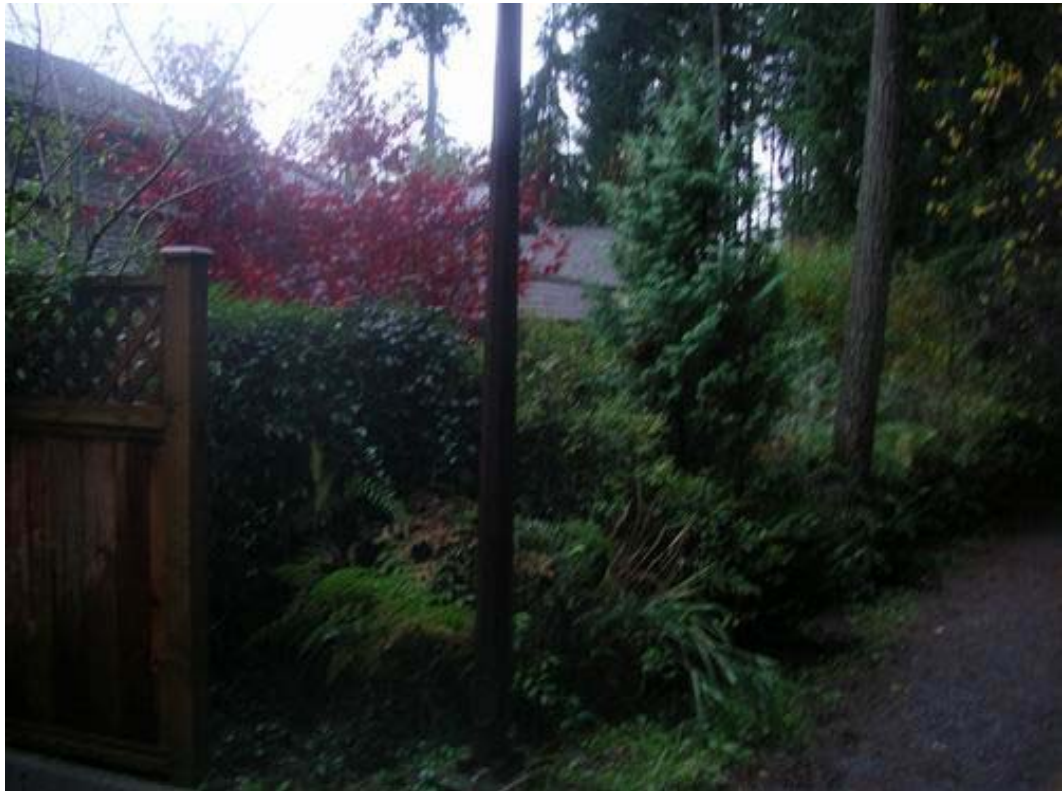
- House is well back from slope crest, public path between slope crest and house
- Immediately below the slope crest three large decomposed conifers fallen over creating appearance of slump blocks

Figure 2. 2469 Berton Place – View of path and house looking SW

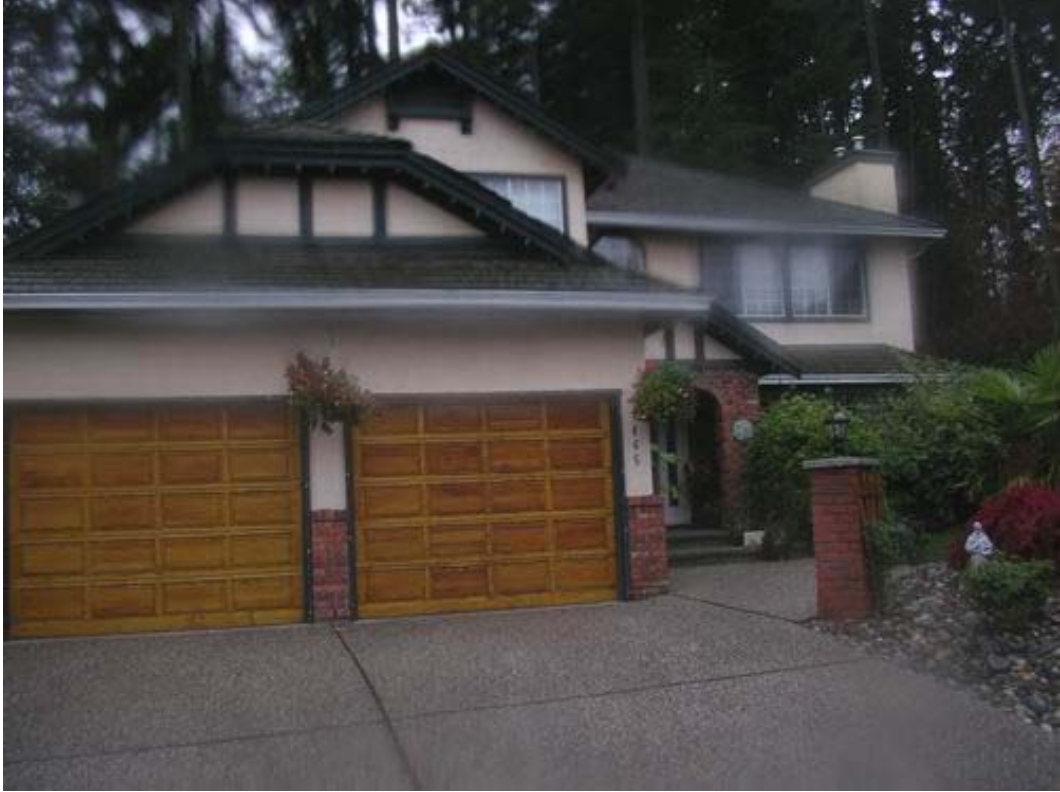
Figure 1. 2465 Berton Place – Front of the house

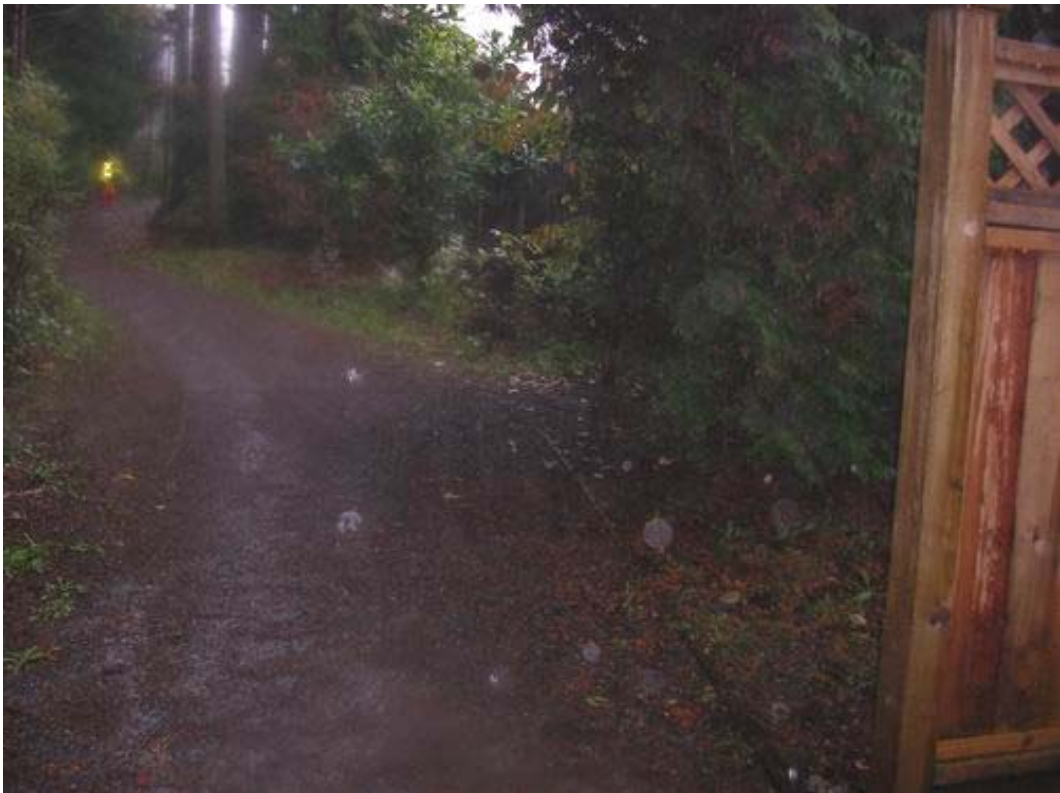
- Public path behind and to the south of property.
- Garden hose connected to hot tub is currently directed toward pathway.

Figure 1. 2465 Berton Place – View of path on west side of house looking north

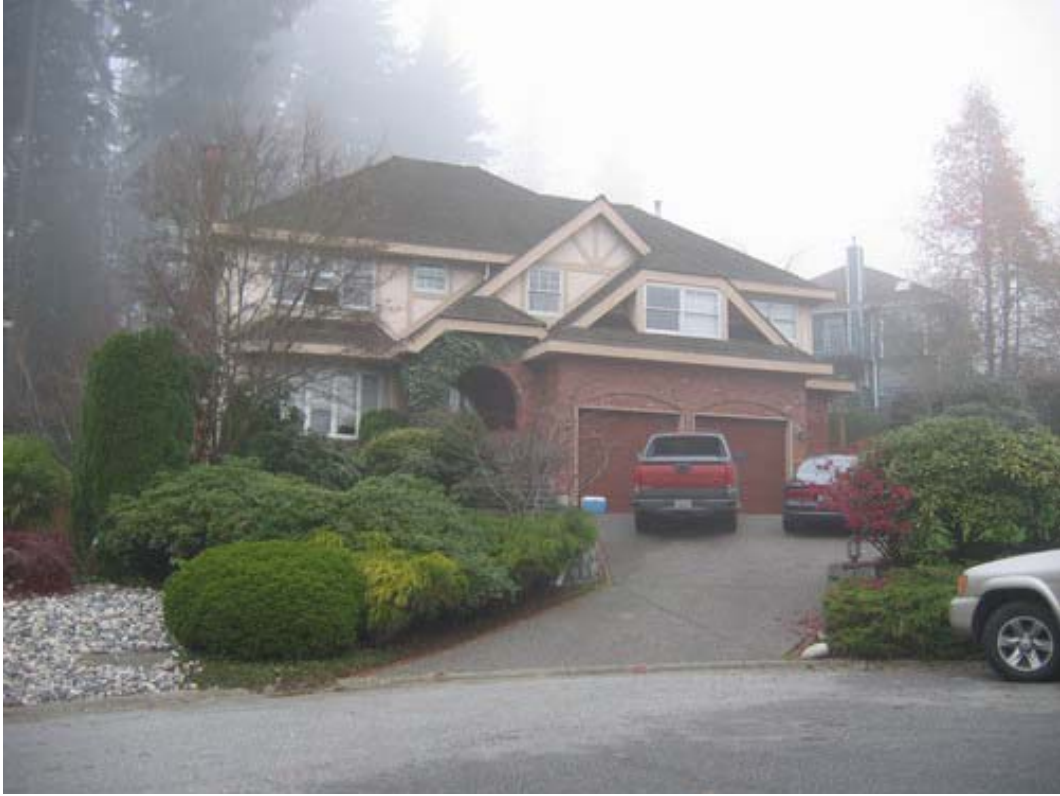
Figure 1. 2461 Berton Place – Front of the house

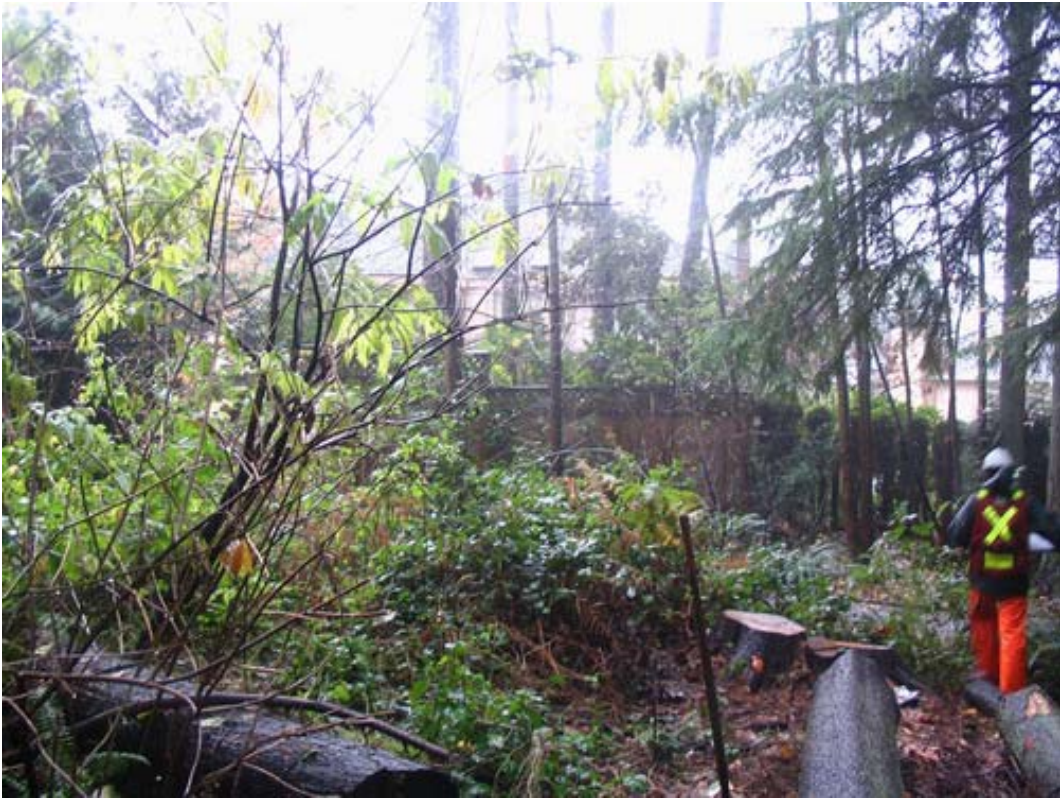
Figure 2. 2461 Berton Place – View looking SE from crest to house
