SITE OBSERVATION FORM:	DNV Landslide Risk Assessment
LOCATION:	2441 Mowat Place
INSPECTION DATE: (mm/dd/yy)	11/08/05
WEATHER:	Rain, rained previous few days

Project : DNV Landslide Risk Assessment

Project No. : 0404-002-01

Client: District of North Vancouver

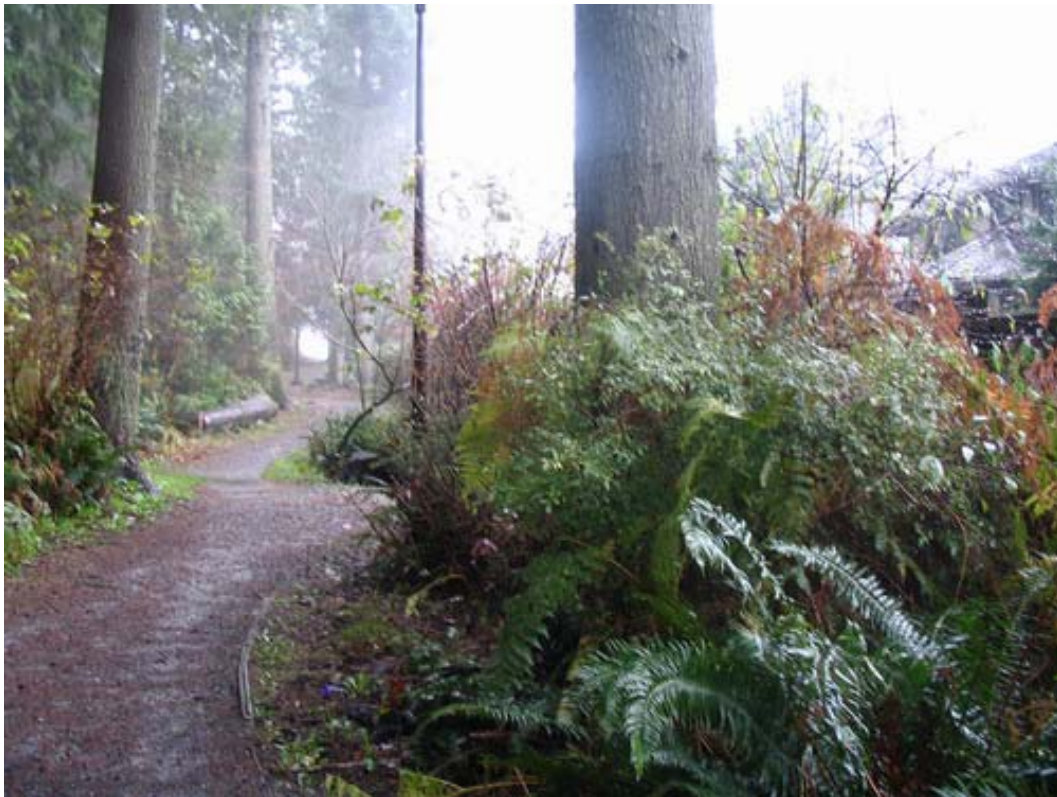
TREES BELOW CREST/ RETAINING STRUCTURE	STRAIGHT	PISTOL-BUTT	LEANING
PERCENT CONIFER:	90%	<input checked="" type="checkbox"/>	
OBSERVATIONS: Fallen logs, branches and considerable compost/garbage on slope.

- Appears to be a communal compost dumping site at crest of slope.

Figure 2. 2441 Mowat Place - View looking north along public path between houses and crest

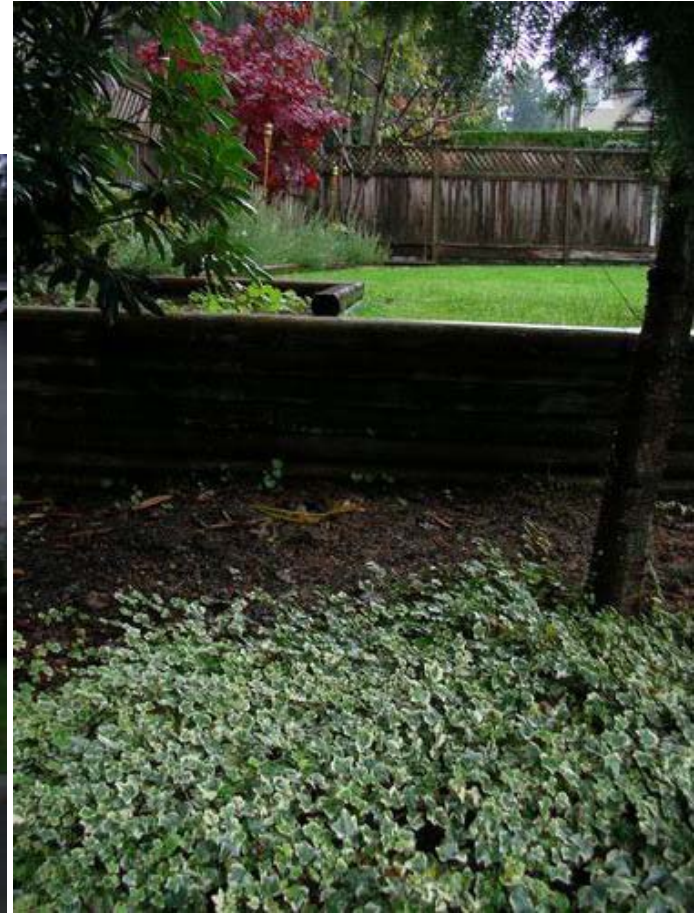
RETAINING STRUCTURES	YES <input checked="" type="checkbox"/>	NO	HEIGHT= 1.5 m
TYPE	BLOCKS CONCRETE	TIMBER CRIB	OTHER:
DEFORMATION	UNDEFORMED <input checked="" type="checkbox"/>	CRACKED	SETTLED BULGING
OBSERVATIONS: 12 m level ground to slope crest.

- Back yard on fill on northern three quarters of yard, 12 m to crest from the front of the property.
- Slope slightly over steepened with compost.

Figure 2. 2437 Mowat Place – View from crest to retaining wall

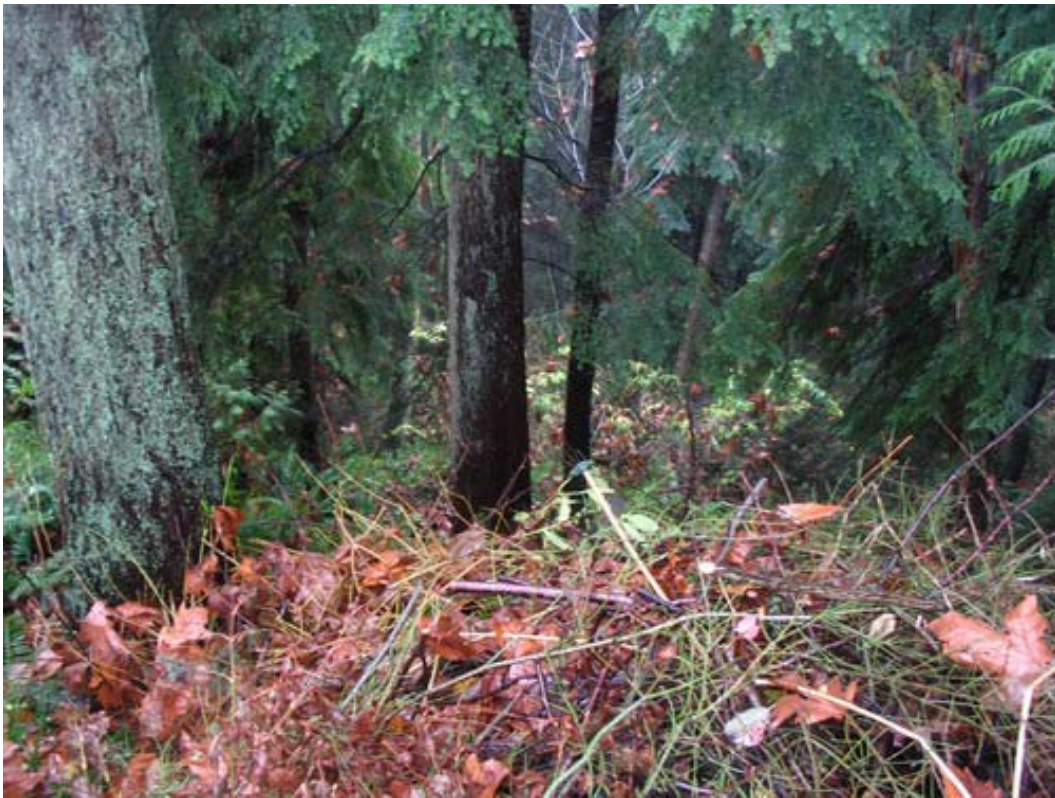
SLOPE BELOW CREST/ RETAINING STRUCTURE	SLOPE = 37°		
	CRACKS	SLIDES	EROSION
			<input checked="" type="checkbox"/>
OBSERVATIONS: Minor surface erosion around trees.

TREES BELOW CREST/ RETAINING STRUCTURE	STRAIGHT	PISTOL-BUTT	LEANING
PERCENT CONIFER: 70%	<input checked="" type="checkbox"/>		<input checked="" type="checkbox"/>
OBSERVATIONS: Mostly straight with some leaning trees.

Figure 2. 2433 Mowat Place - View downslope from crest

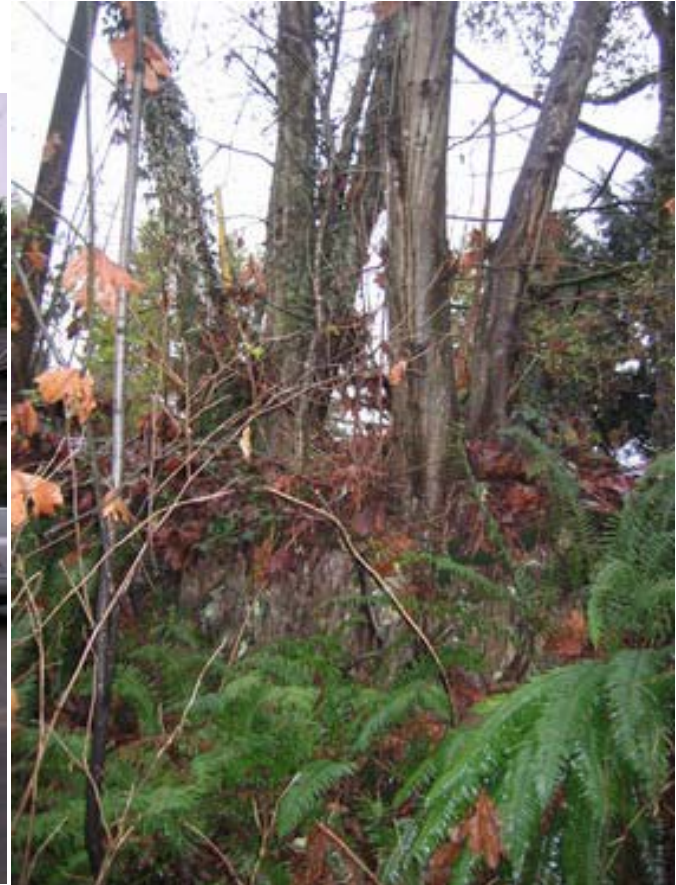
SLOPE BELOW CREST/ RETAINING STRUCTURE	SLOPE = 33°		
	CRACKS	SLIDES	EROSION
OBSERVATIONS: Minor soil erosion.			<input checked="" type="checkbox"/>

- Public path between house and slope crest, path sloping to the south.
- Crest slightly over steepened by compost.

Figure 2. 2429 Mowat - Eroded root system of tree near crest

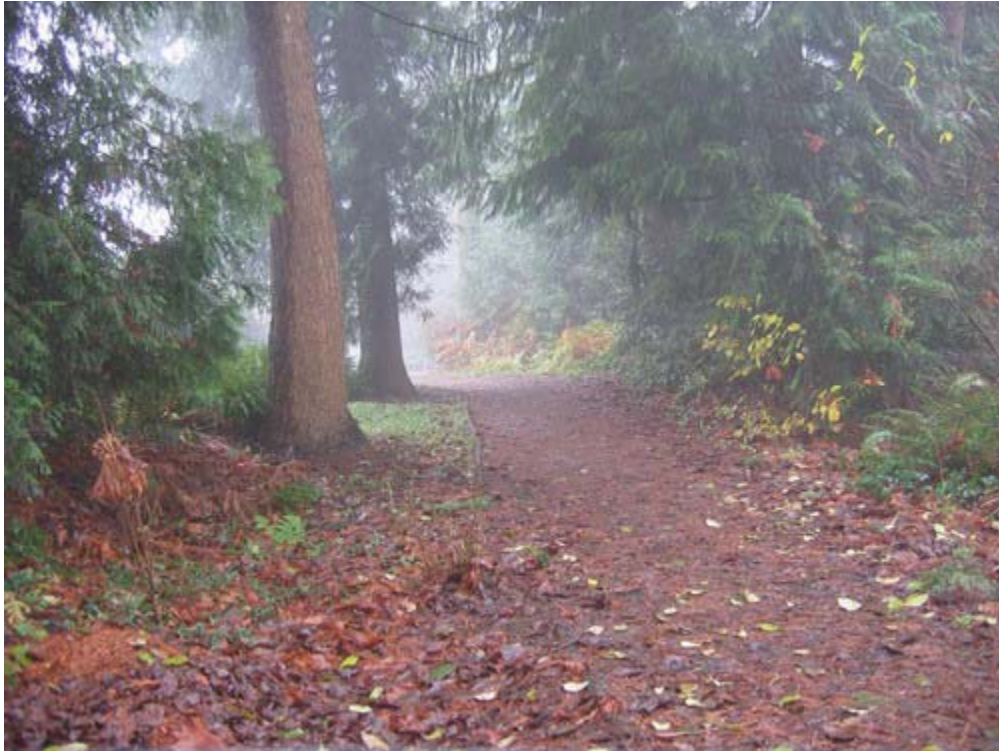
- House is well back from slope crest.
- Public path and park are between slope crest and house.

Figure 2. 2425 Mowat Place - View looking south along public path between houses and crest
