SITE OBSERVATION FORM: DNV Landslide Risk Assessment
LOCATION: 1231 Lennox Street
INSPECTION DATE: (mm/dd/yy) 11/04/05
WEATHER: Raining, heavy rain for several days prior to visit.

Project : DNV Landslide Risk Assessment

Project No. : 0404-002-01

Client: District of North Vancouver

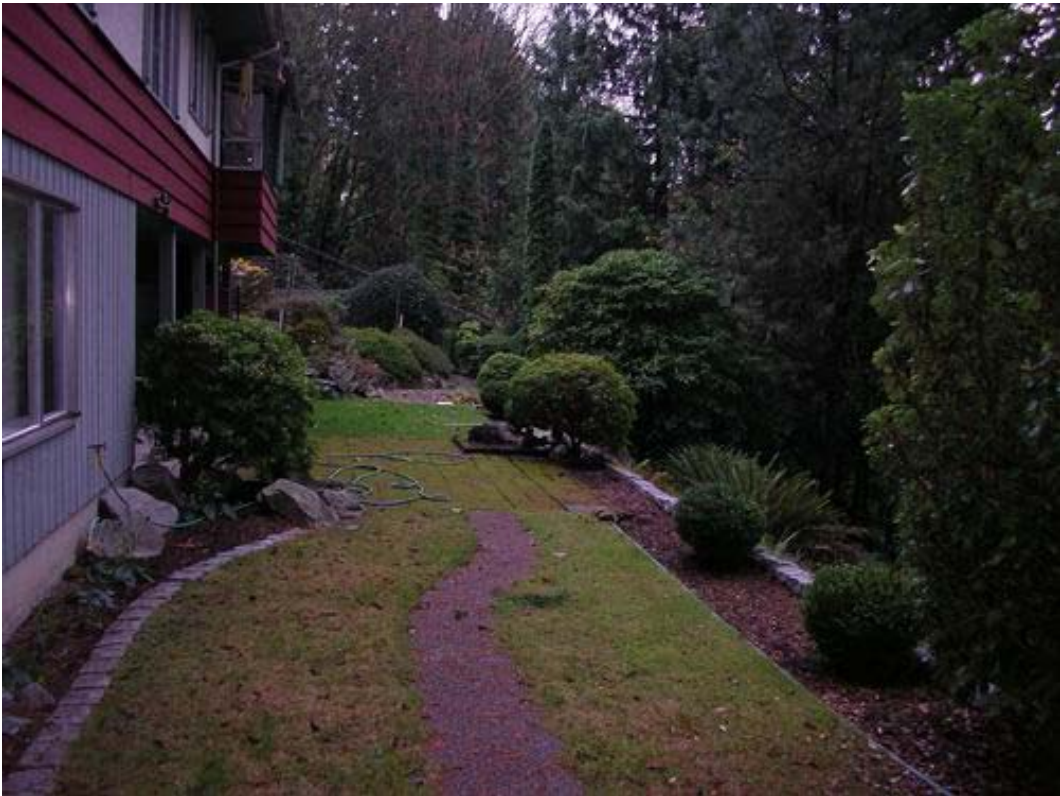
Figure 2. 1231 Lennox Street – View of backyard and crest looking south

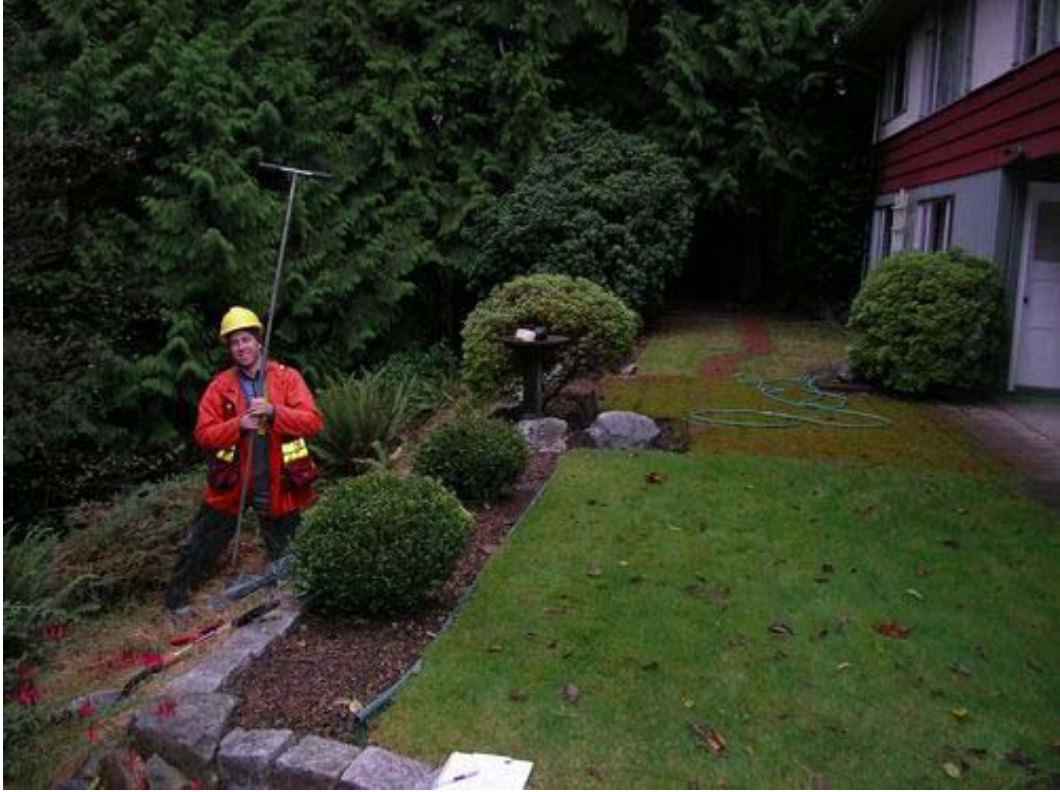
- Patio is level, owners note there has been no change in the last 50 years.
- Possible failure scarp in gully at north property boundary with adjacent property.
- Property flattens out approximately 50 m down slope.

Figure 3. 1231 Lennox Street – View looking north along crest

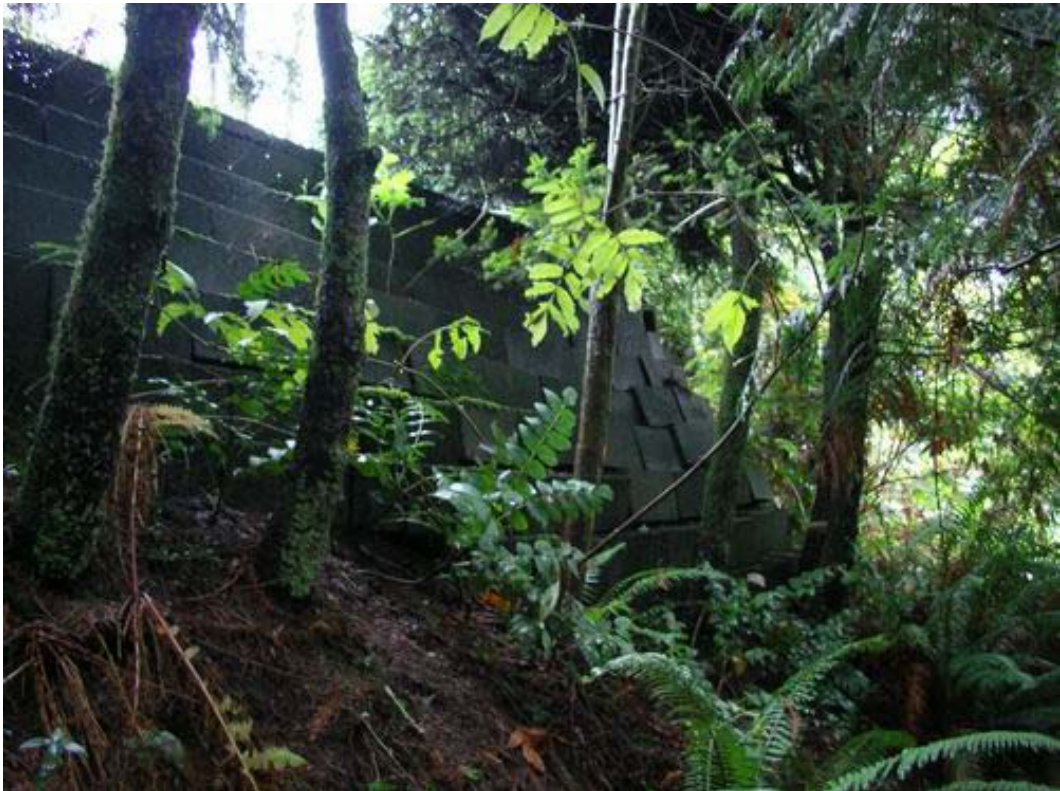
RETAINING STRUCTURES	YES <input checked="" type="checkbox"/>	NO	HEIGHT= 2.0 m
TYPE	BLOCKS <input checked="" type="checkbox"/>	CONCRETE <input checked="" type="checkbox"/>	TIMBER CRIB
DEFORMATION	UNDEFORMED	CRACKED	SETTLED
			BULGING <input checked="" type="checkbox"/>
OBSERVATIONS: No mortar used to construct the concrete block wall located at south end of backyard. Young trees are leaning at base.

Figure 4. 1231 Lennox Street – Failing concrete retaining wall

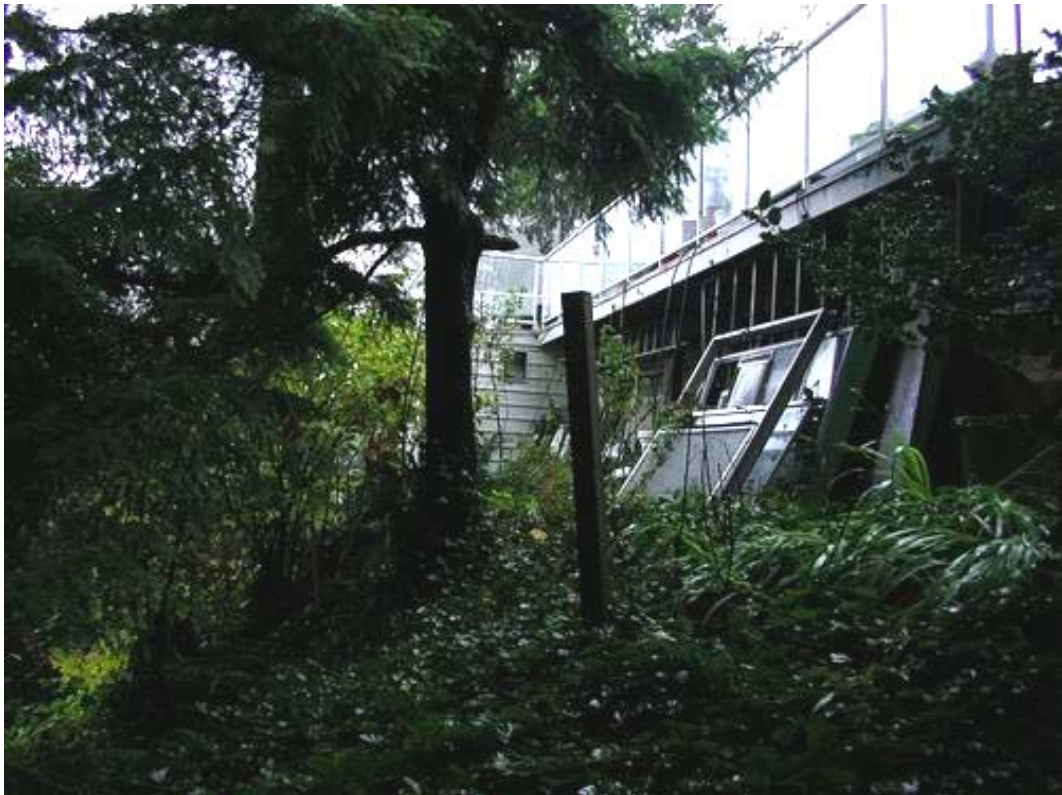
- The elevated deck is built on and over the crest.
- Old slide site approx. 20 m down slope from the crest.
- Part of retaining wall from adjacent house runs onto this property.

Figure 2. 1275 Lennox Street – View looking NW along crest

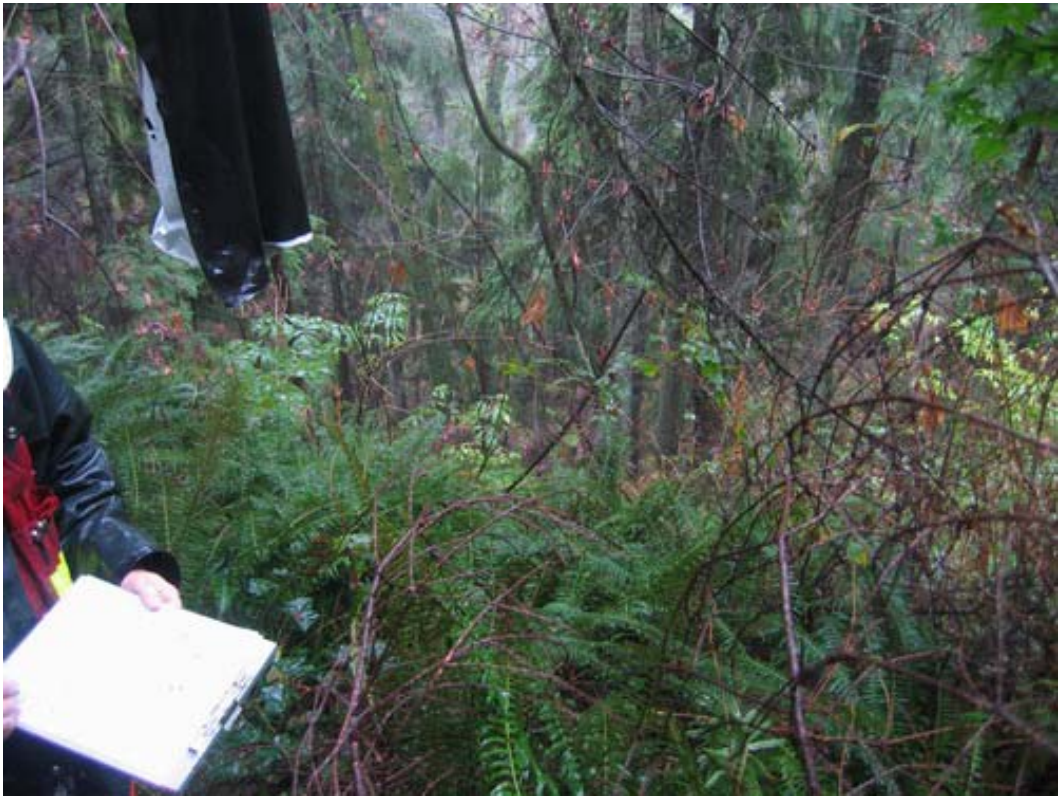
SLOPE BELOW FENCE/ RETAINING STRUCTURE	SLOPE = 40°		
	CRACKS	SLIDES	EROSION
		<input checked="" type="checkbox"/>	<input checked="" type="checkbox"/>
OBSERVATIONS: Minor erosion. Small slide above AH02. 40' from crest of slope to 10 m down slope, 35' from 10 m down slope to bottom. Possible oversteepening.

Figure 2. 1279 Lennox Street - View down-slope from AH#2

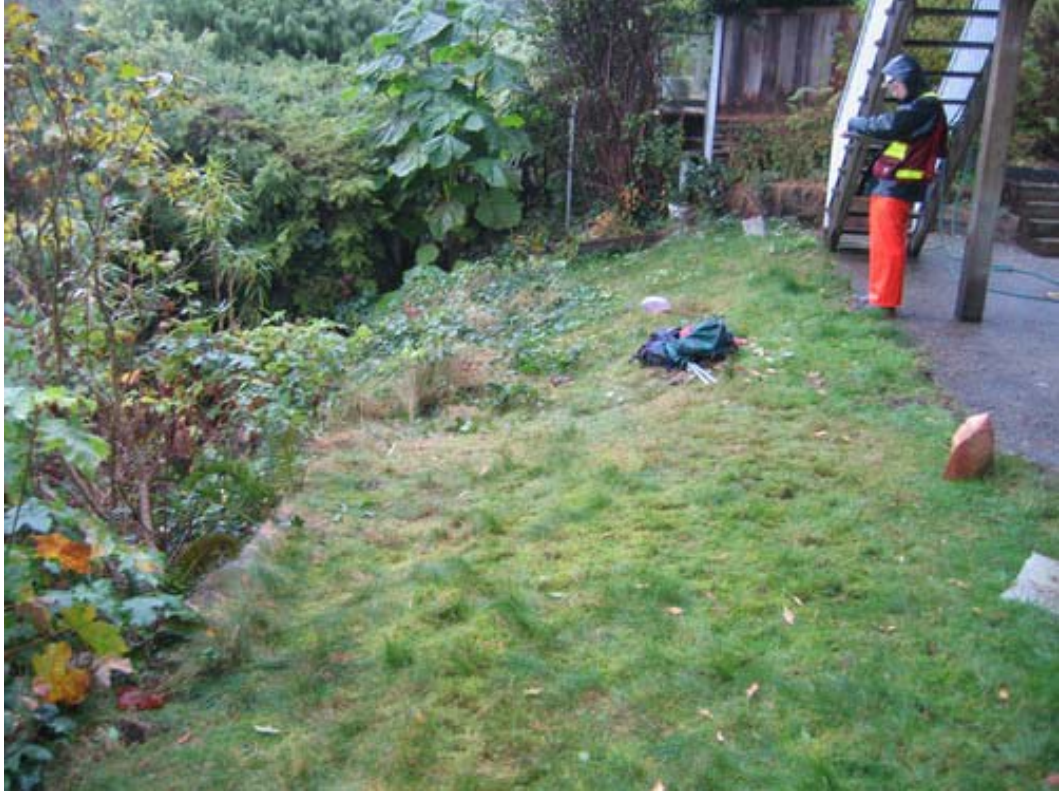
DEFORMATION IN BACKYARD	YES	NO <input checked="" type="checkbox"/>
LOCATION: Backyard		
DESCRIPTION: Backyard dips toward crest of slope.

Figure 3. 1279 Lennox Street – View looking north at slumping backyard

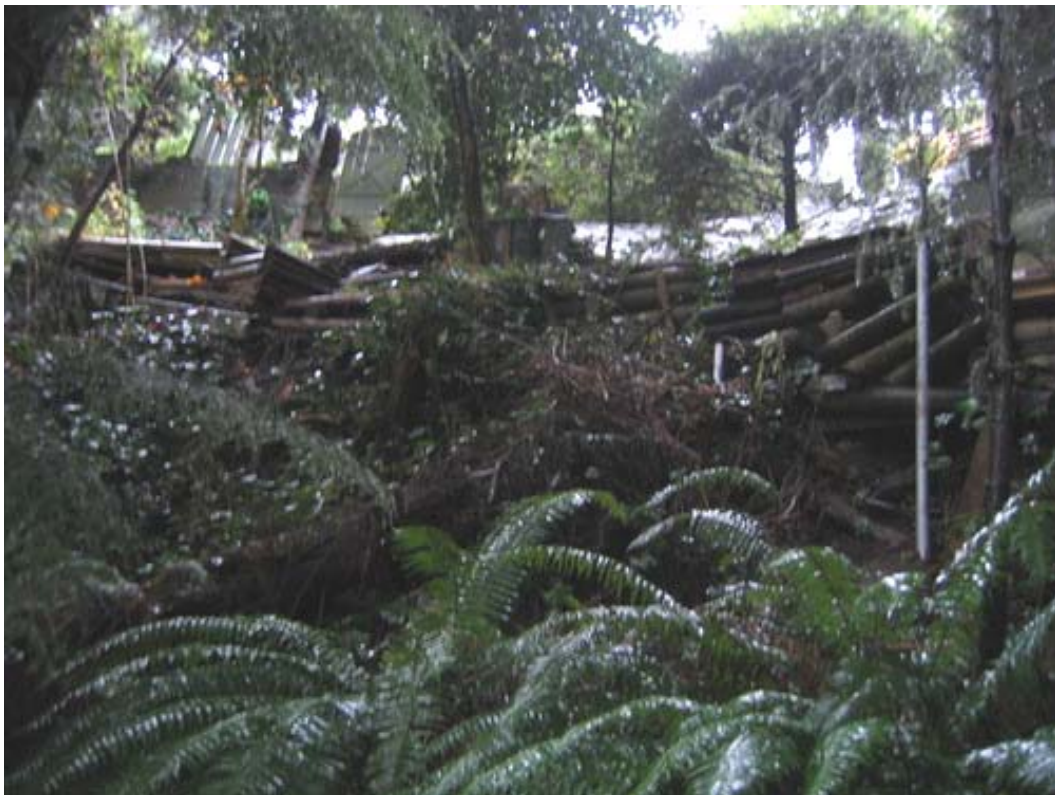
RETAINING STRUCTURES	YES <input checked="" type="checkbox"/>	NO	HEIGHT= 3.3 m
TYPE	BLOCKS	CONCRETE	TIMBER CRIB
DEFORMATION	UNDEFORMED	CRACKED	SETTLED
			BULGING
OBSERVATIONS: Many generations of retaining structures, some tilting, mainly built with timber cribbing with stones. Main retaining wall is concrete. Complicated system of steps, timbers and retaining walls down slope. Timber crib is bulging and cracking.

Figure 2. 1305 Lennox Street – View up-slope at timber crib wall

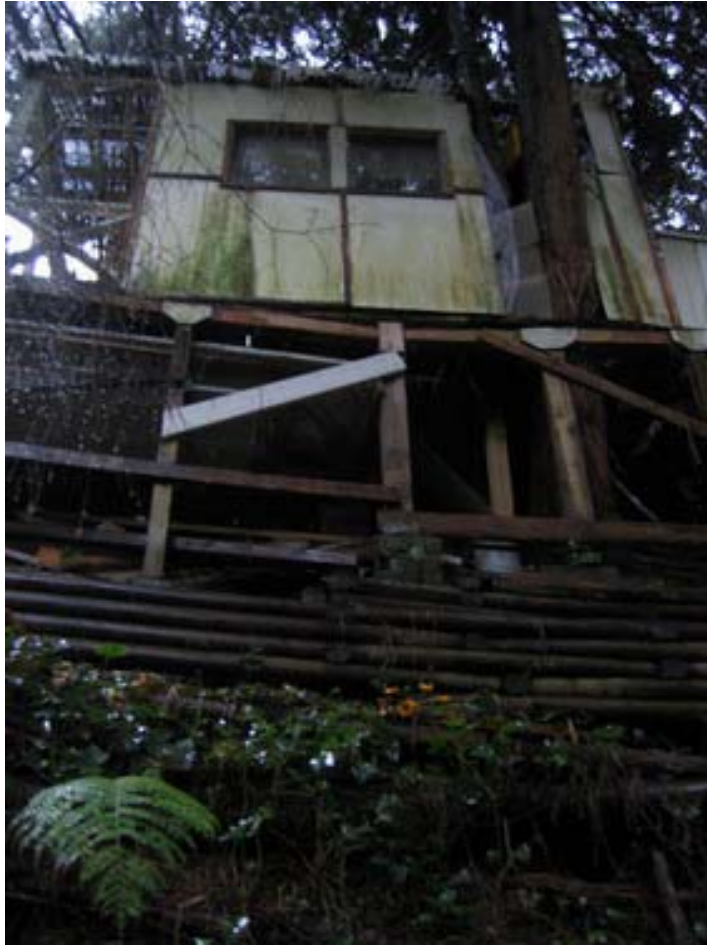
Figure 3. 1305 Lennox Street – Wooden crib wall and shed perched on slope

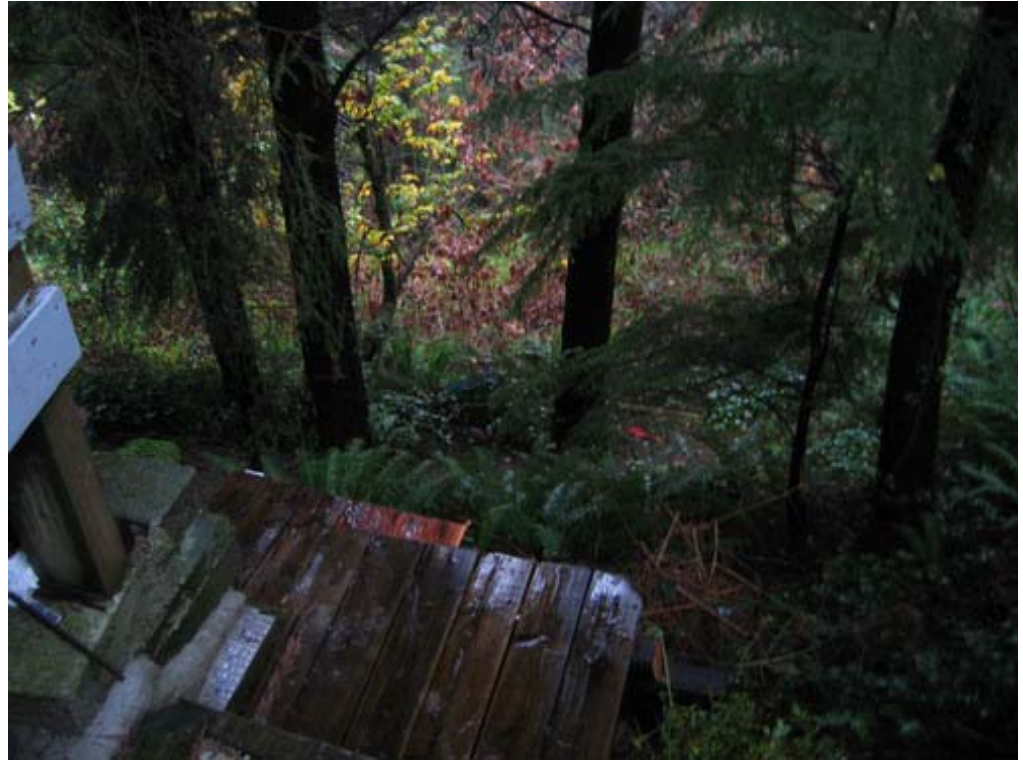
Figure 4. 1305 Lennox Street – View down-slope from just below the crest

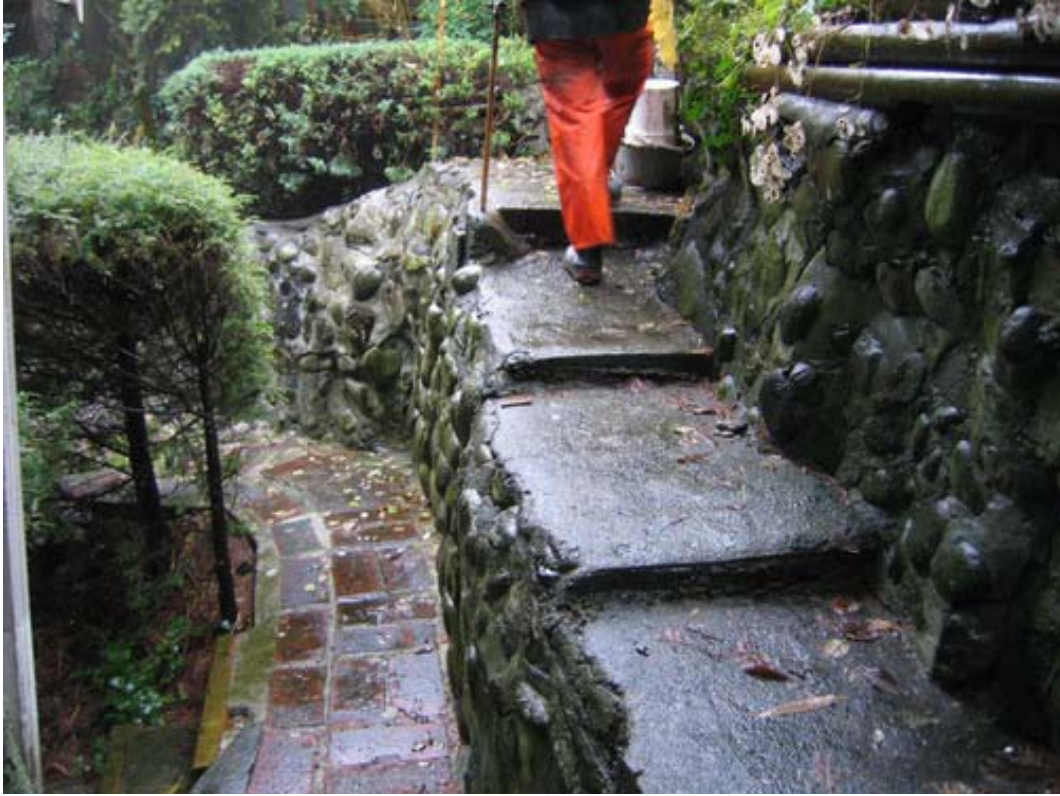
Figure 5. 1305 Lennox Street – Concrete retaining wall above the shed with built in steps

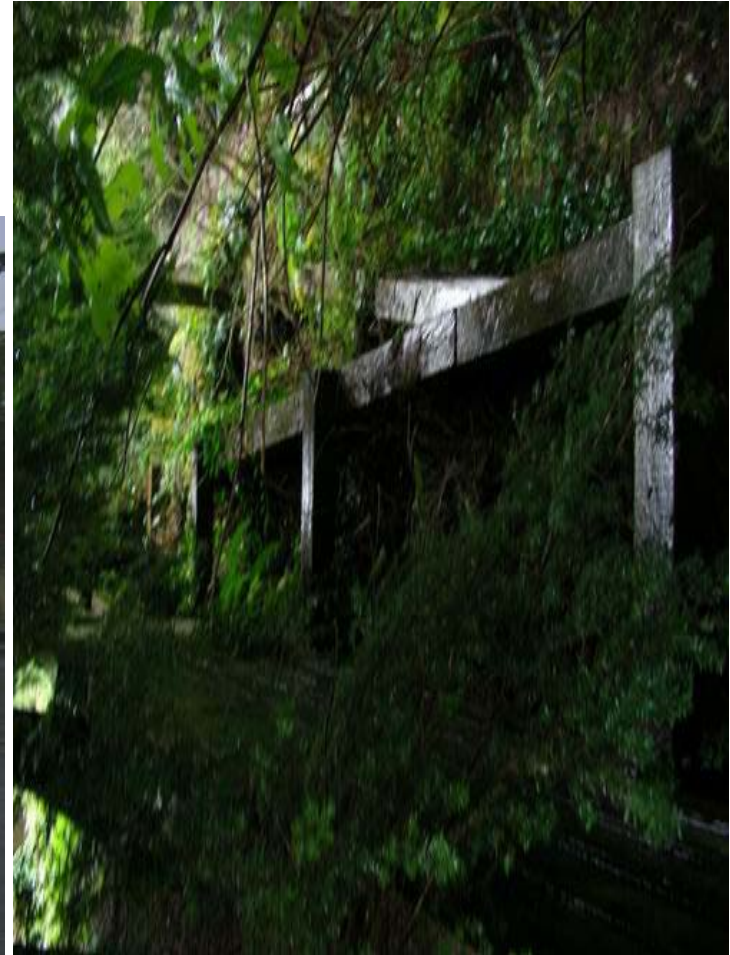
RETAINING STRUCTURES	YES <input checked="" type="checkbox"/>	NO	HEIGHT= 0.3 – 1.5 m
TYPE	CONCRETE	TIMBER CRIB	OTHER:
DEFORMATION	UNDEFORMED <input checked="" type="checkbox"/>	CRACKED	BULGING
OBSERVATIONS: 4 terraces ranging in height; walls increase with height down slope. Total height = 5 m. Top wall (0.30 m high) is slightly tilted.

Figure 2. 1345 Lennox Street – View looking NW along timber crib retaining wall

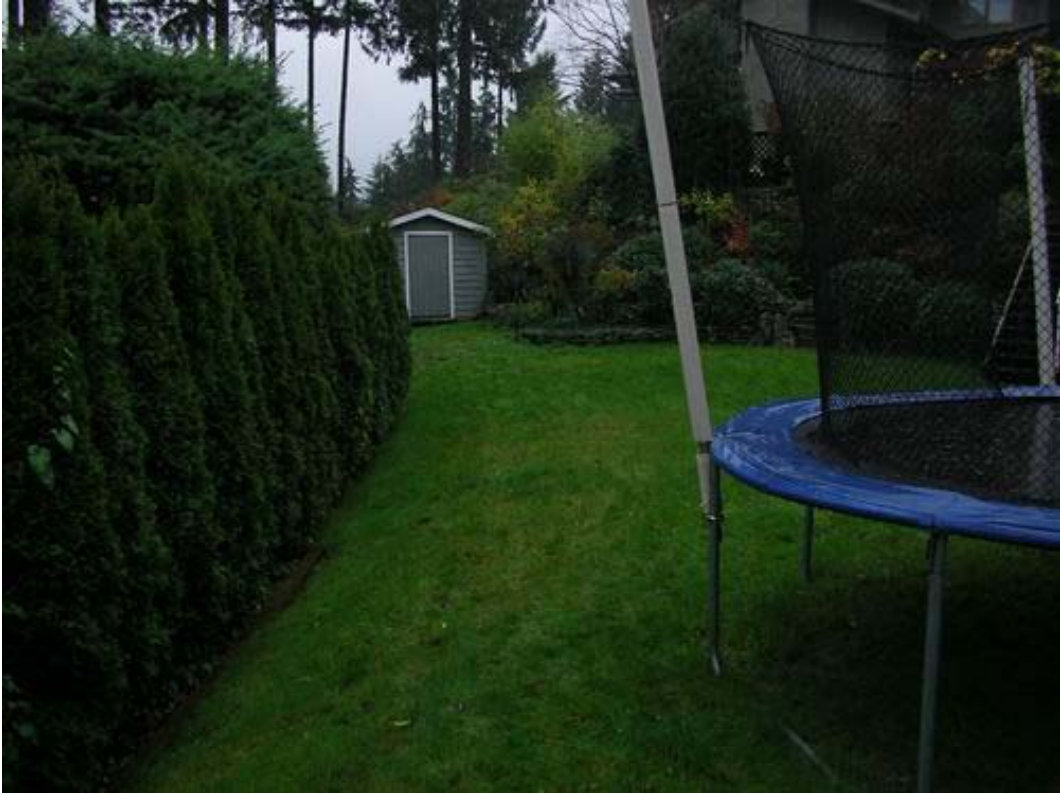
Figure 3. 1345 Lennox Street – View looking NW along property line

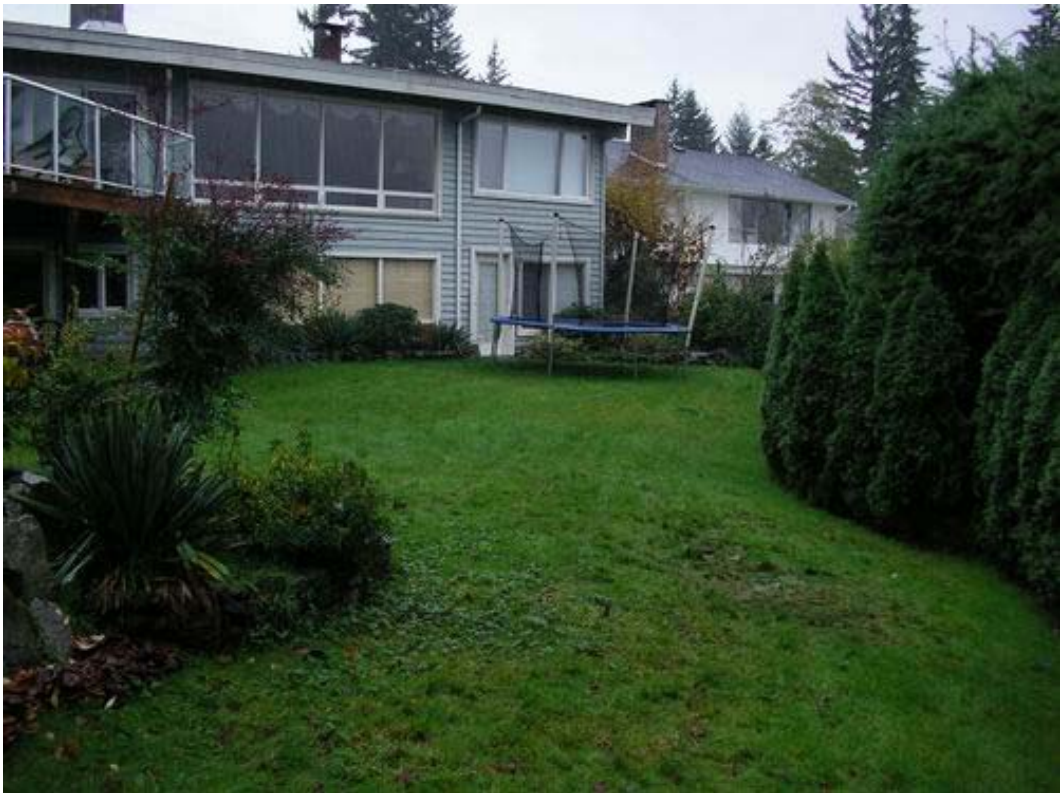
DEFORMATION IN BACKYARD	YES <input checked="" type="checkbox"/>	NO
LOCATION: Backyard lawn.		
DESCRIPTION: Lawn is hummocky and there is a depression in the centre that may have been from a septic tank. Appears to be settlement along the crest of slope.

Figure 4. 1345 Lennox Street – View of backyard looking SE
