SITE OBSERVATION FORM: DNV Landslide Risk Assessment
LOCATION: 1383 Lennox Street
INSPECTION DATE: (mm/dd/yy) 11/03/05
WEATHER: Heavy rain, heavy rain for several days prior to visit.

BGC ENGINEERING INC.
 AN APPLIED EARTH SCIENCES COMPANY

Project : DNV Landslide Risk Assessment

Project No. : 0404-002-01

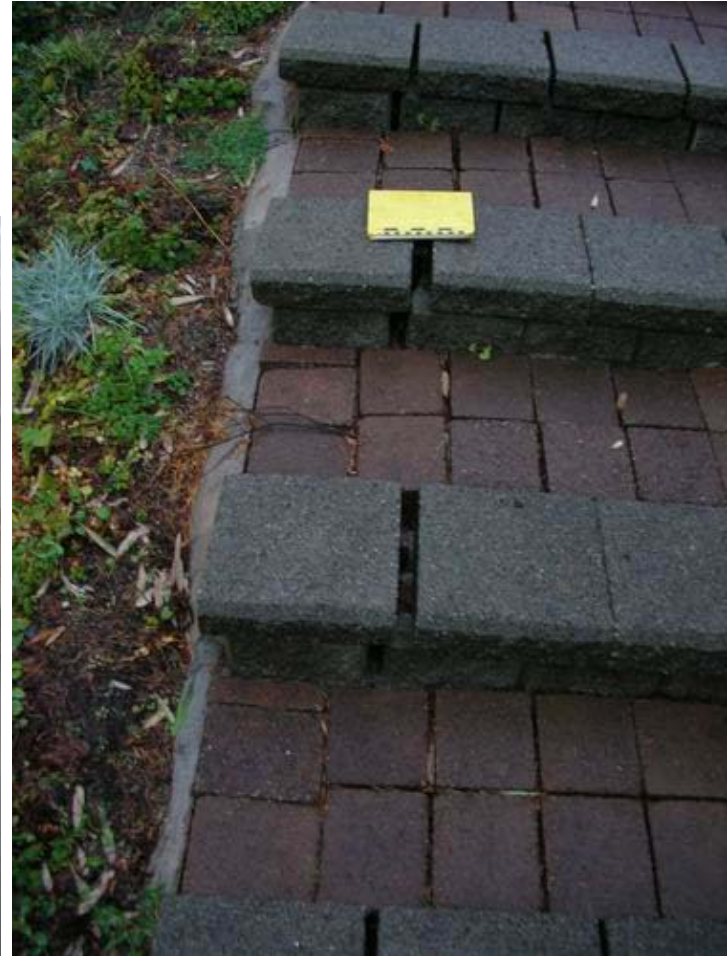
DEFORMATION IN BACKYARD	YES <input checked="" type="checkbox"/>	NO
LOCATION: Patio steps, 4 m from southwest corner of house		
DESCRIPTION: Patio steps tilted and separated in down slope direction.

Figure 2. 1383 Lennox Street – Slight deformation in steps

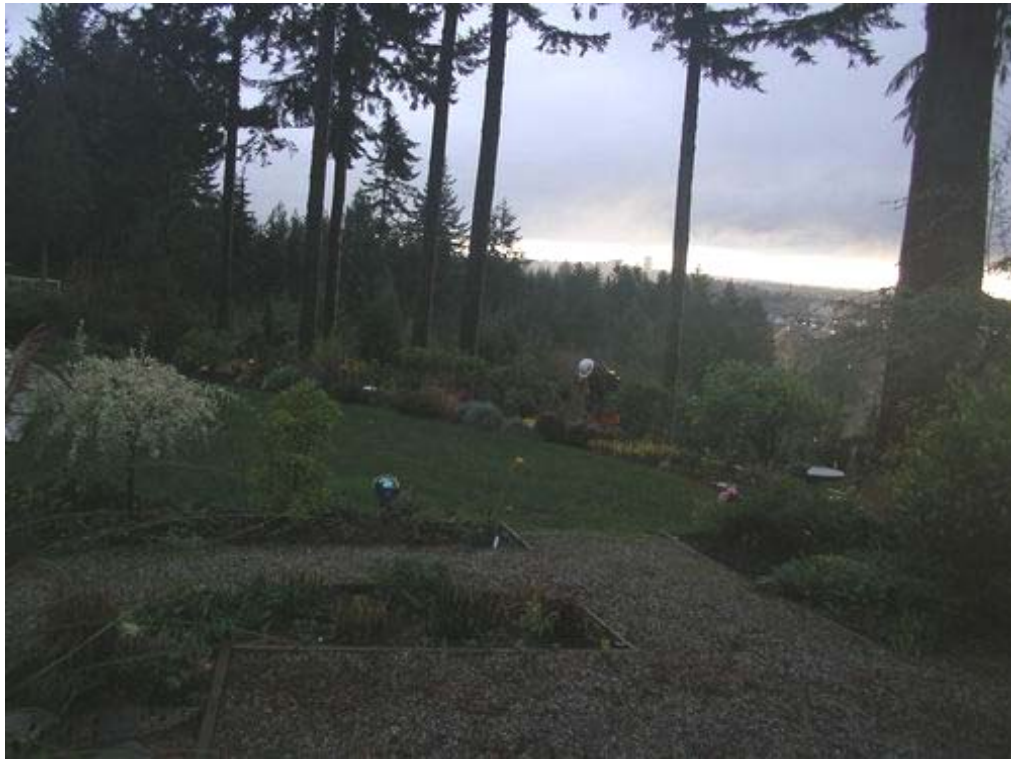
SLOPE BELOW FENCE/ RETAINING STRUCTURE	SLOPE = 38°		
	CRACKS	SLIDES	EROSION
OBSERVATIONS: Evidence of minor soil erosion around trees.			<input checked="" type="checkbox"/>

Figure 3. 1383 Lennox Street – View of backyard looking SW

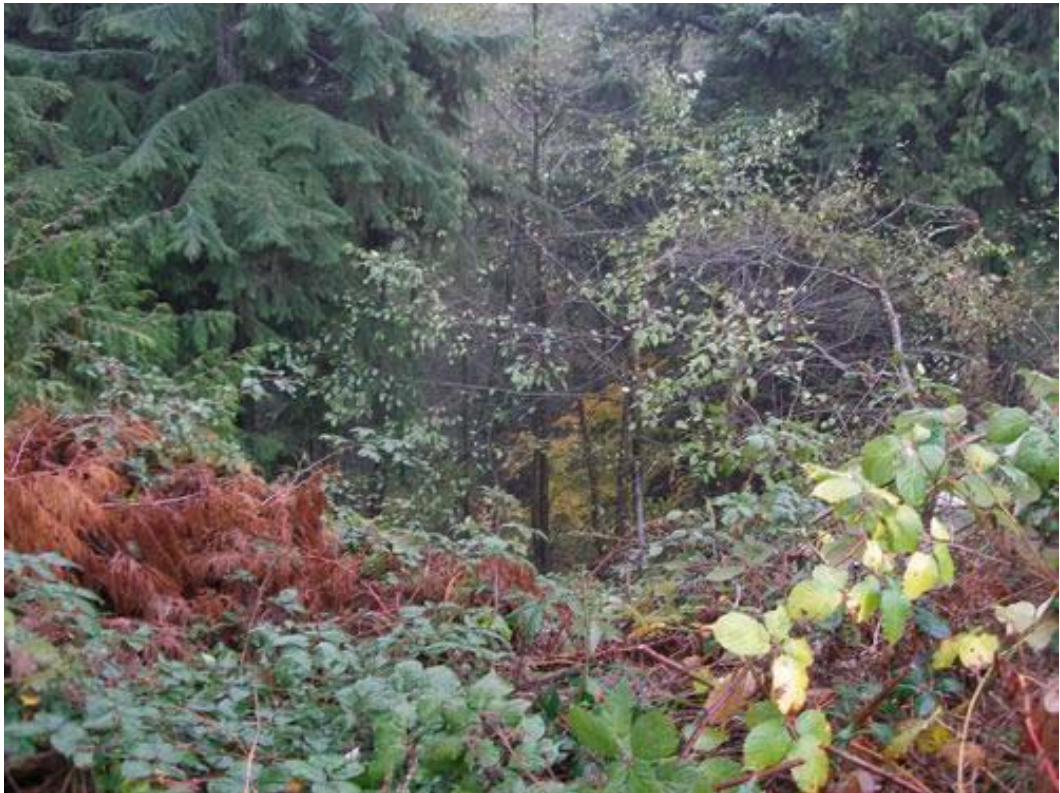
SLOPE BELOW FENCE/ RETAINING STRUCTURE	SLOPE = 42°		
	CRACKS	SLIDES	EROSION
		<input checked="" type="checkbox"/>	
OBSERVATIONS: Evidence of a small recent slide at the north end of the property at the crest. Evidence of 1972 slide downslope from crest.

Figure 2. 1425 Lennox Street – View down-slope from crest

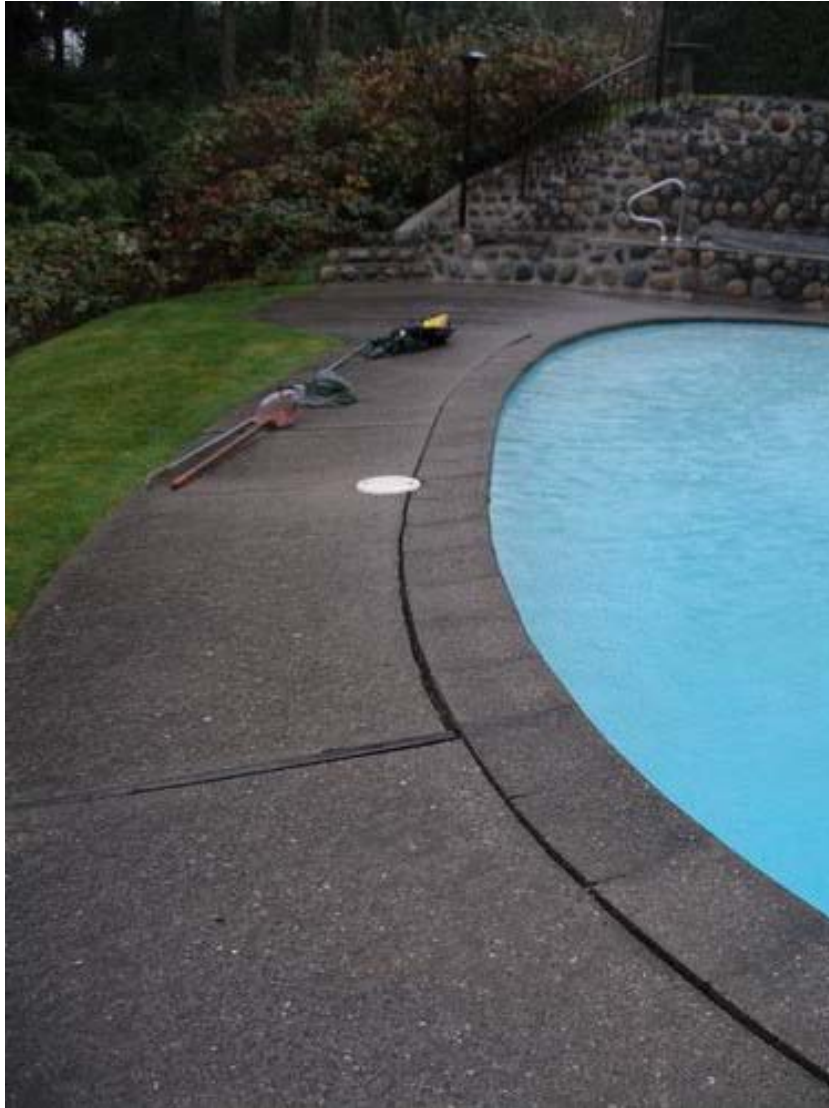
DEFORMATION IN BACKYARD	YES <input checked="" type="checkbox"/>	NO
LOCATION: Around pool, 2 m from crest.		
DESCRIPTION: Deck around pool tilted and settled

POOLS	YES <input checked="" type="checkbox"/>	NO
DESCRIPTION: Pool and hot tub. Hot tub appears to be settling.

Figure 3. 1425 Lennox Street – Settlement of concrete panels around swimming pool

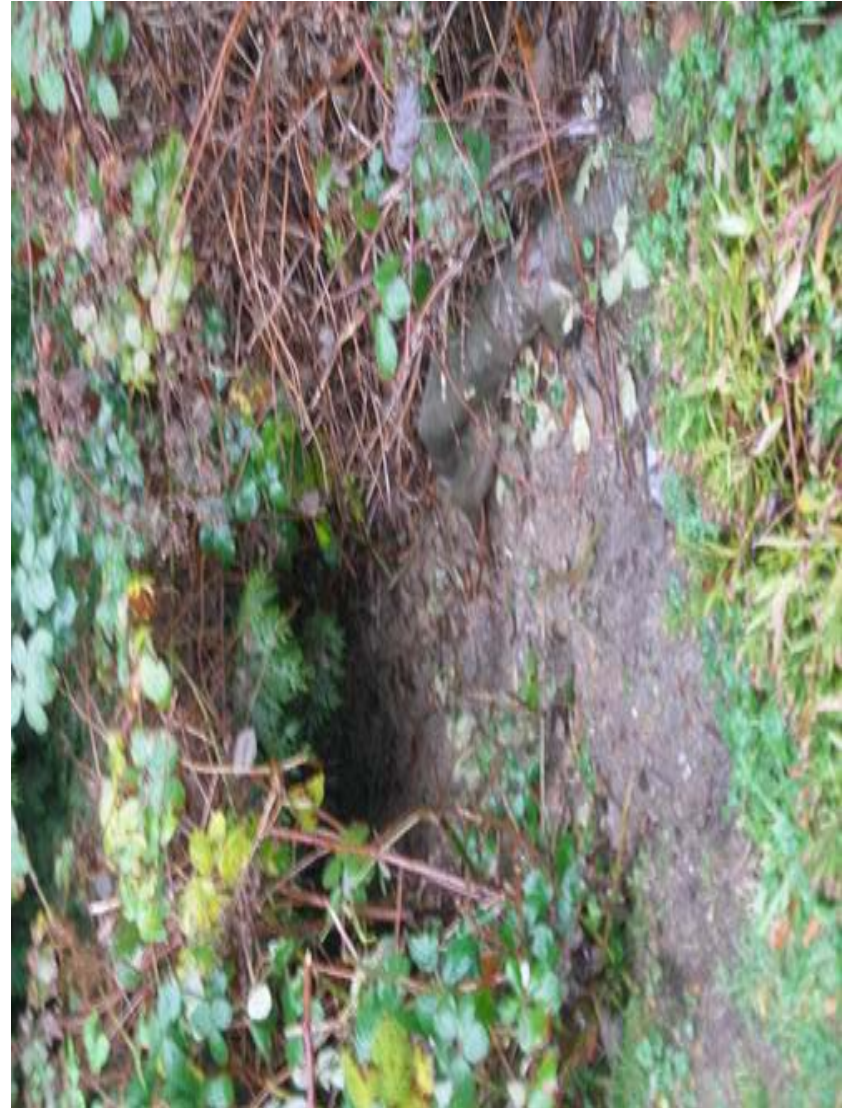
Figure 4. 1425 Lennox Street – Exit of drainage at slope crest

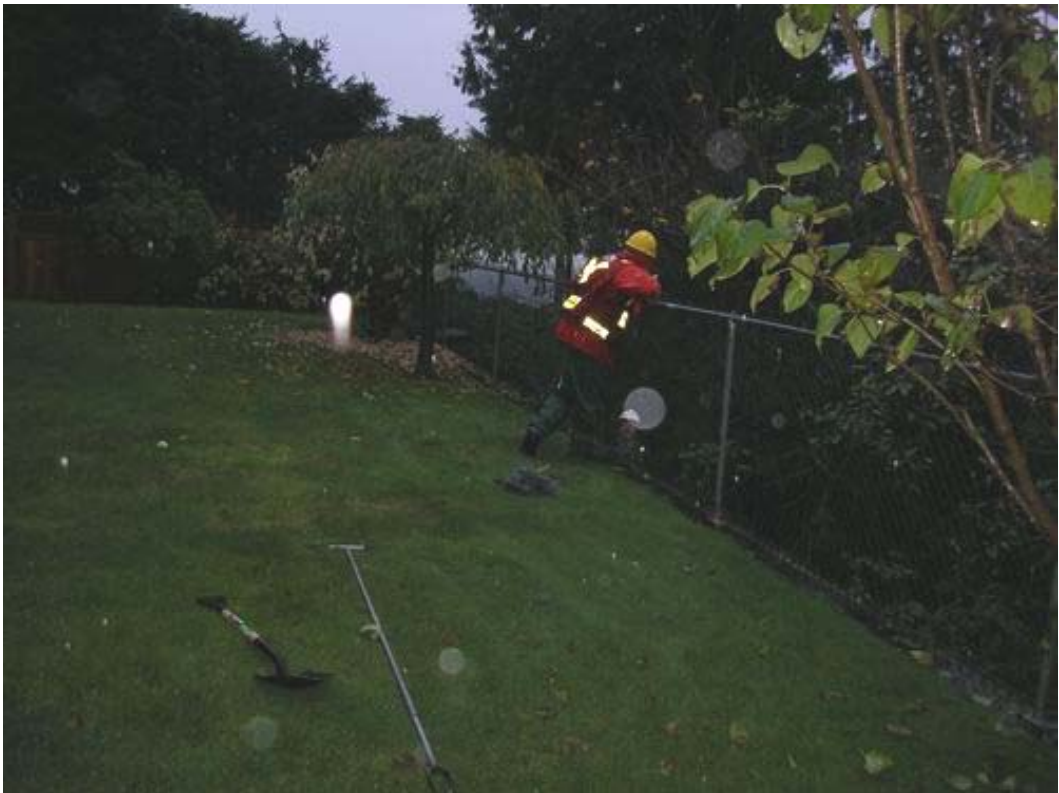
SLOPE BELOW FENCE/ RETAINING STRUCTURE	SLOPE = 33°		
	CRACKS	SLIDES	EROSION
			<input checked="" type="checkbox"/>
OBSERVATIONS: Surficial erosion at base of retaining wall. Scattered surficial erosion on slope.

Figure 2. 1477 Lennox Street – View looking south along fenceline

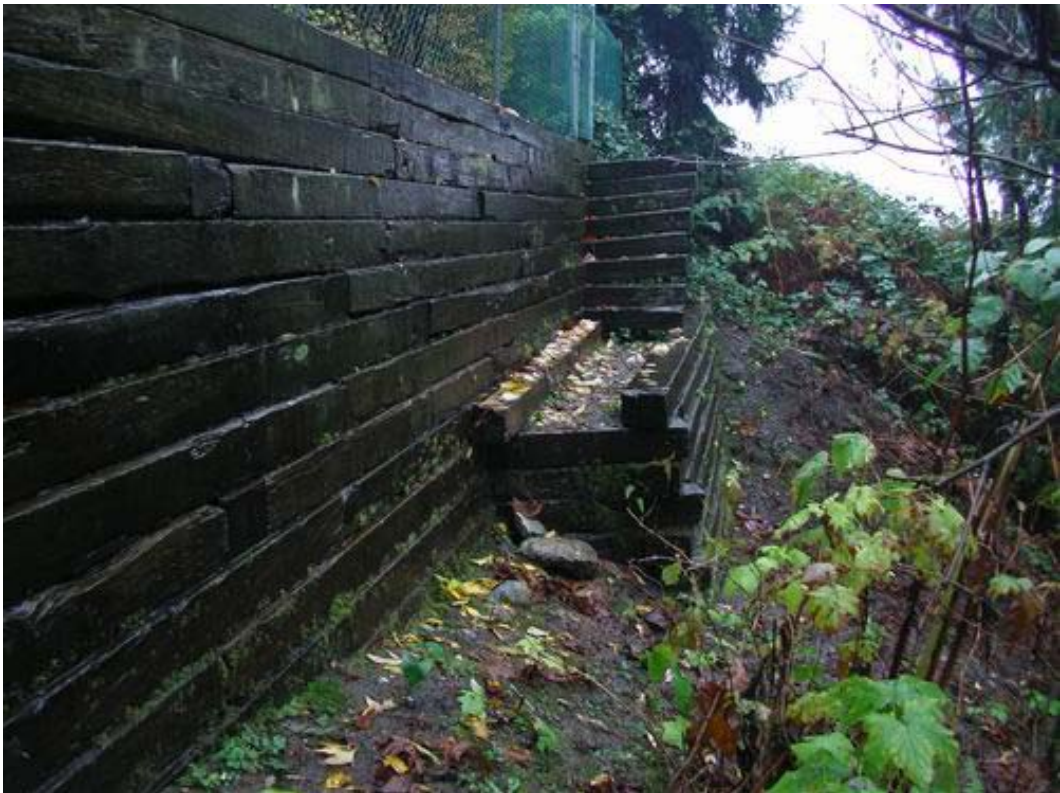
RETAINING STRUCTURES	YES <input checked="" type="checkbox"/>	NO	HEIGHT = 1.50 - 2.85 m
TYPE	BLOCKS	CONCRETE	TIMBER CRIB
DEFORMATION	UNDEFORMED <input checked="" type="checkbox"/>	CRACKED	SETTLED
OBSERVATIONS: Timber crib is in good condition. Crib consists of two steps: 1.35m and 1.5m high.

DEFORMATION IN BACKYARD	YES	NO <input checked="" type="checkbox"/>
LOCATION:		
DESCRIPTION:	Minor settlement behind retaining wall.

Figure 4. 1477 Lennox Street – Timber crib retaining wall

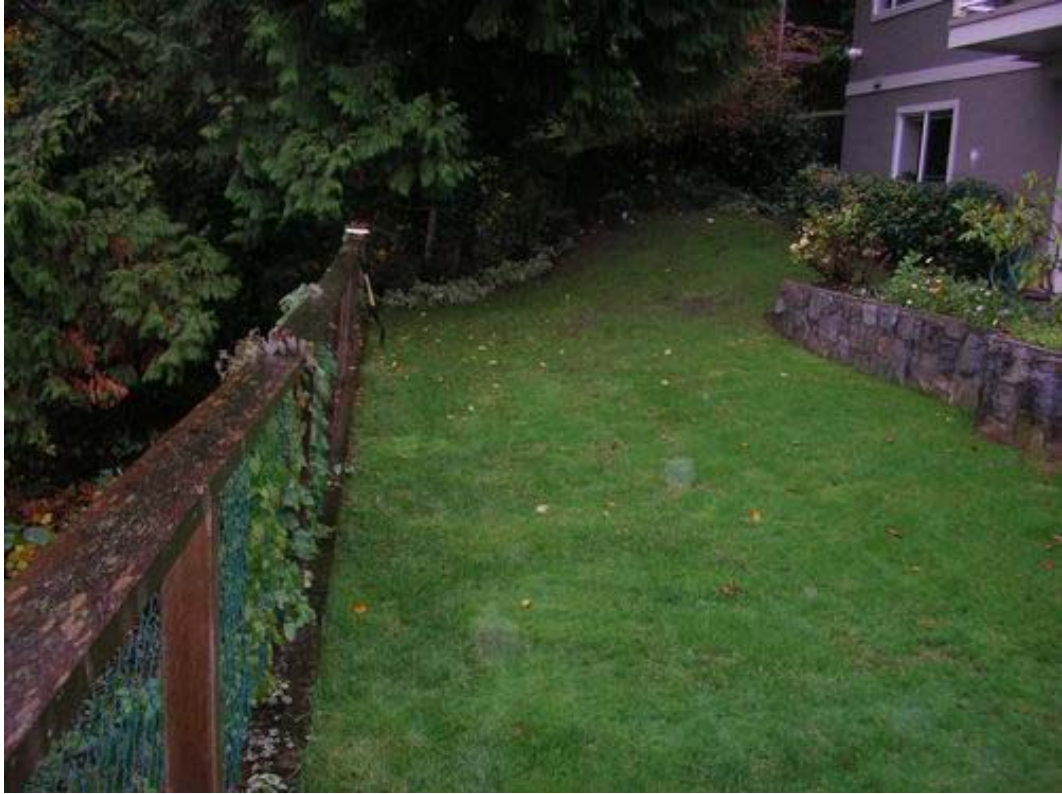
SLOPE BELOW FENCE/ RETAINING STRUCTURE	SLOPE = 37°		
	CRACKS	SLIDES	EROSION
			<input checked="" type="checkbox"/>
OBSERVATIONS: Minor surficial slumping on slope. Soil erosion occurring around fence post on south side of property.

Figure 3. 1479 Lennox Street – View looking north along fenceline

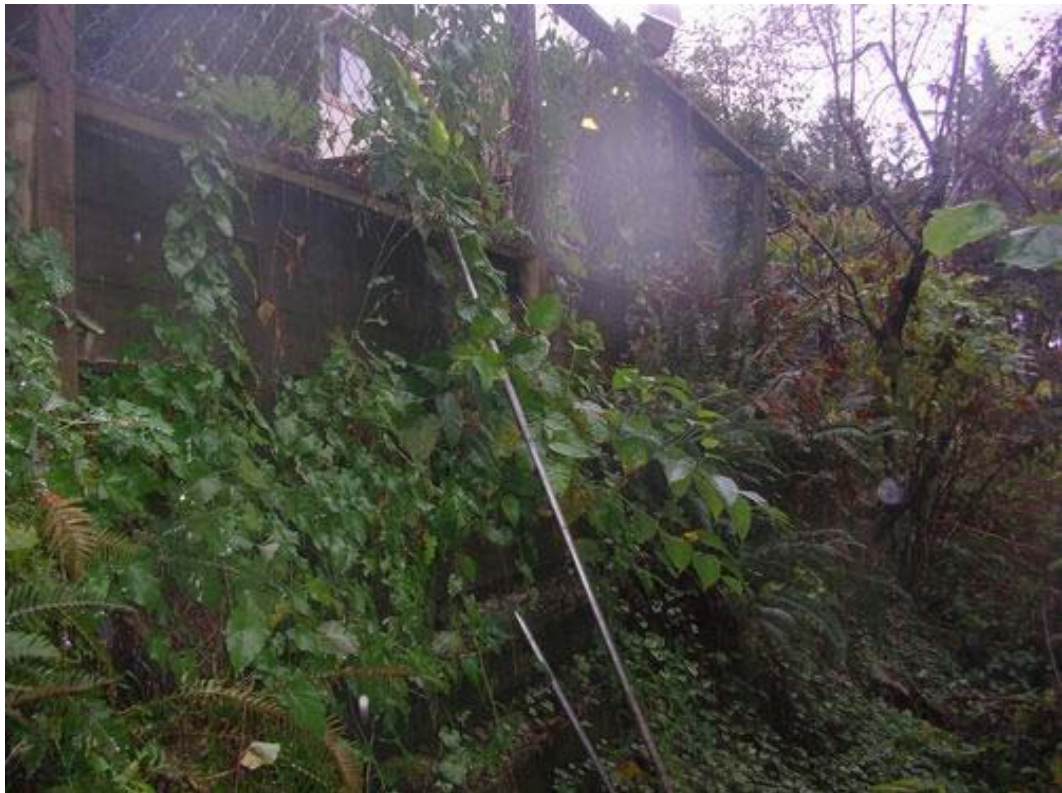
DEFORMATION IN BACKYARD	YES <input checked="" type="checkbox"/>	NO
LOCATION: Retaining wall		
DESCRIPTION: Settlement behind retaining wall.

Figure 4. 1479 Lennox Street – Timber crib retaining wall

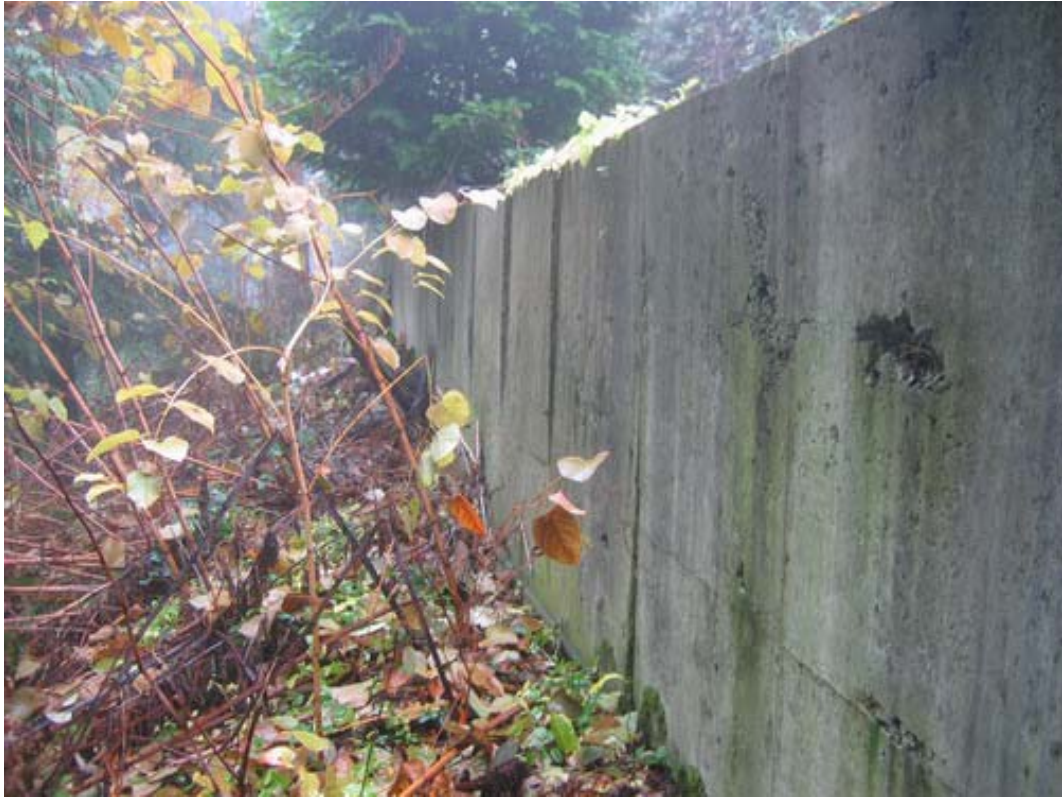
RETAINING STRUCTURES	YES <input checked="" type="checkbox"/>	NO	HEIGHT = 3.5 m
TYPE	BLOCKS	CONCRETE	TIMBER CRIB
DEFORMATION	UNDEFORMED	CRACKED	SETTLED
OBSERVATIONS: Series of 2 walls. The top wall is 1.9 m high and the bottom is 1.6 m high. Some cracking observed.

Figure 3. 1491 Lennox Street – Concrete retaining wall (lower wall)

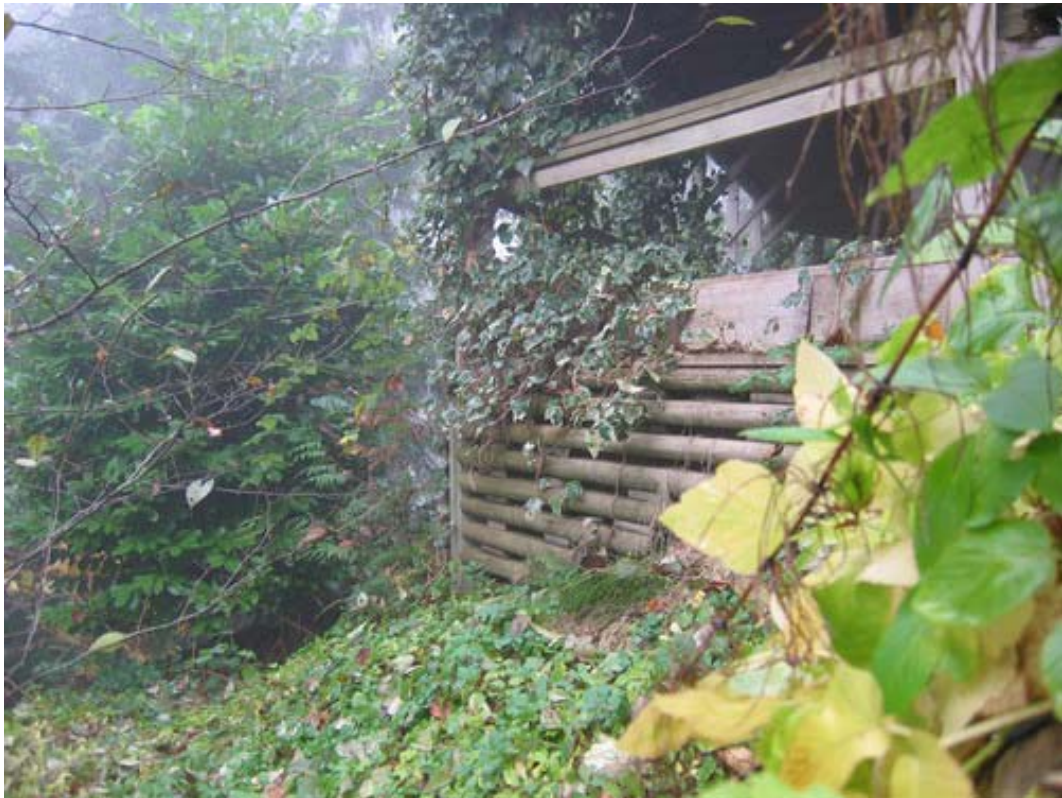
Figure 4. 1491 Lennox Street – Deck and timber crib retaining wall (upper wall)
