SITE OBSERVATION FORM: DNV Landslide Risk Assessment
LOCATION: 1535 Lennox Street
INSPECTION DATE: (mm/dd/yy) 11/03/05
WEATHER: Rain, heavy rain for several days prior to visit.

Project : DNV Landslide Risk Assessment

Project No. : 0404-002-01

Client: District of North Vancouver

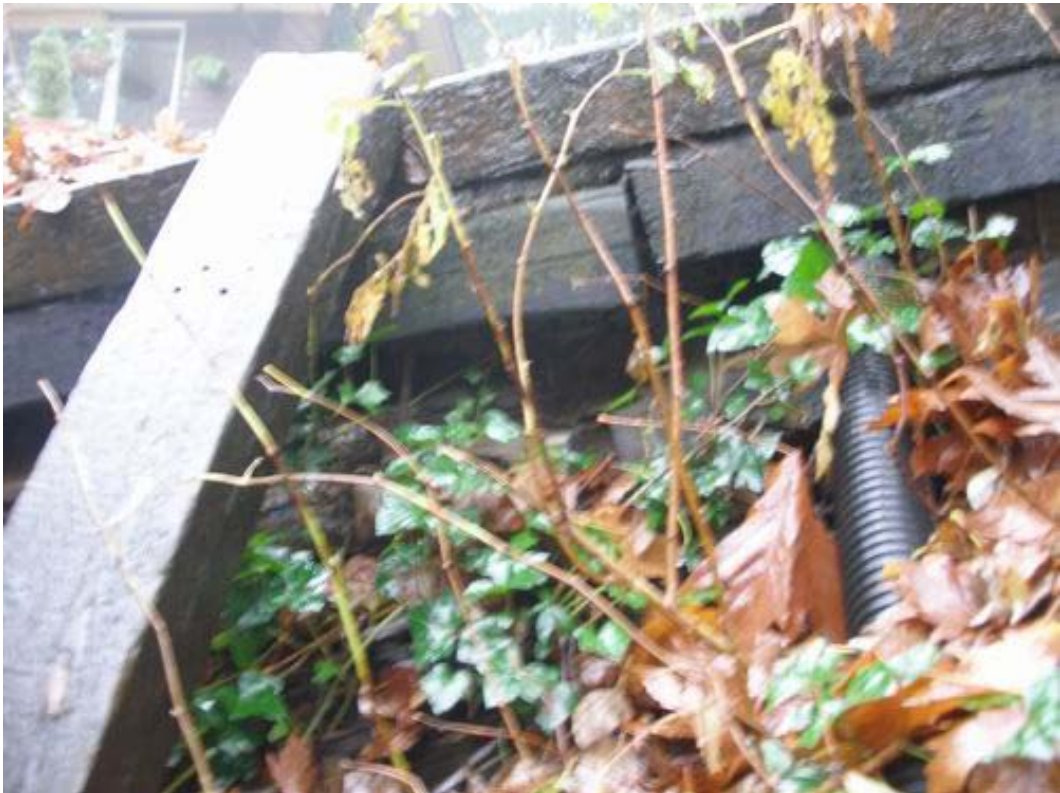
RETAINING STRUCTURES	YES <input checked="" type="checkbox"/>	NO	HEIGHT= 1.90 m
TYPE	BLOCKS CONCRETE	TIMBER CRIB	OTHER:
DEFORMATION	UNDEFORMED	CRACKED	BULGING
OBSERVATIONS: A small crib wall by patio is slumping. Bulging wall down slope is breaking apart. Wall being pressed against a tree at the crest causing the tree to lean.

Figure 2. 1535 Lennox Street – Bulging timber crib retaining wall

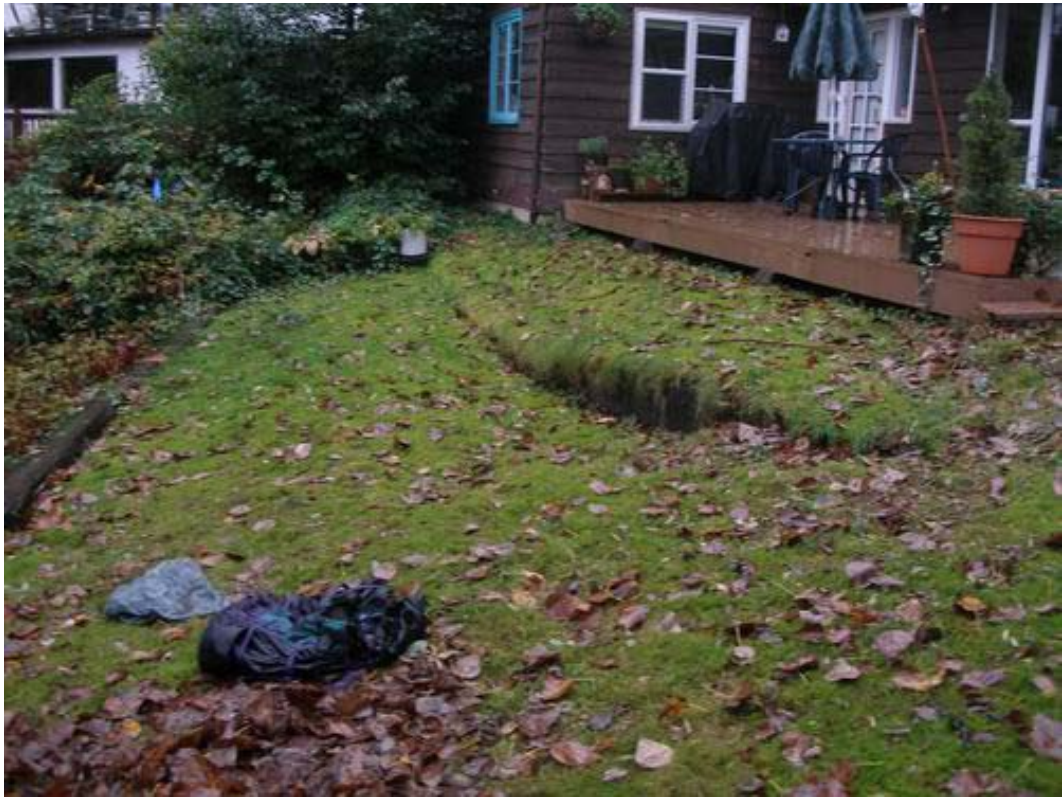
DEFORMATION IN BACKYARD	YES <input checked="" type="checkbox"/>	NO
LOCATION: Immediately behind crib wall.		
DESCRIPTION: Backyard is settling, and slumping in the down slope direction. Displacement on large crack is approximately 40 cm.

Figure 3. 1535 Lennox Street – View looking north of settling/slumping backyard

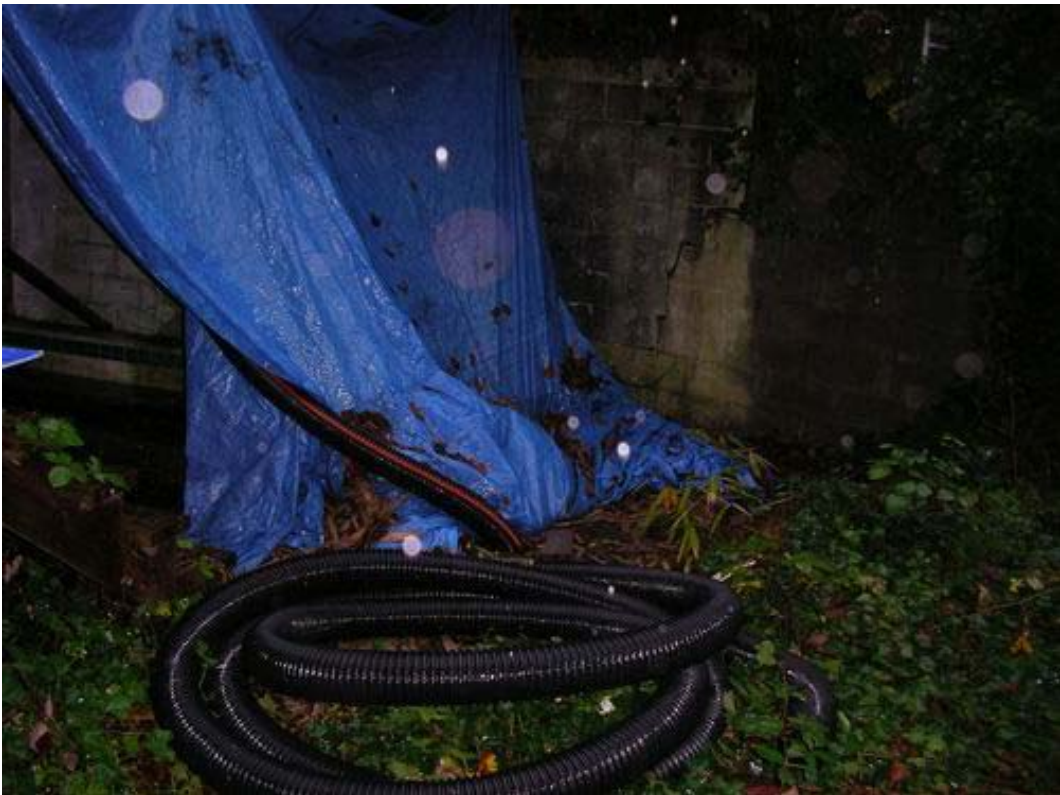
RECEIVES SURFACE RUNOFF FROM	BACKYARD	1/2 ROOF	FULL ROOF	FRONT YARD	STREET
	<input checked="" type="checkbox"/>	<input checked="" type="checkbox"/>	<input checked="" type="checkbox"/>	<input checked="" type="checkbox"/>	
OBSERVATIONS: PVC pipe captures roof drainage and directs it through the wood deck and retaining walls discharging down the slope. Exact location of end of pipe unknown.

CONNECTED TO STORM SEWER	YES	NO <input checked="" type="checkbox"/>	UNSURE
OWNERS COMMENTS:	DNV reports that this property is connected to the storm sewer, however site observations confirm that some roof drainage is diverted down slope by a PVC pipe.

Figure 2. 1557 Lennox Street – Drainage pipe exiting house, draining downslope

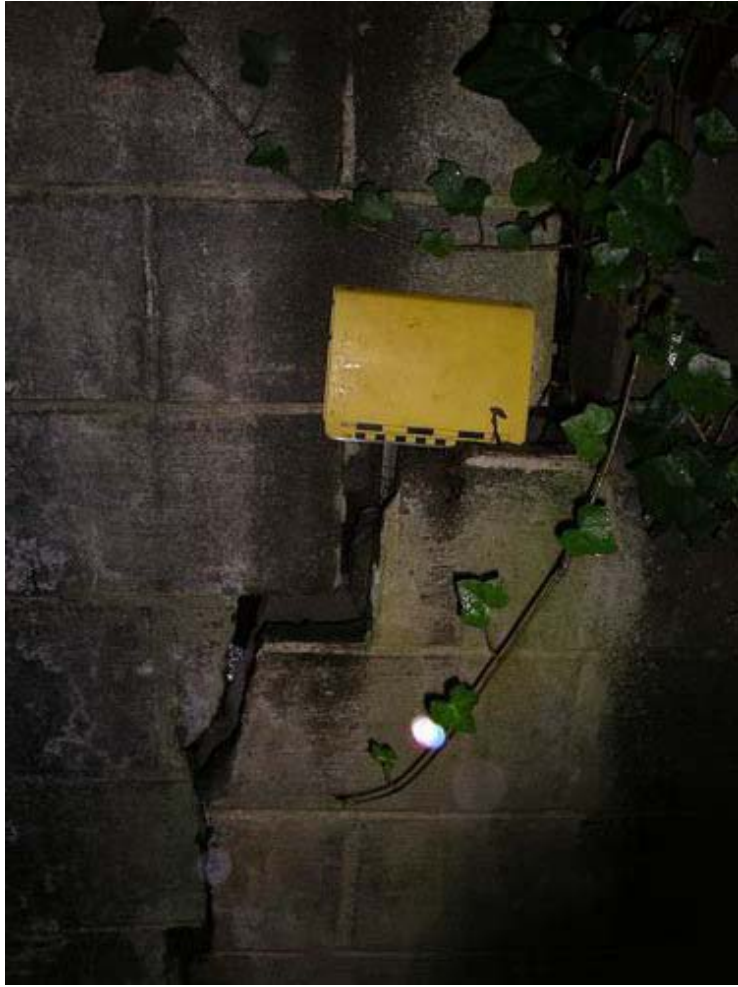
DEFORMATION IN BACKYARD	YES <input checked="" type="checkbox"/>	NO
LOCATION:		
DESCRIPTION:	Entire backyard is covered by deck and concrete retaining wall. Cracking observed in concrete retaining wall.

- Owner reports that this site has been monitored by a geotechnical engineer
- Various cracks (maximum displacement approx. 5 cm) were observed in upper retaining wall below wood deck.

Figure 3. 1557 Lennox Street – Crack in concrete retaining wall

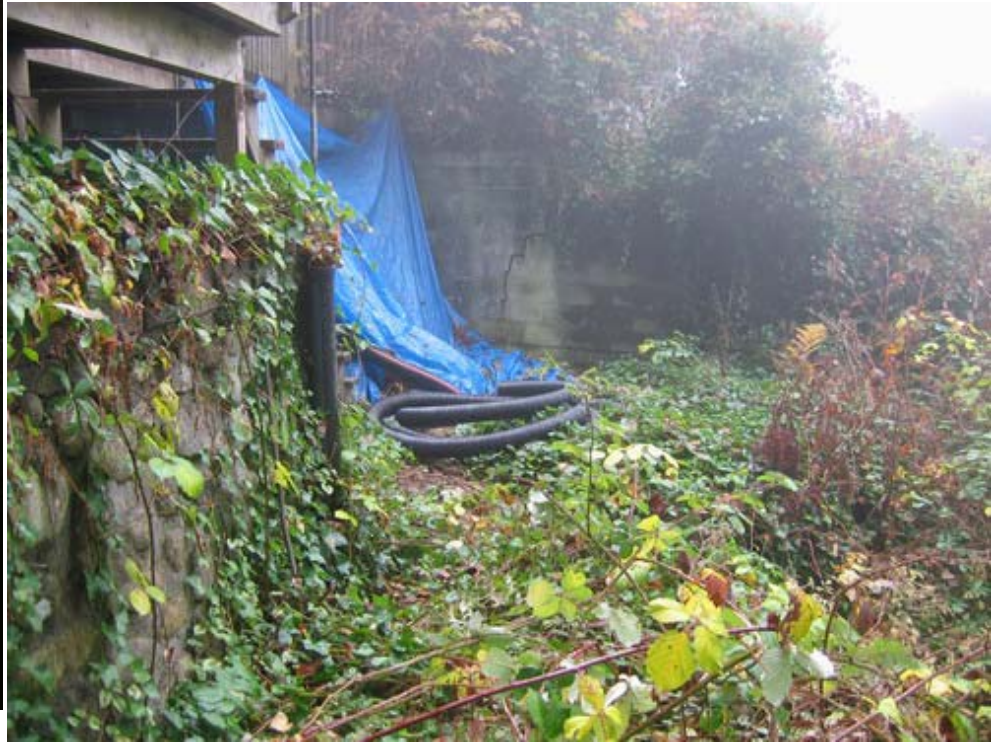
Figure 4. 1557 Lennox Street – View looking south along crest

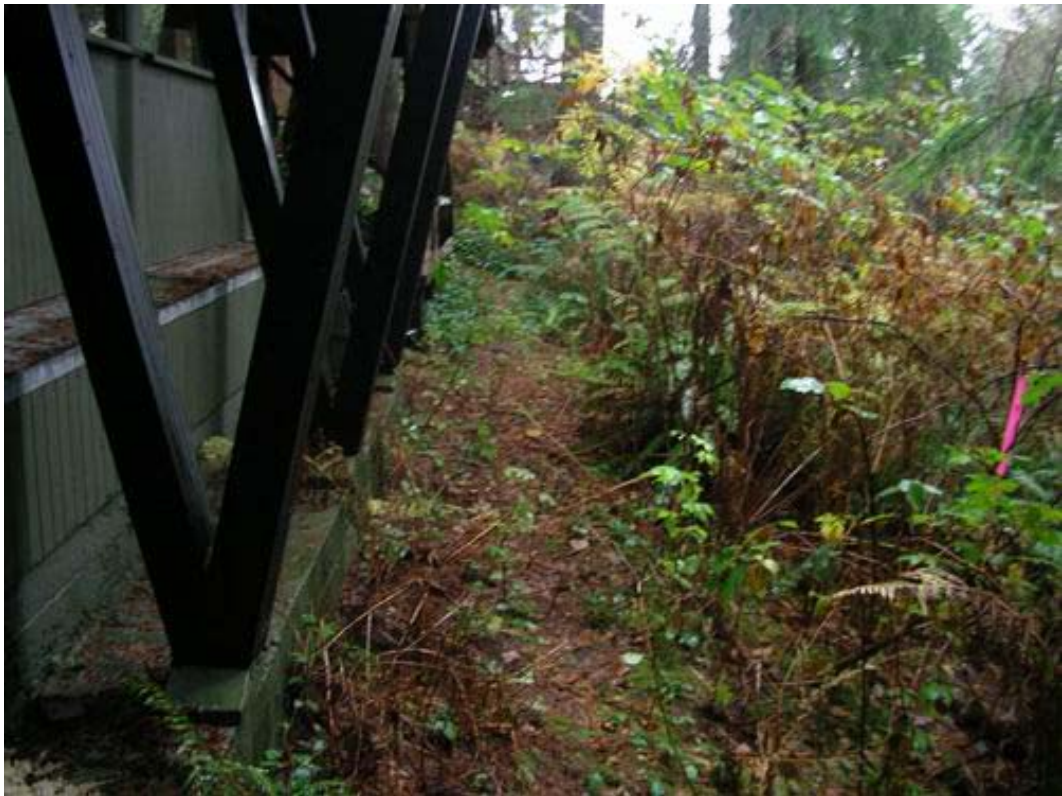
Figure 2. 1583 Lennox Street – View of slope crest looking south

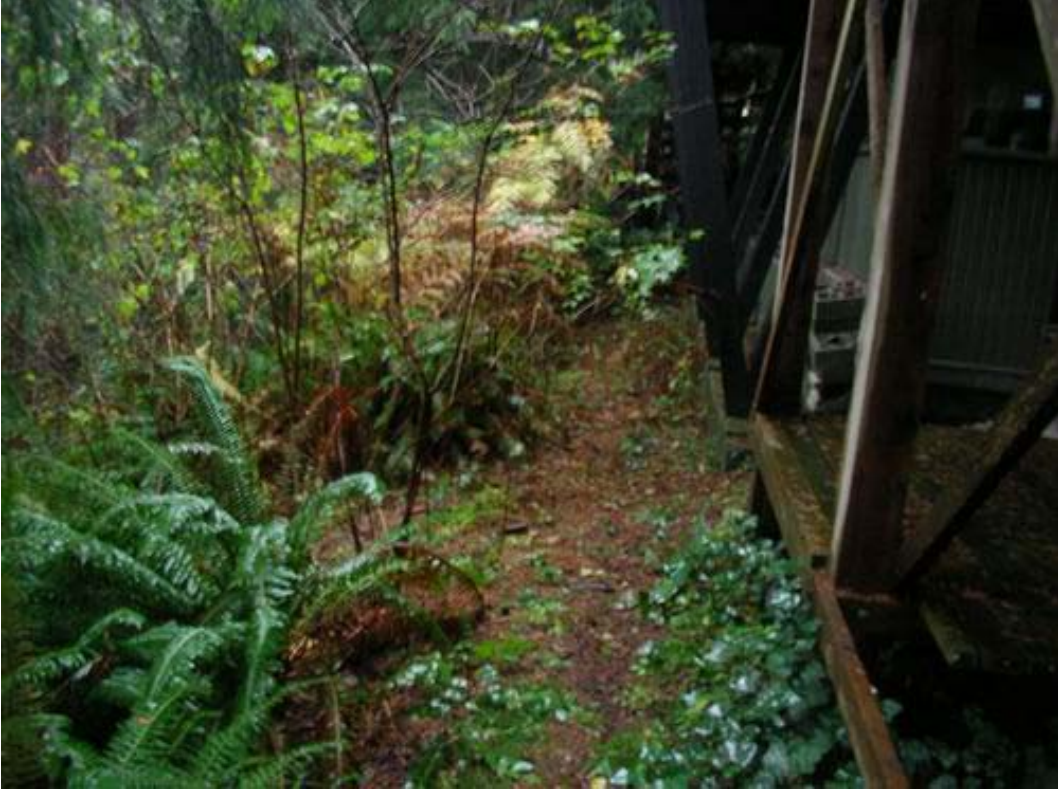
Figure 3. 1583 Lennox Street - View of slope crest looking north

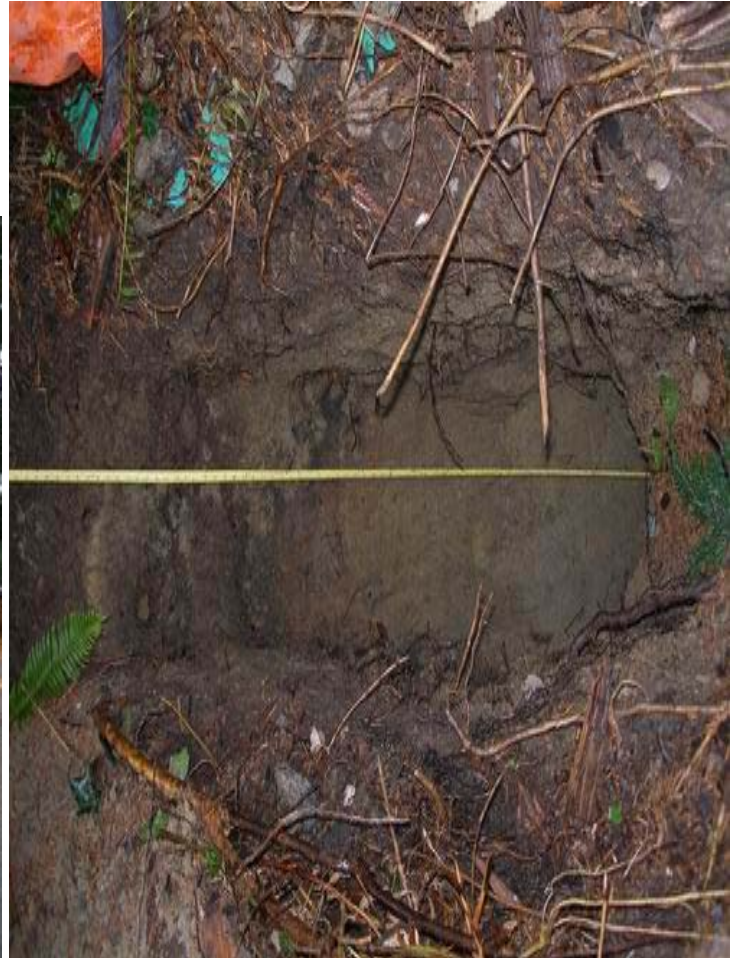
Figure 2. 1593 Lennox Street – Test pit excavated for a previous investigation used in conjunction with AH#1

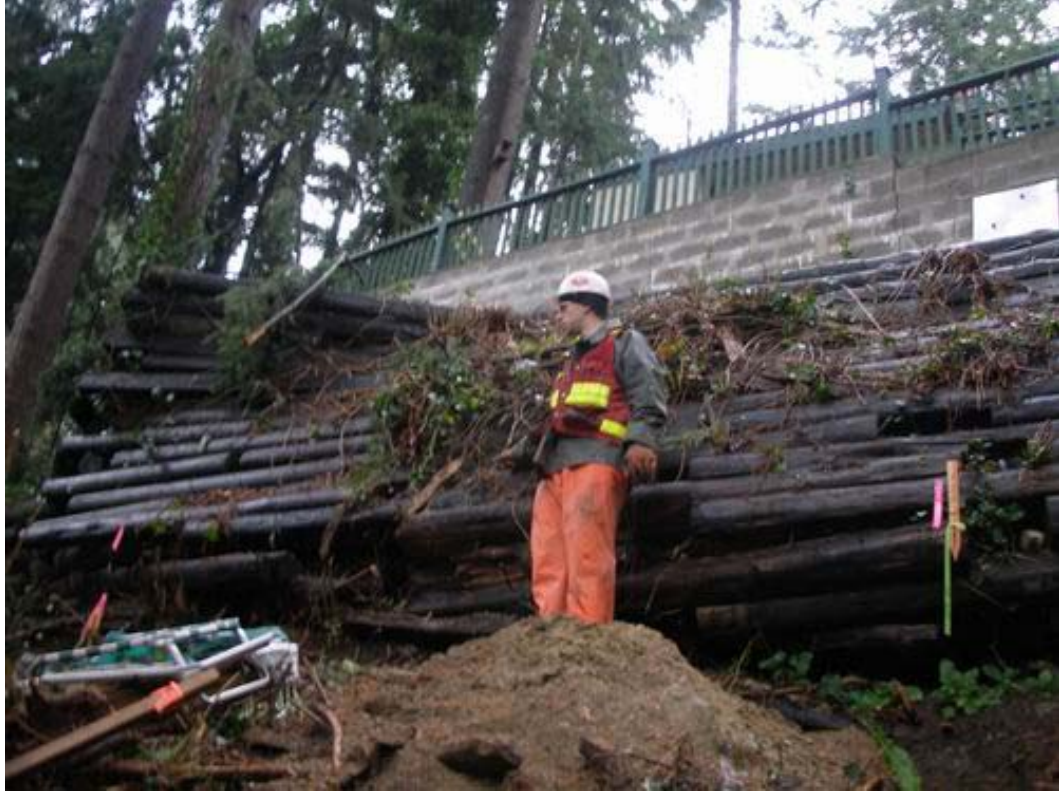
RETAINING STRUCTURES	YES <input checked="" type="checkbox"/>	NO	HEIGHT= 3 m concrete; 3 m timber
TYPE	CONCRETE <input checked="" type="checkbox"/>	TIMBER CRIB <input checked="" type="checkbox"/>	OTHER: <input checked="" type="checkbox"/>
DEFORMATION	UNDEFORMED <input checked="" type="checkbox"/>	CRACKED <input checked="" type="checkbox"/>	SETTLED <input checked="" type="checkbox"/>
OBSERVATIONS: Concrete and timber crib walls overlap by 1.5 m. Concrete wall is constructed with concrete blocks above the timber crib wall. Concrete wall is cracking in several places. Timber crib wall is bulging (1 m horizontal bulge from original placement).

Figure 3. 1593 Lennox Street – Concrete retaining wall built on top of old timber crib wall (timber crib wall is bulging and concrete wall is cracking)

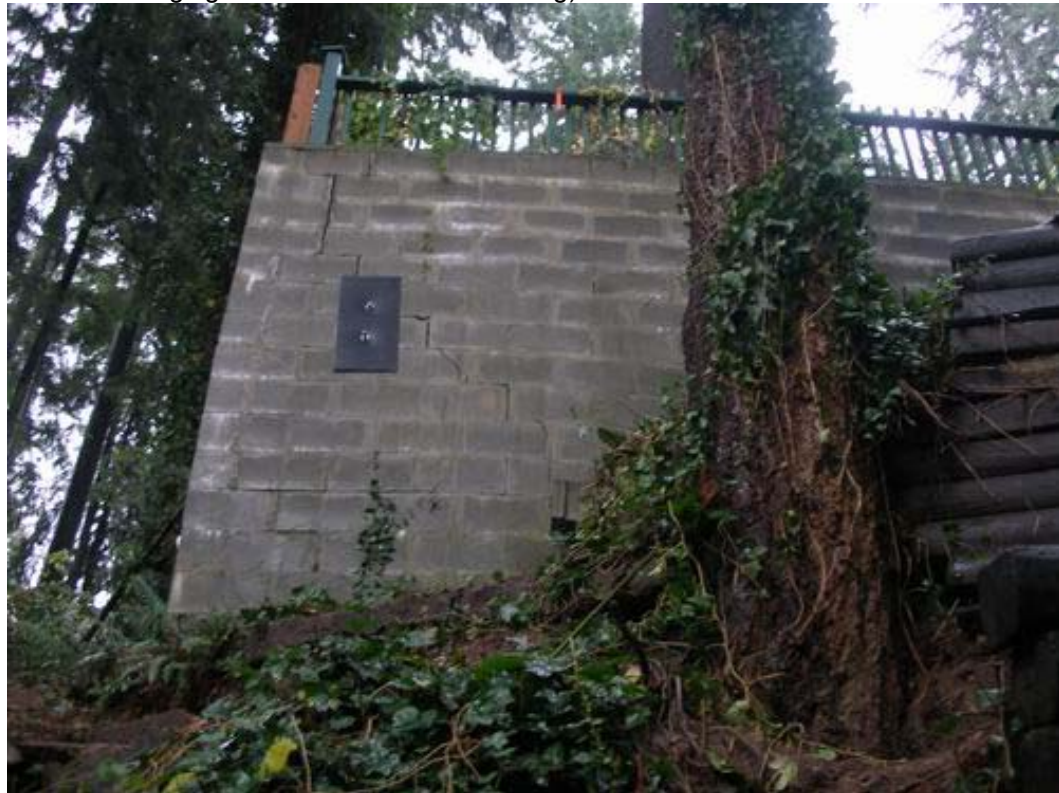
Figure 4. 1593 Lennox Street – Cracking on the west side of the concrete retaining wall

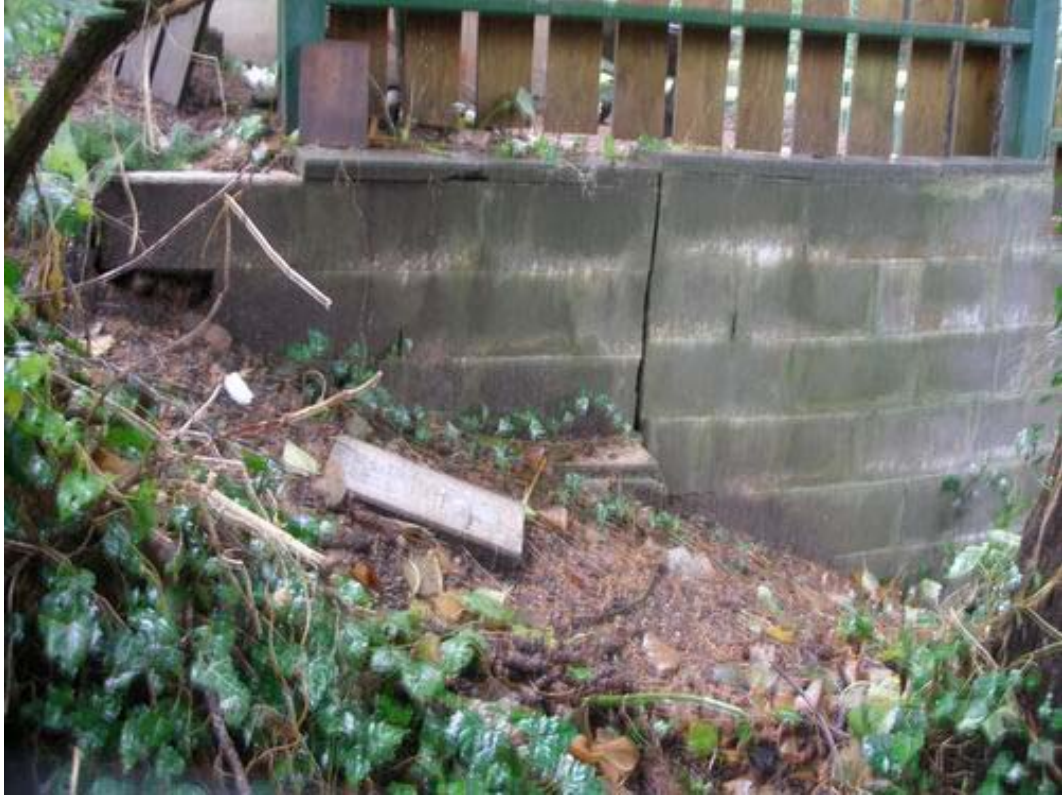
Figure 5. 1593 Lennox Street – Crack on the north side of the concrete retaining wall
