SITE OBSERVATION FORM: DNV Landslide Risk Assessment
LOCATION: 2402 Swinburne Avenue
INSPECTION DATE: (mm/dd/yy) 11/02/05
WEATHER: Rain, heavy rain for several days prior to visit.

SITE OBSERVATION FORM: DNV Landslide Risk Assessment
LOCATION: 2410 Swinburne Avenue
INSPECTION DATE: (mm/dd/yy) 11/02/05
WEATHER: Raining, heavy rain for several days prior to visit.

SITE OBSERVATION FORM: DNV Landslide Risk Assessment
LOCATION: 2414 Swinburne Avenue
INSPECTION DATE: (mm/dd/yy) 11/02/05
WEATHER: Light rain, heavy rain for several days prior to visit.

Client: District of North Vancouver

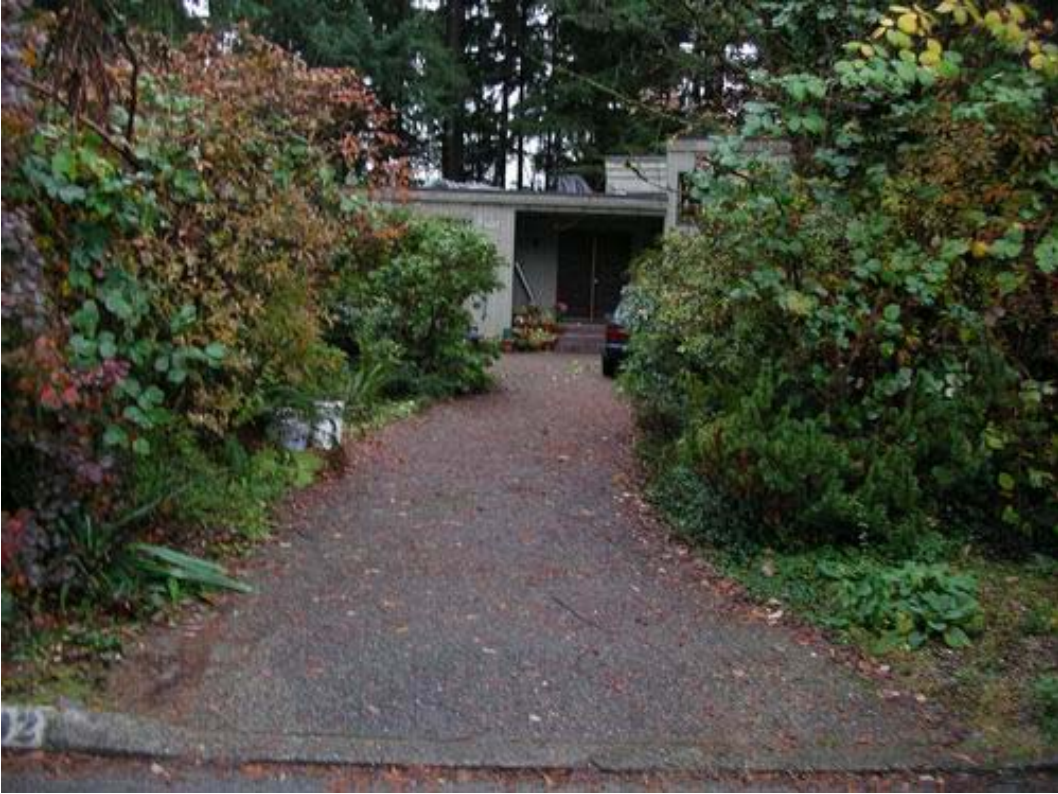
Figure 1. 2402 Swinburne Avenue – Front of the house

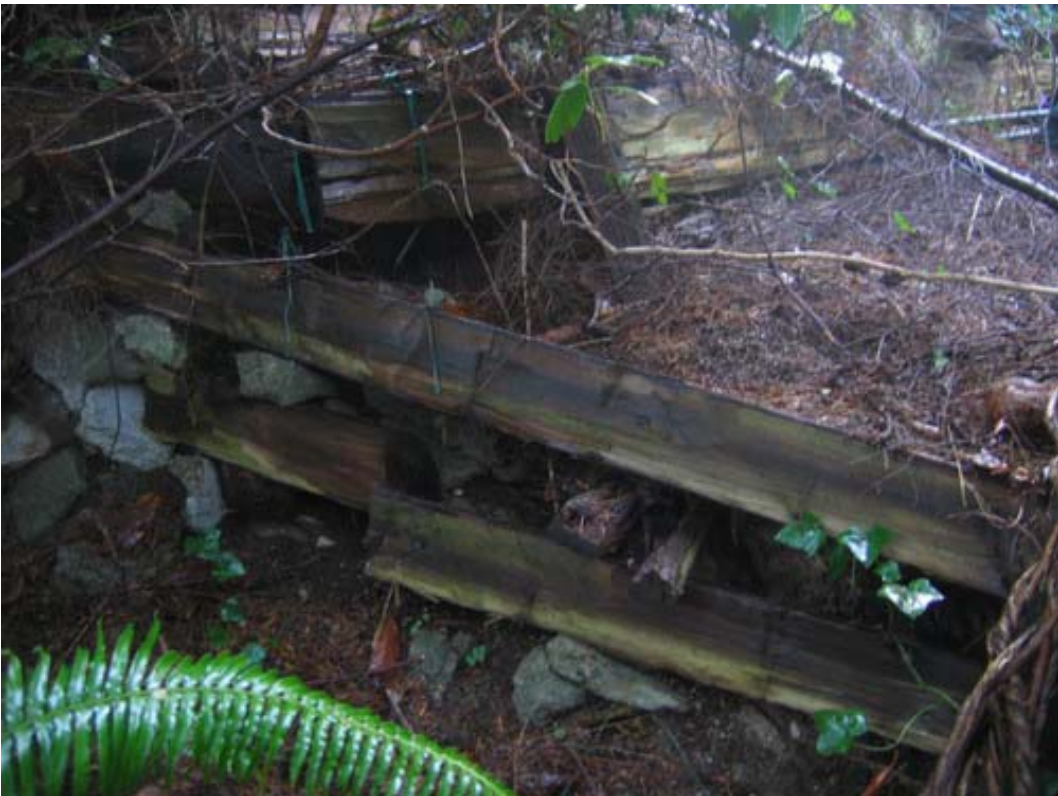
| RETAINING STRUCTURES | YES <input checked="" type="checkbox"/> | NO | HEIGHT = 6.5 m |
|--|---|---|---|
| OBSERVATIONS: Height is the total height of 4 terraces of retaining walls. Wall height increases down slope, ranging from 0.15 m to 1.5 m. Fill contained by wall is settling due to rotting, bulging timbers. | | | |

| DEFORMATION IN BACKYARD | YES <input checked="" type="checkbox"/> | NO |
|---|---|---|
| DESCRIPTION: Tension cracks observed in fill behind bulging timber retaining walls. | | |

- The timber cribbing at the lowest terrace level on the southeast side of the property is failing.
- Gully located on south side of property.

Figure 2. 2402 Swinburne Avenue – Retaining wall

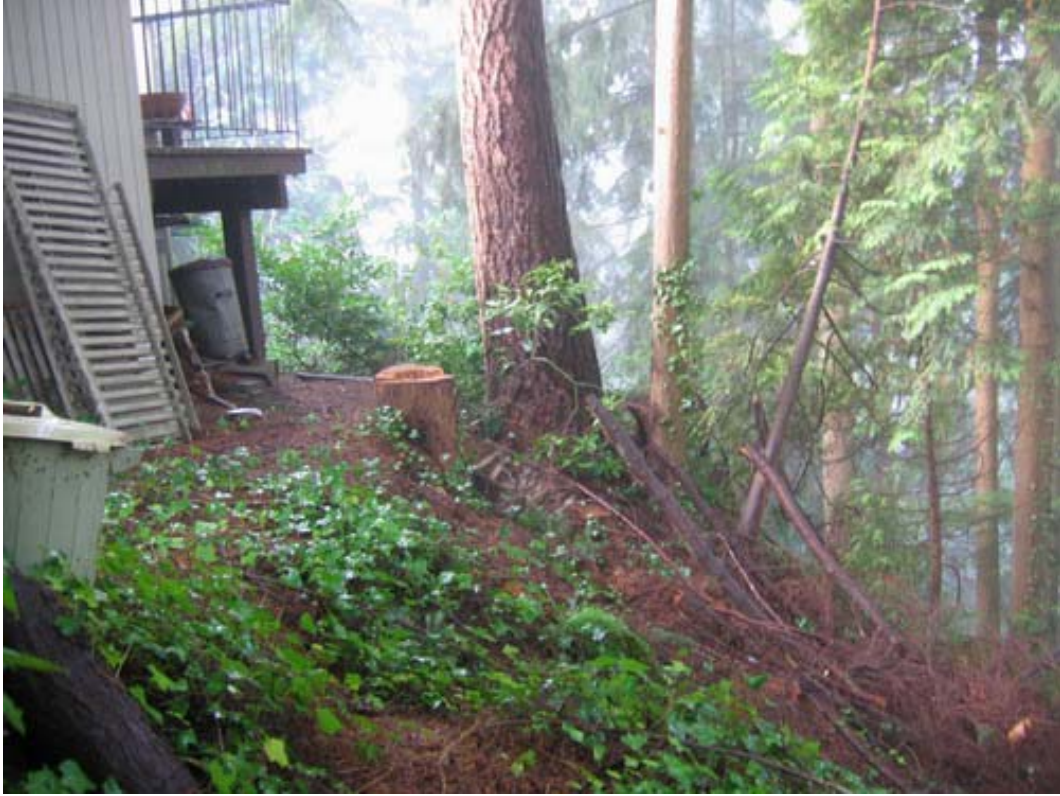
Figure 3. 2402 Swinburne – View west along fenceline (backyard)

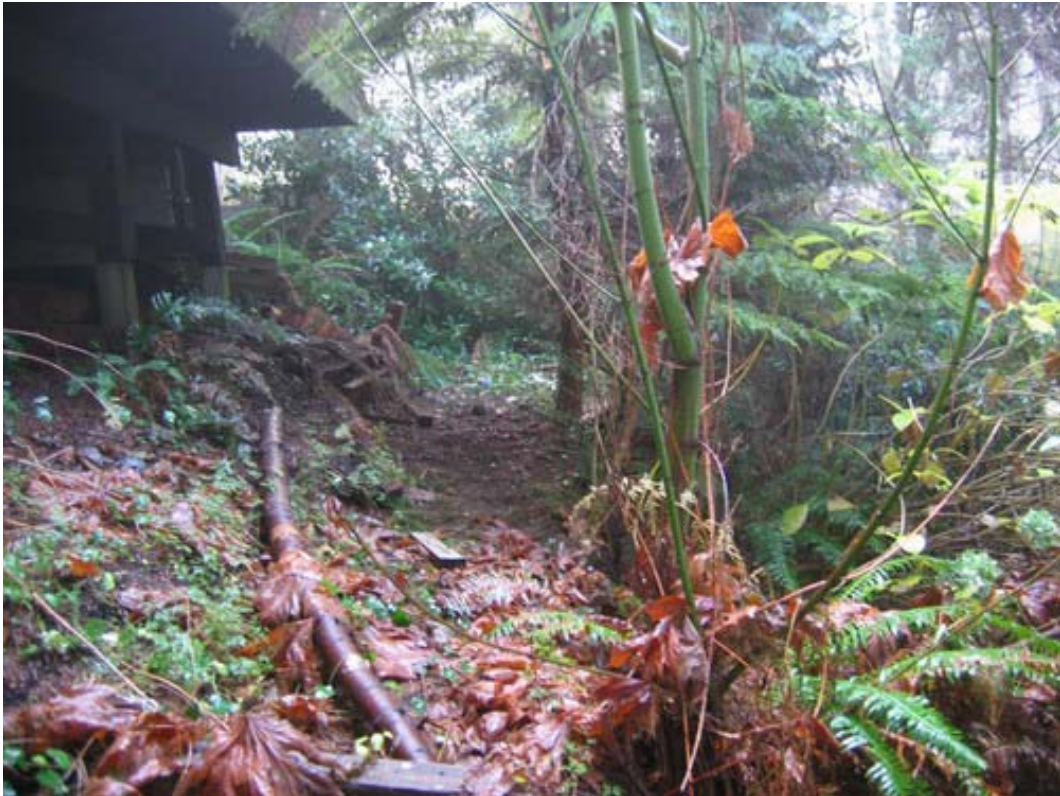
Figure 4. 2402 Swinburne – View south along fenceline (backyard)

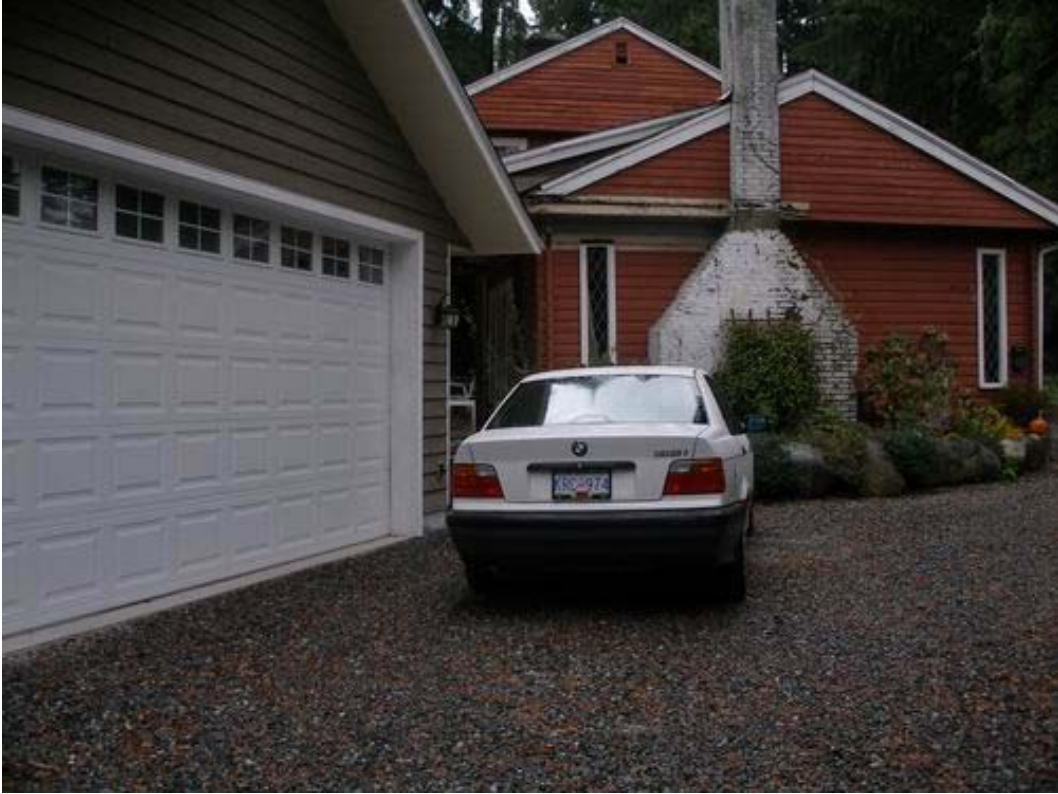
Figure 1. 2410 Swinburne Avenue – Front of the house

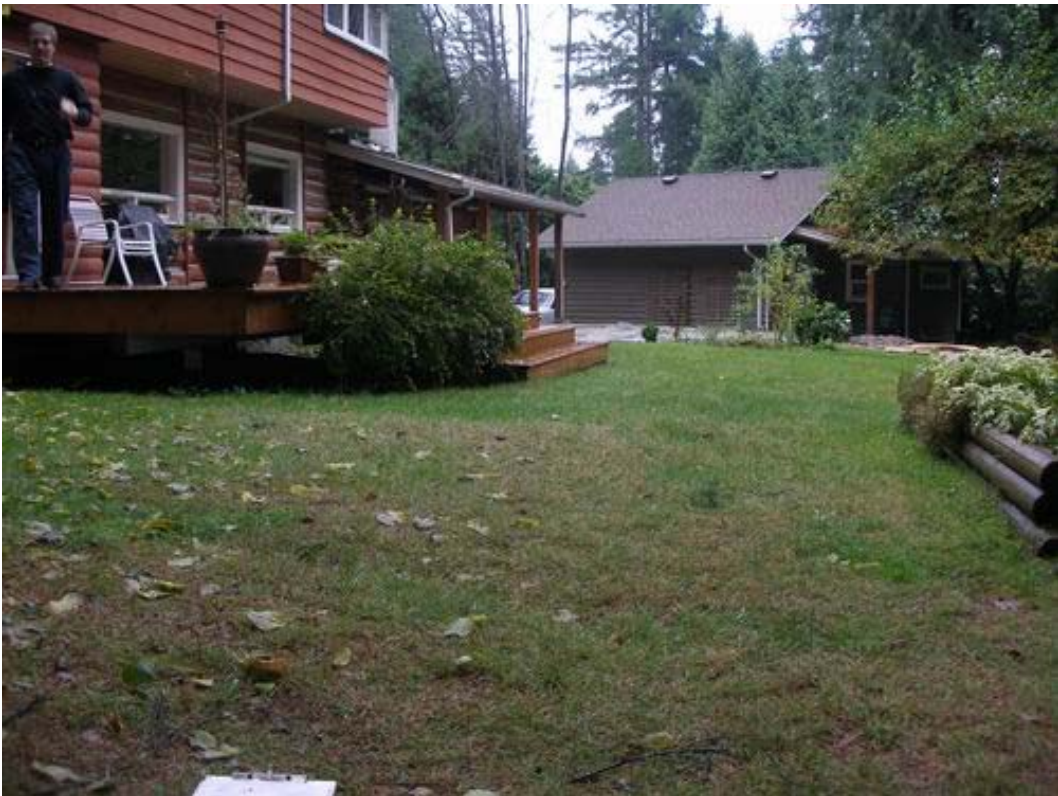
| RECEIVES SURFACE RUNOFF FROM | BACKYARD <input checked="" type="checkbox"/> | 1/2 ROOF | FULL ROOF | FRONT YARD | STREET |
|---|--|---|---|---|---|
| OBSERVATIONS: | Backyard dips southwest away from crest. | | | | |

Figure 2. 2410 Swinburne Avenue – View of backyard dipping towards the south

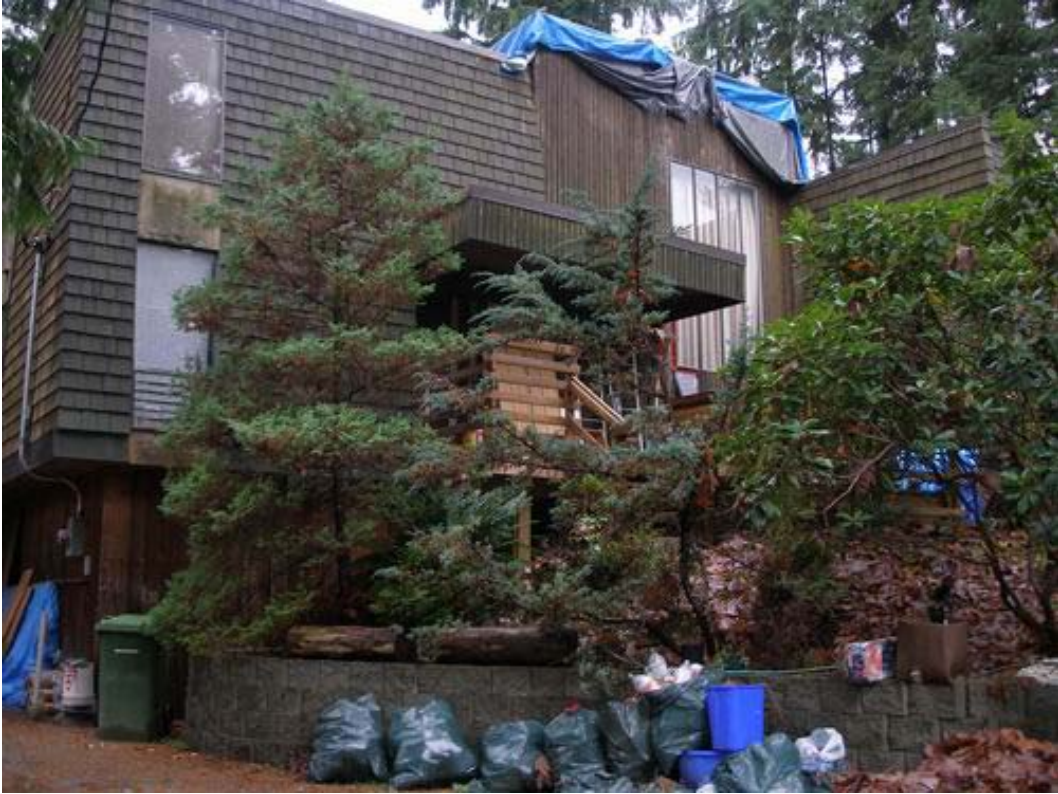
Figure 1. 2414 Swinburne Avenue – Front of the house

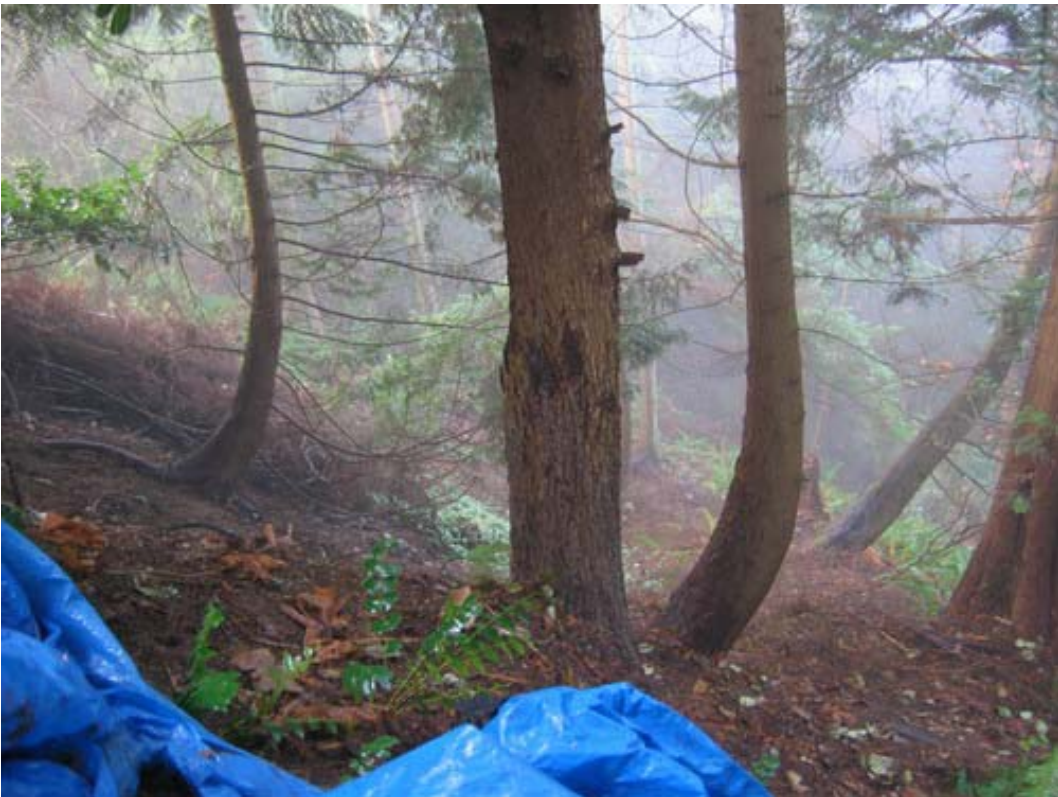
| TREES BELOW FENCE/ RETAINING STRUCTURE | STRAIGHT | PISTOL-BUTT | LEANING |
|---|---|---|---|
| OBSERVATIONS: West corner of property has a large 0.9 m diameter leaning tree at crest of slope. | | | |

Figure 2. 2414 Swinburne Avenue – Leaning trees downslope

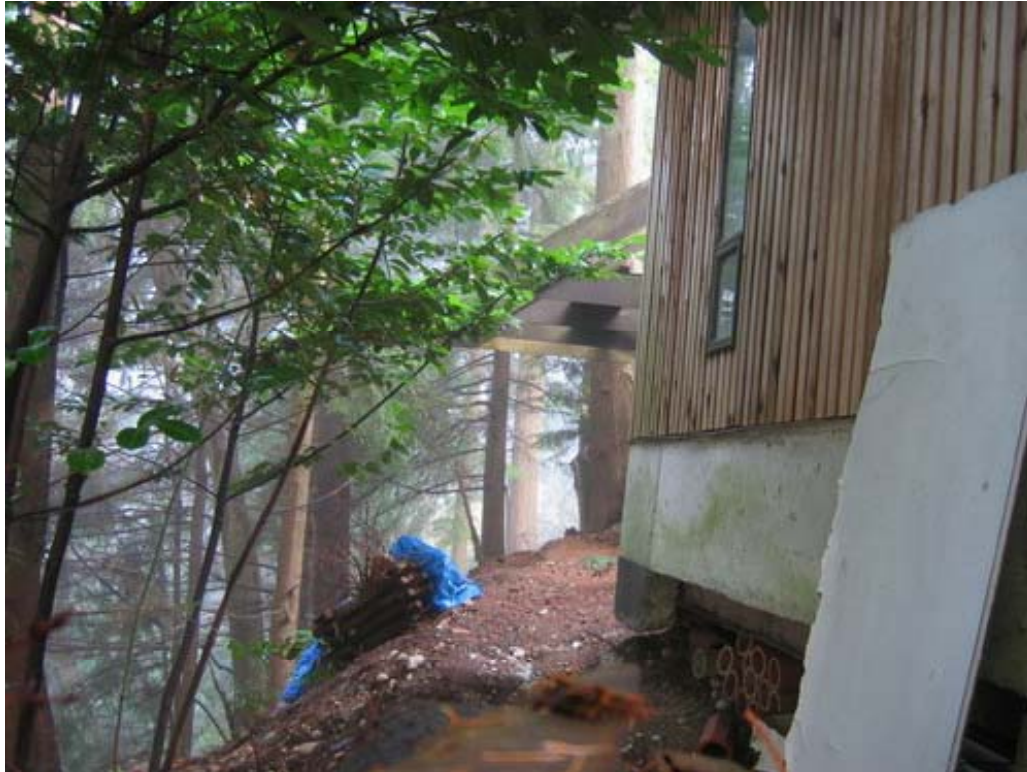
Figure 3. 2414 Swinburne Avenue – View north along fenceline (backyard)

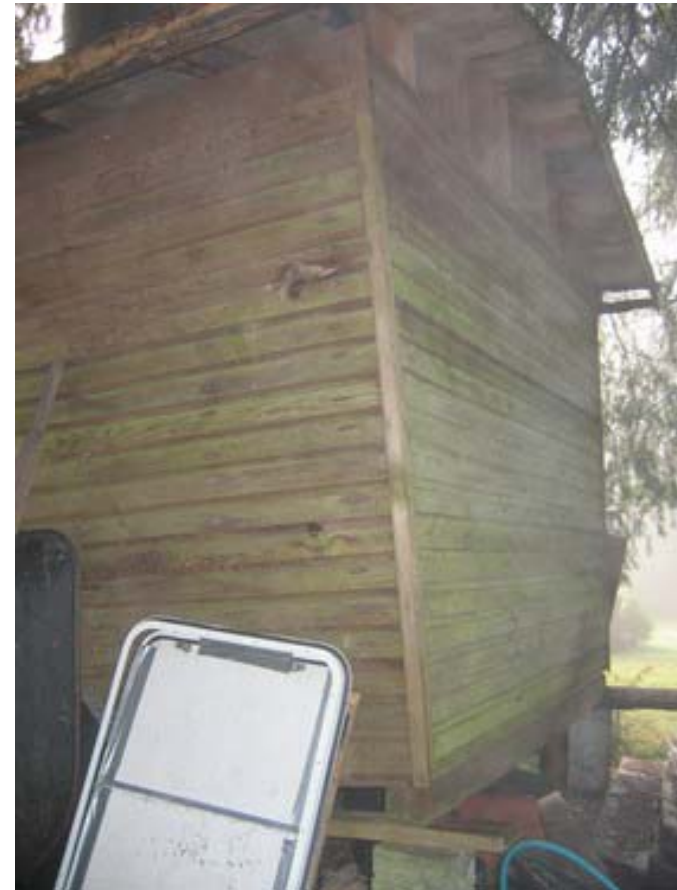
- Owner spent \$200,000 repairing house foundation because house was settling. Owner noted that the new foundation is on 'hardpan'.
- Owner has downspouts collecting in a sump. (Location uncertain)
- Shed in West corner of property is settling and twisting with deformation. Some foundations are located on the crest and are settling.

Figure 4. 2414 Swinburne Avenue - View looking south at tilted shed
