SITE OBSERVATION FORM: DNV Landslide Risk Assessment
LOCATION: 1677 Layton Drive
INSPECTION DATE: (mm/dd/yy) 11/02/05
WEATHER: Raining, heavy rain for several days prior to visit.

Project : DNV Landslide Risk Assessment

Project No. : 0404-002-01

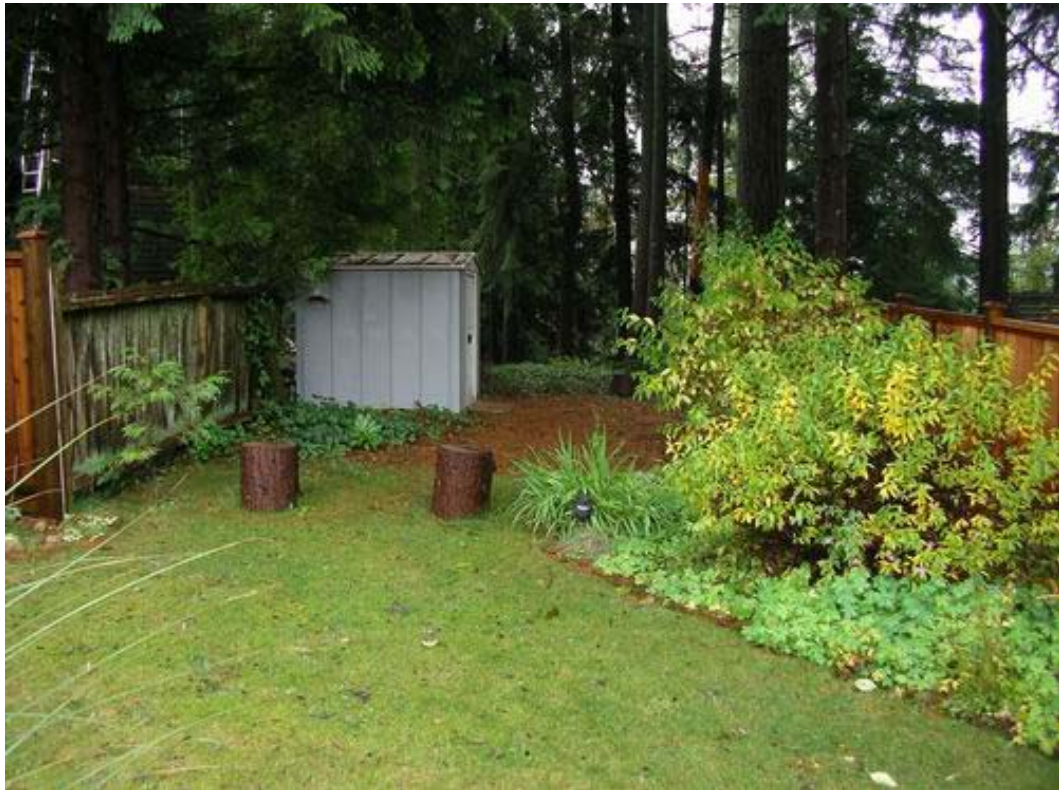
- House is a long distance from the crest of the slope; Fill extends over the slope
- Slope is steep below the crest and appears to be oversteepened by compost and mulch that have been placed over the edge.
- Evidence of slope movement activity observed along property line with adjacent property to the south. 30 cm settlement above headscarp.

Figure 2. 1677 Layton Drive – View from backyard looking SW towards crest

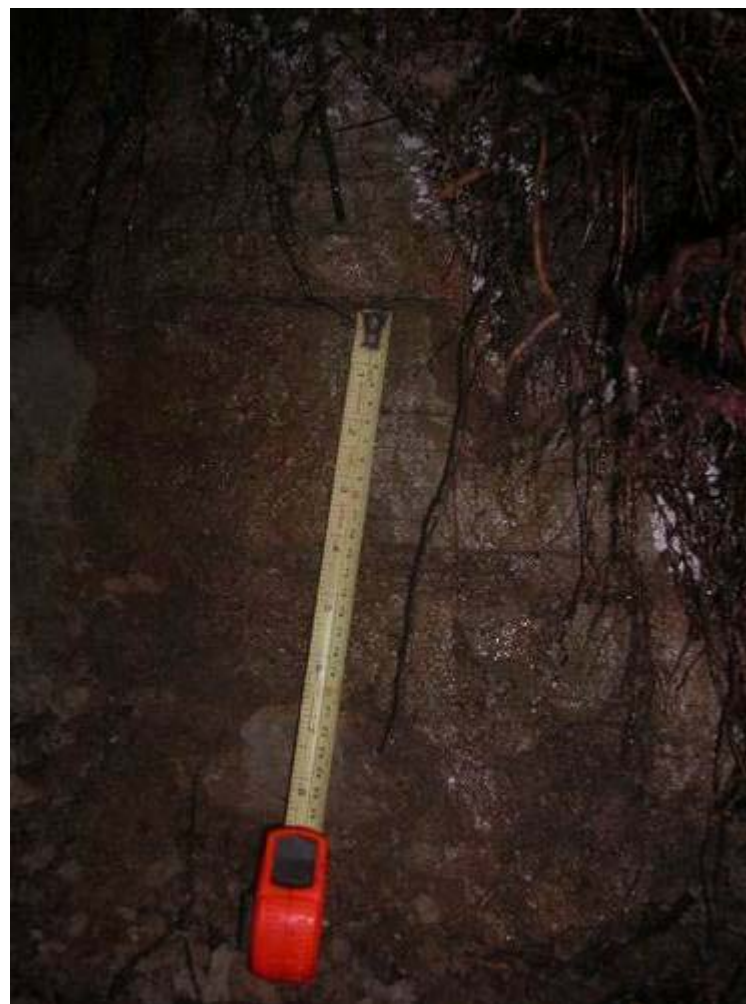
SLOPE BELOW FENCE/ RETAINING STRUCTURE	SLOPE = 33° on slide runout; 35-40° near crest of slope		
	CRACKS	SLIDES	EROSION
		<input checked="" type="checkbox"/>	<input checked="" type="checkbox"/>
OBSERVATIONS: Slump/slide observed on southwest corner of property below crest near property line with Swinburne Drive property. Slide is approximately 4 m wide with a 5-7 m runout. Root of fallen tree has exposed Glaciomarine sediments approximately 20 m downslope of crest.

Figure 4. 1677 Layton Drive – Glaciomarine soil exposure

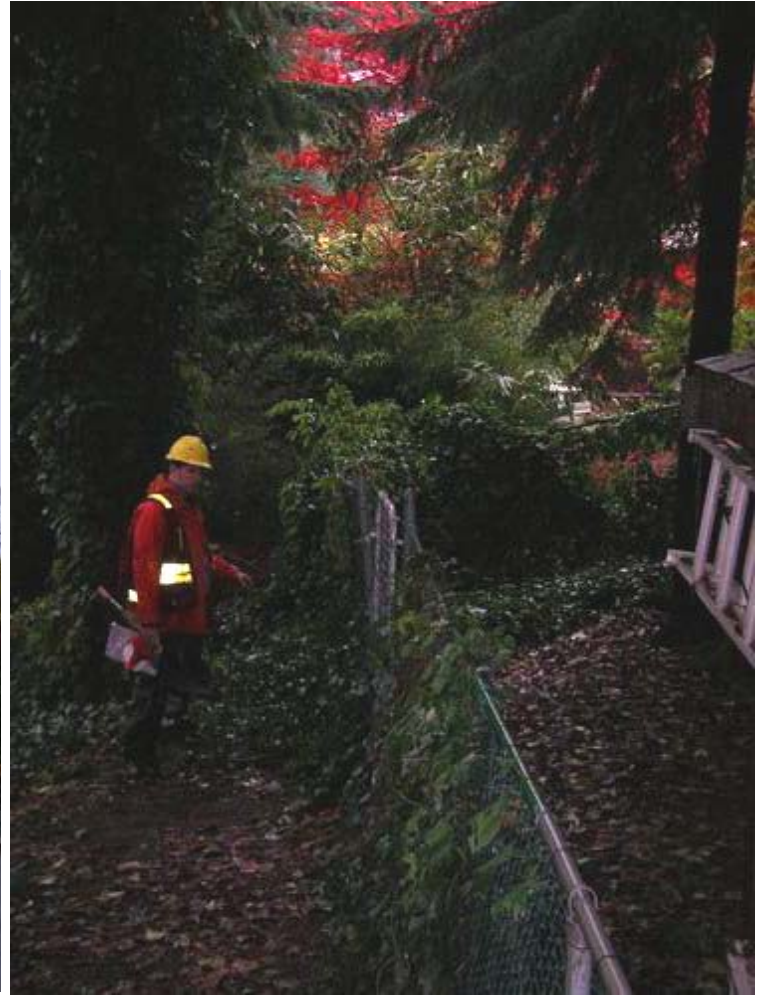
DEFORMATION IN BACKYARD	YES <input checked="" type="checkbox"/>	NO
LOCATION: North corner of backyard near fence line.		
DESCRIPTION: Corner of yard is sloping down slope more steeply than the rest of the yard. Slumping occurred after the 1979 event.

Figure 2. 1691 Layton Drive – View looking NW along fenceline

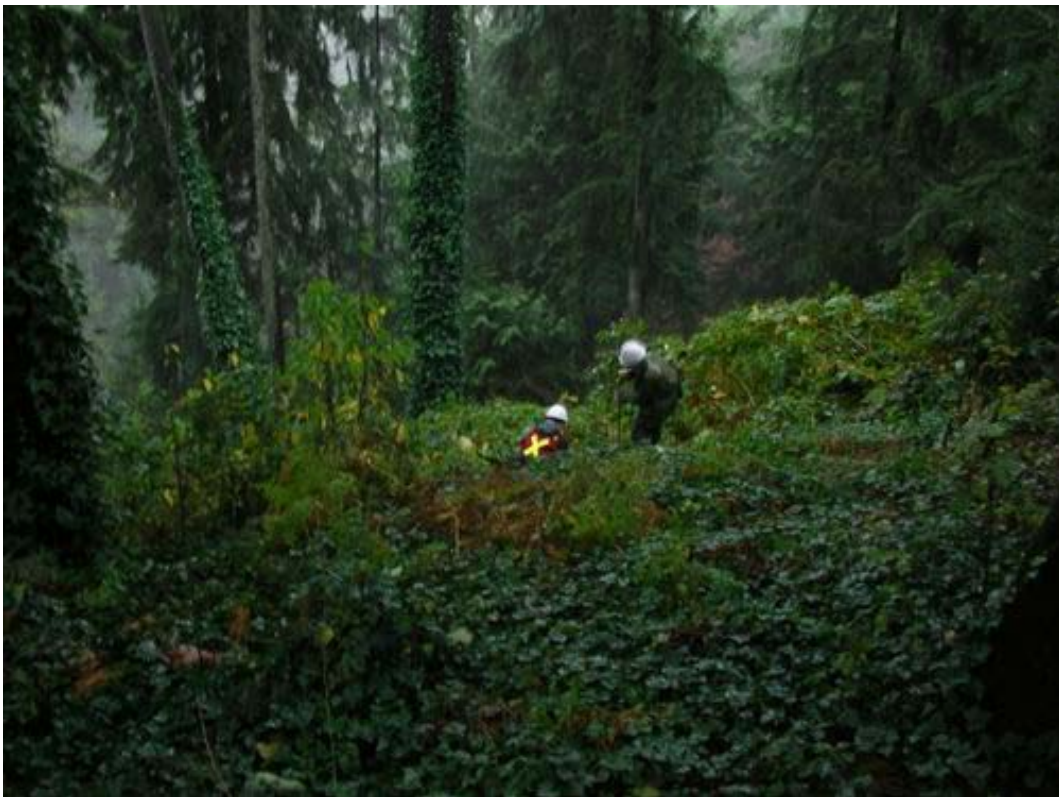
- Landscaping makes it difficult to see any natural settlement.
- Slope crest at south end of property appears to be an old scarp.

Figure 2. 1709 Layton Drive – View looking west downslope from crest

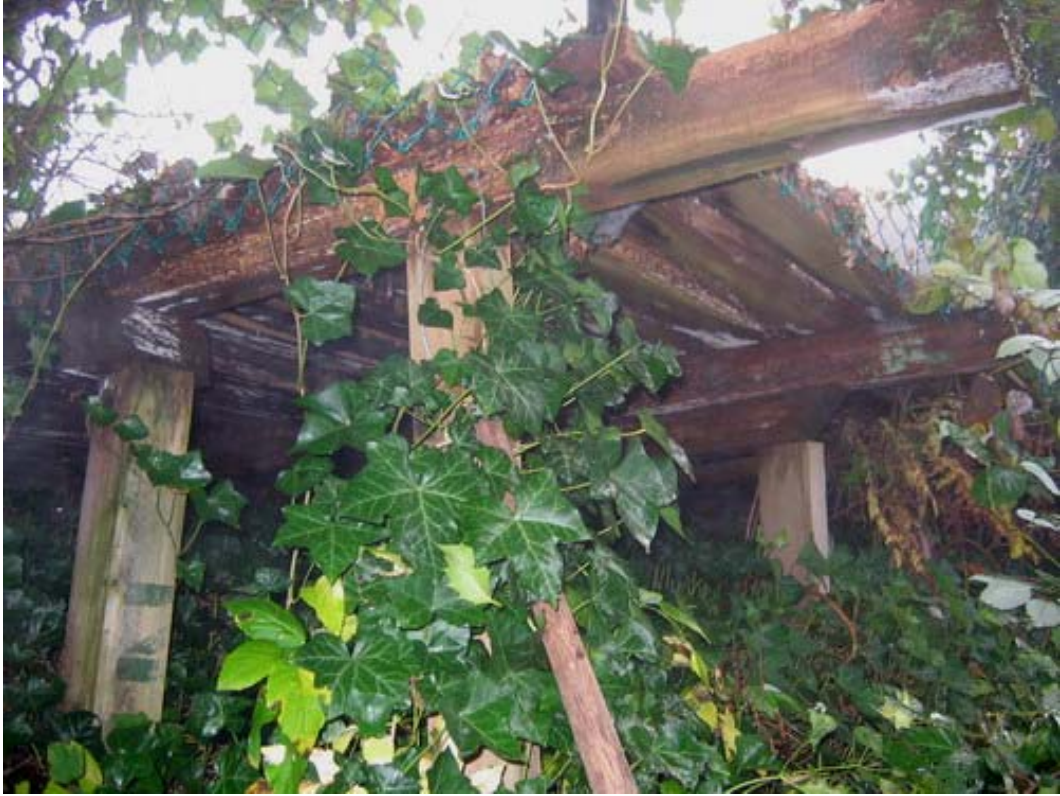
- GENERAL OBSERVATIONS**
- Owner notes that he constantly jacks up his deck to keep it level. Footing is located on down slope side of crest. Owner estimated that the deck settles 2" per year.
 - House does not have a basement below ground level.
 - Compost thrown over crest.

Figure 3. 1731 Layton Drive – View upslope looking at bottom of rotting deck

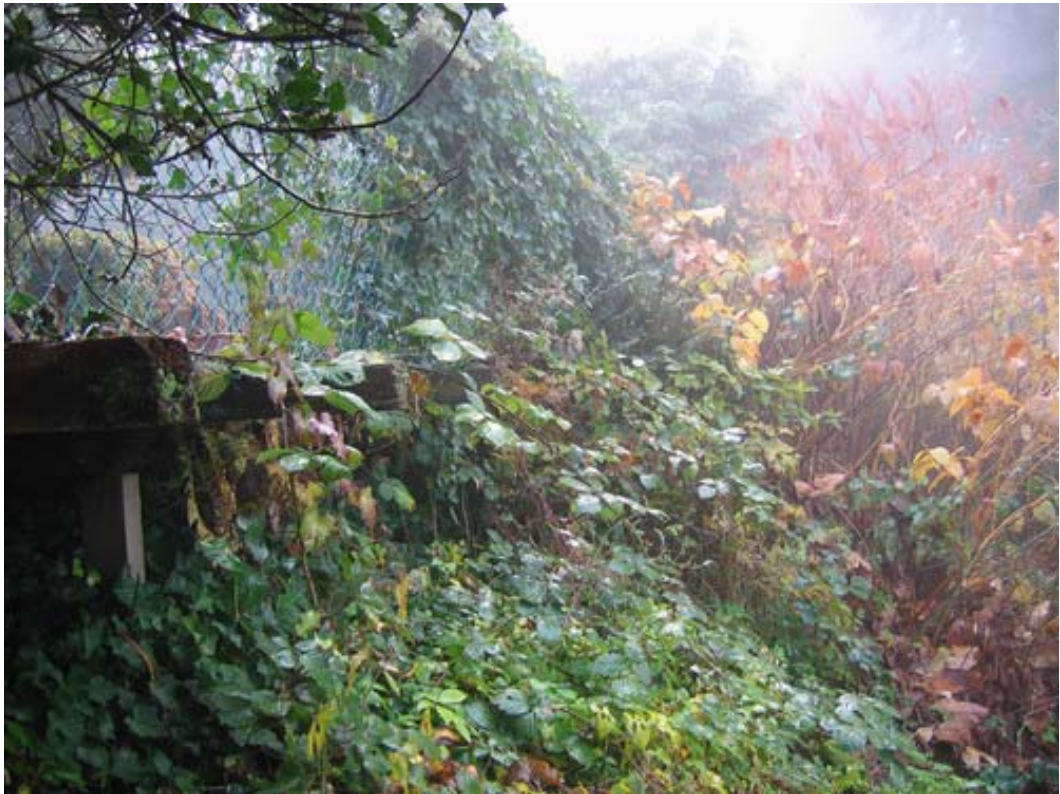
DEFORMATION IN BACKYARD	YES <input checked="" type="checkbox"/>	NO
LOCATION: Fence line		
DESCRIPTION: Deck behind the yard straddles the crest; Evidence of settlement.

Figure 4. 1731 Layton Drive – View looking SE along deck/fenceline

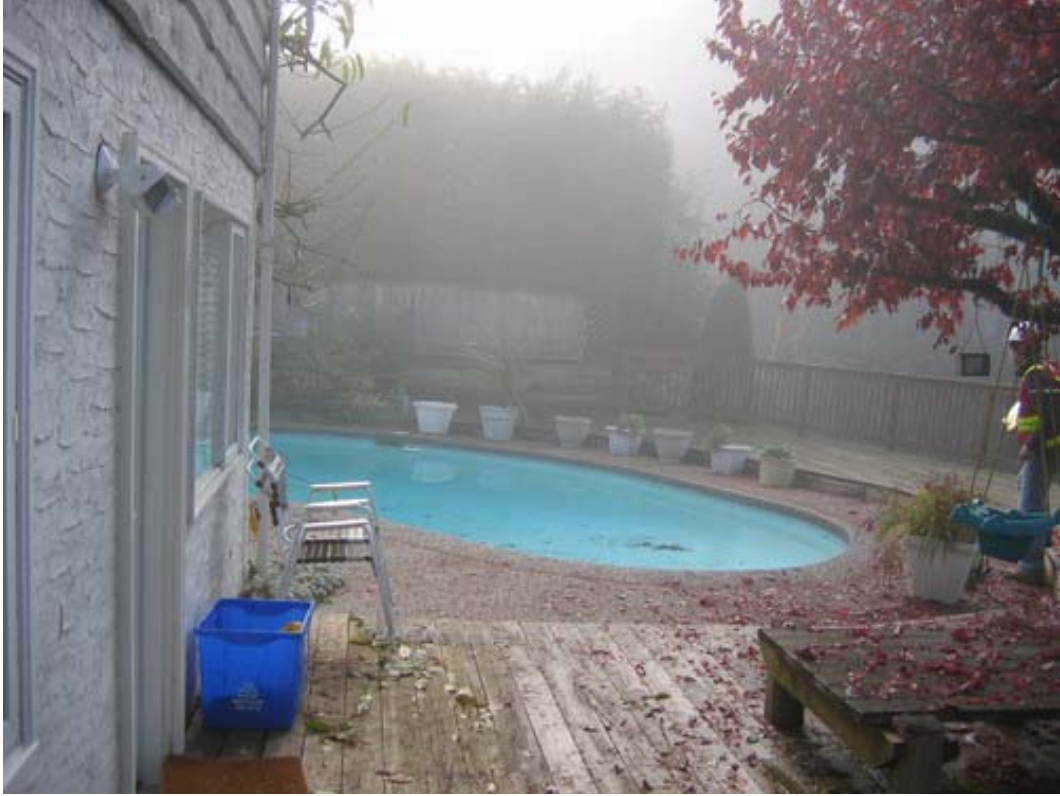
DEFORMATION IN BACKYARD	YES <input checked="" type="checkbox"/>	NO
LOCATION: Edge of wood deck.		
DESCRIPTION: Owner noted movement/settlement of deck after 1979 event. Settlement possibly due to rotting wood observed in south east corner of wood deck.

- Entire backyard is covered by cement pool deck or by large curved wood deck that overhangs the crest of the slope.
- Owner noted movement some of deck after 1979 event.

Figure 3. 1753 Layton Drive – View looking south of pool and backyard/deck

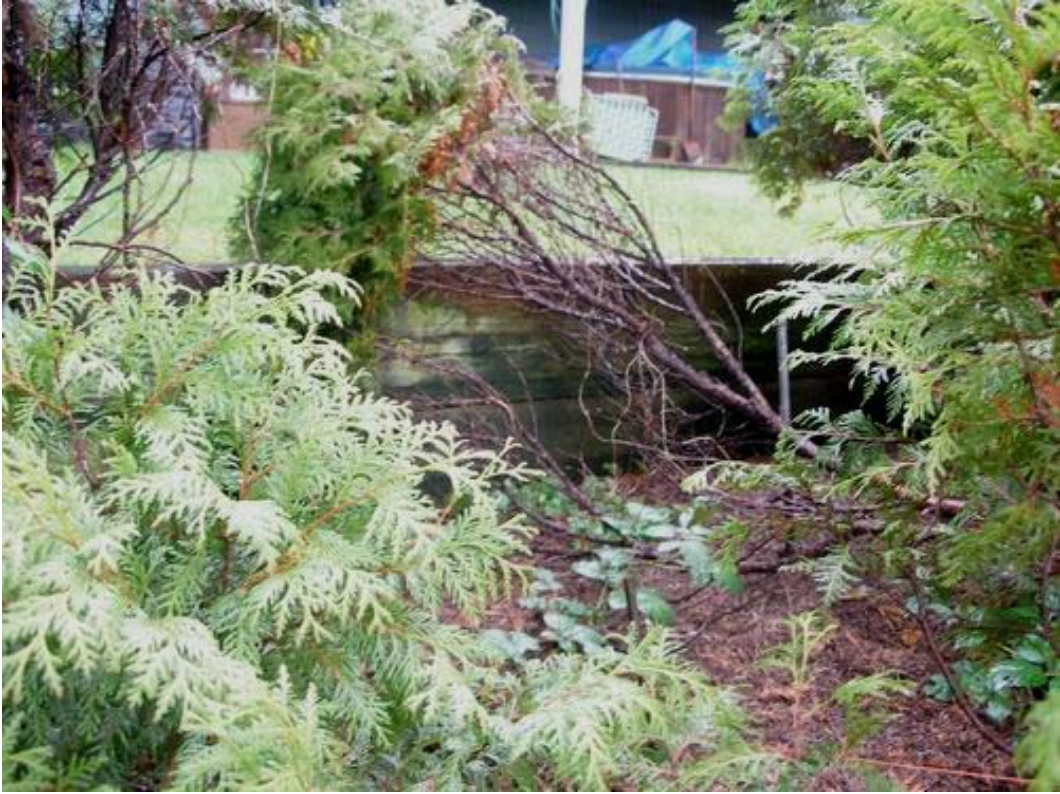
RETAINING STRUCTURES	YES <input checked="" type="checkbox"/>	NO	HEIGHT= 0.60 m
TYPE	BLOCKS	CONCRETE	TIMBER CRIB
DEFORMATION	UNDEFORMED <input checked="" type="checkbox"/>	CRACKED	SETTLED
OBSERVATIONS: No evidence of deformation.

Figure 3. 1775 Layton Drive – Timber retaining wall
