SITE OBSERVATION FORM: DNV Landslide Risk Assessment
LOCATION: 1797 Layton Drive
INSPECTION DATE: (mm/dd/yy) 11/01/05
WEATHER: Heavy rain, heavy rain for several days prior to visit.

SITE OBSERVATION FORM: DNV Landslide Risk Assessment
LOCATION: 1815 Layton Drive
INSPECTION DATE: (mm/dd/yy) 11/01/05
WEATHER: Raining, heavy rain for several days prior to visit.

Project : DNV Landslide Risk Assessment

Project No. : 0404-002-01

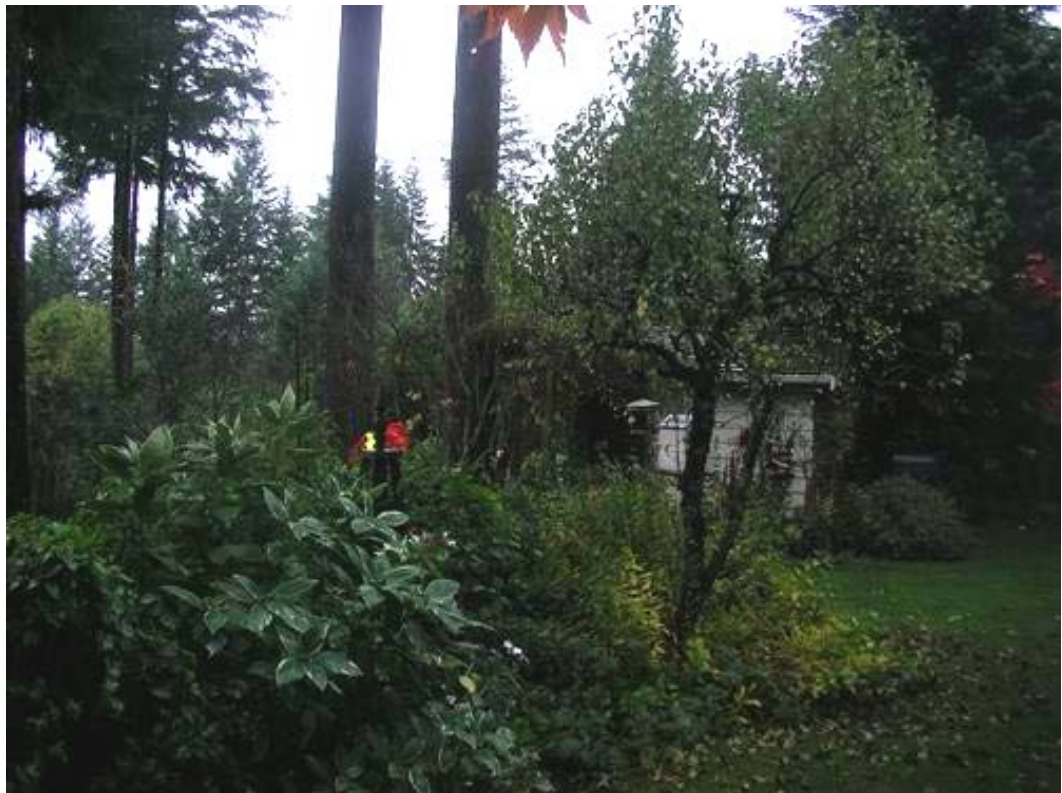
- GENERAL OBSERVATIONS**
- Slope heavily vegetated with blackberries.
 - Slope appears steeper on western edge of property.
 - Back 2-3 m of yard dips gently toward crest of slope.
 - Studio/shed is 2 m from crest of slope.

Figure 2. 1797 Layton Drive – View looking west from backyard towards crest

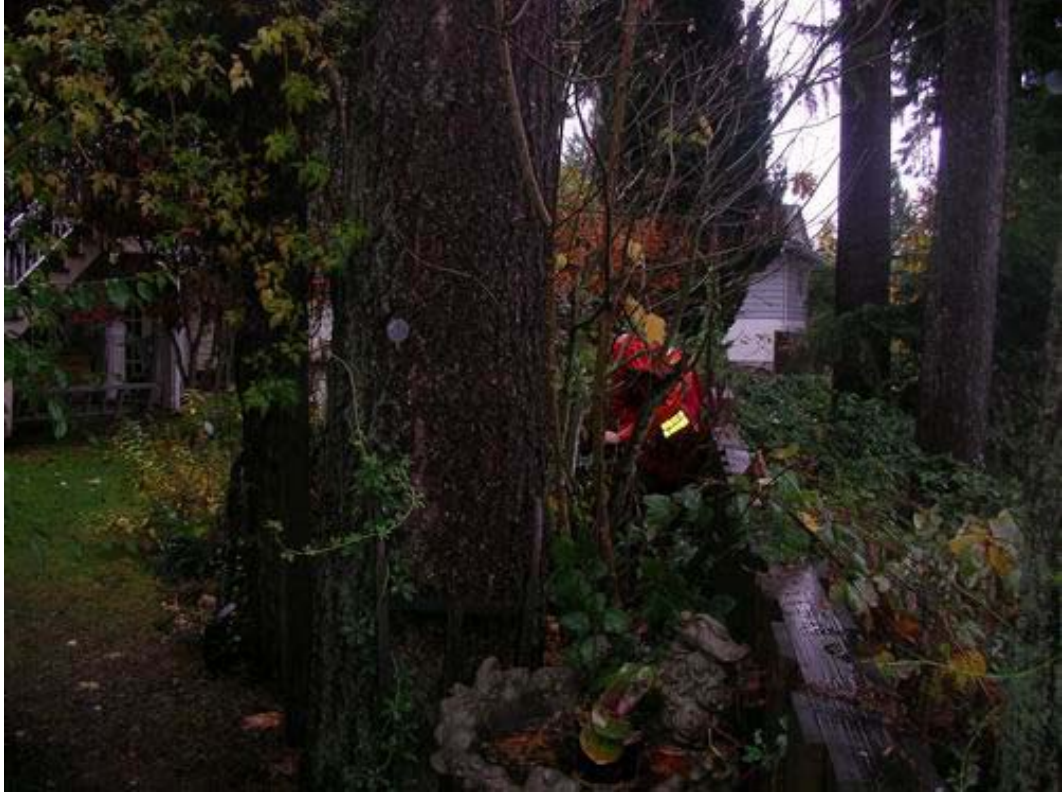
SLOPE BELOW FENCE/ RETAINING STRUCTURE	SLOPE = 45-47°		
	CRACKS	SLIDES	EROSION
OBSERVATIONS: No evidence of slope deformation. Slope angles taken on the western edge of the property.

TREES BELOW FENCE/ RETAINING STRUCTURE	STRAIGHT	PISTOL-BUTT	LEANING
PERCENT CONIFER: 60%	<input checked="" type="checkbox"/>		
OBSERVATIONS: Trees at crest are generally straight, some trees are slightly swayed.

Figure 3. 1797 Layton Drive – View looking SE along fence/crestline

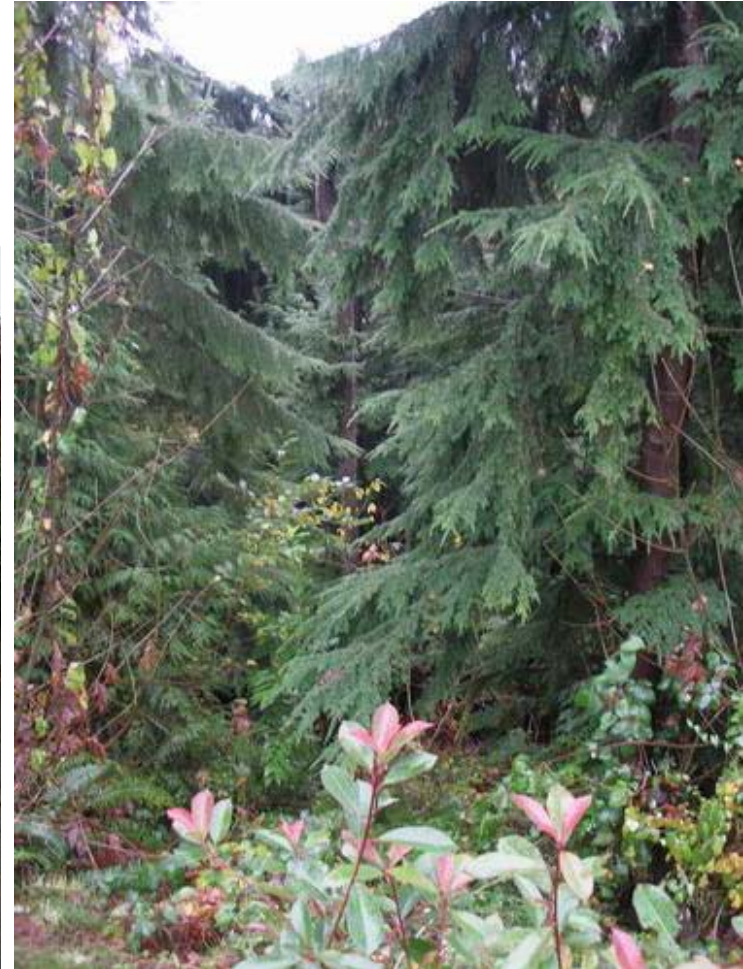
SLOPE BELOW FENCE/ RETAINING STRUCTURE	SLOPE = 33°		
	CRACKS	SLIDES	EROSION
OBSERVATIONS: No evidence of slope deformation. Occupant in the process of building deck that will straddle the crest of the slope and level with the lawn.

- A concrete retaining wall is at lawn level
- A 20 cm high crib wall is located 2-3 m downslope from concrete wall
- An old concrete wall (20 cm high) is located 2 m downslope from the cribwall
- Fallen trees (old) placed across slope held in place with stumps.

Figure 2. 1815 Layton Drive – View looking SW downslope from crest

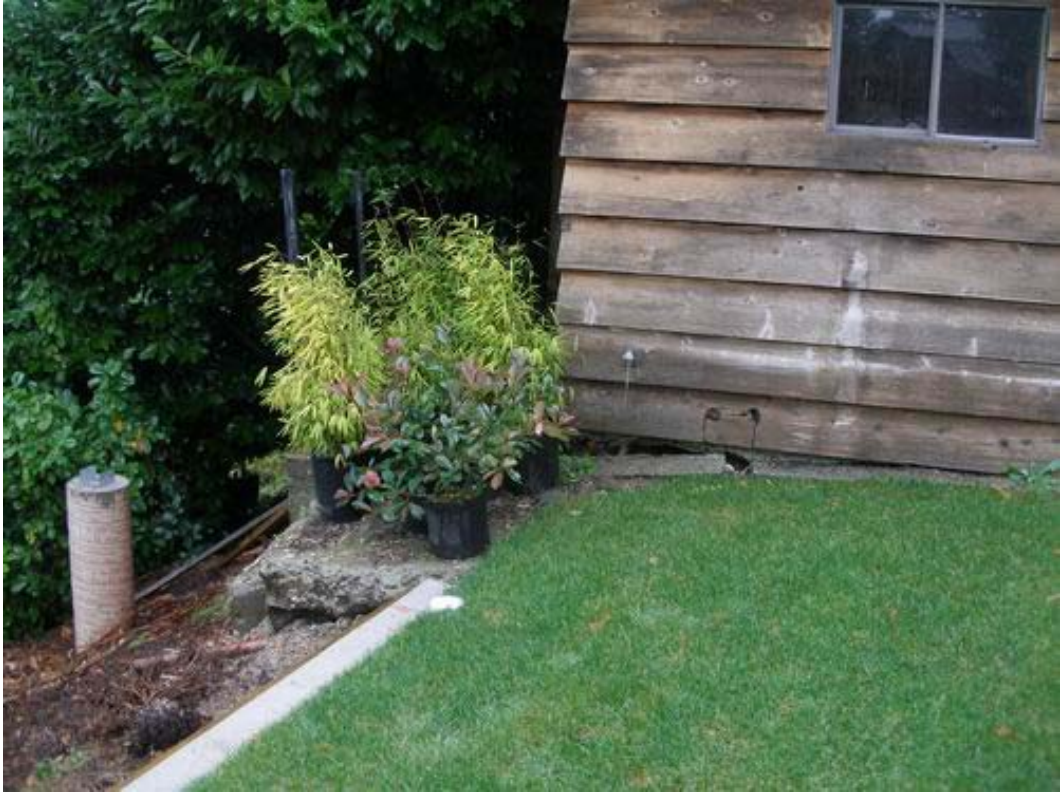
DEFORMATION IN BACKYARD	YES <input checked="" type="checkbox"/>	NO
LOCATION: West corner of backyard.		
DESCRIPTION: Some slumping and settlement occurring underneath a small shed.

Figure 3. 1815 Layton Drive – Slumping underneath a shed on the NW side of the backyard

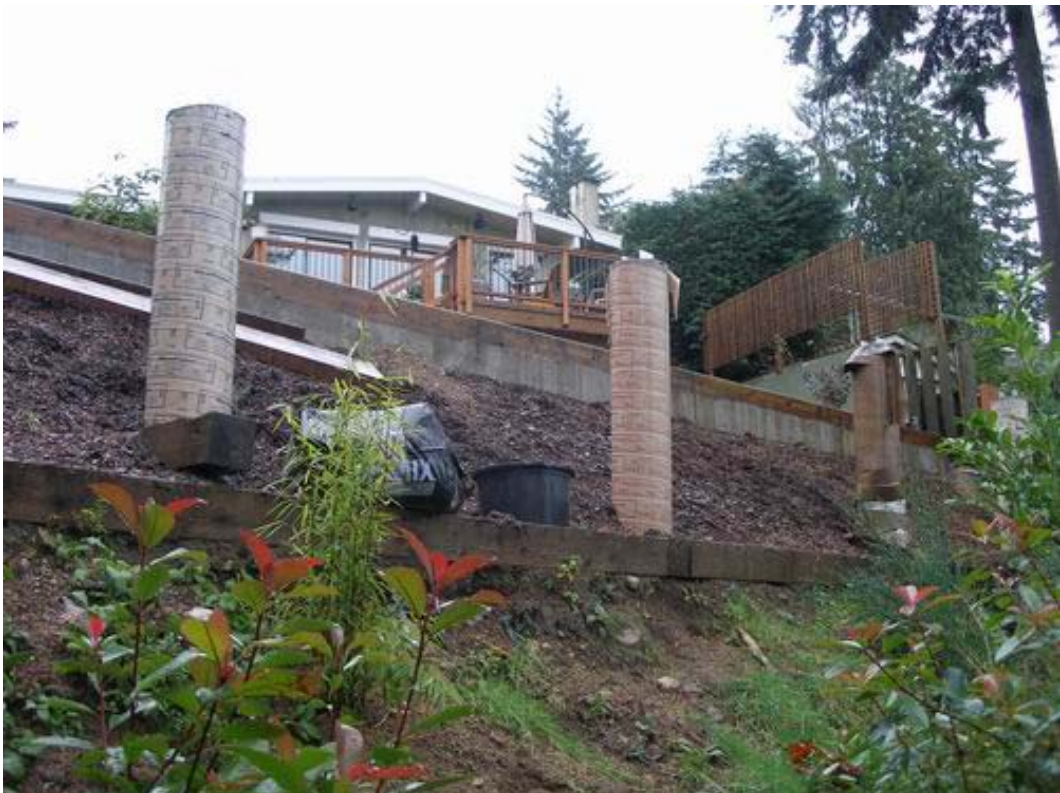
RETAINING STRUCTURES	YES <input checked="" type="checkbox"/>	NO	HEIGHT= 0.70 m
TYPE	BLOCKS	CONCRETE	TIMBER CRIB
DEFORMATION	UNDEFORMED	CRACKED	SETTLED
OBSERVATIONS: No evidence of deformation, wall appears to be newly built. Concrete wall at crest, concrete posts for deck and timber wall downslope form concrete wall.

Figure 4. 1815 Layton Drive – View of retaining wall and in-progress construction from west side of property
