SITE OBSERVATION FORM: DNV Landslide Risk Assessment
LOCATION: 2391 Carman Place
INSPECTION DATE: (mm/dd/yy) 10/31/05
WEATHER: Raining heavily, heavy rain for several days prior to visit.

Project : DNV Landslide Risk Assessment

Project No. : 0404-002-01

Client: District of North Vancouver

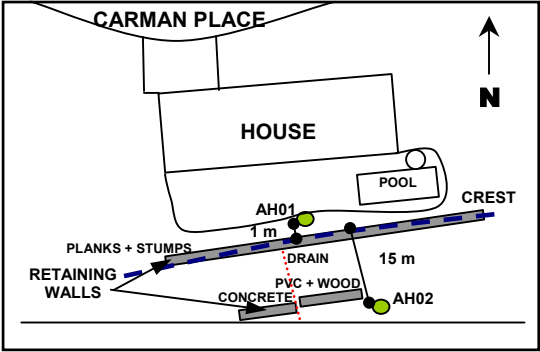
DEFORMATION IN BACKYARD	YES <input checked="" type="checkbox"/>	NO
LOCATION: Patio around pool near crest of slope.		
DESCRIPTION: Tilted patio (cement blocks) around pool on down slope side of pool.

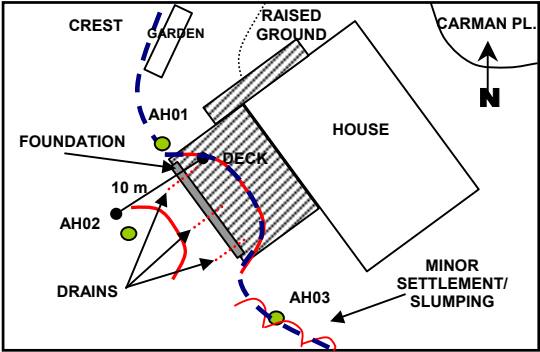
DEFORMATION IN BACKYARD	YES <input checked="" type="checkbox"/>	NO
LOCATION: South west corner of property on lawn at crest of slope.		
DESCRIPTION: Minor slumping or settlement.

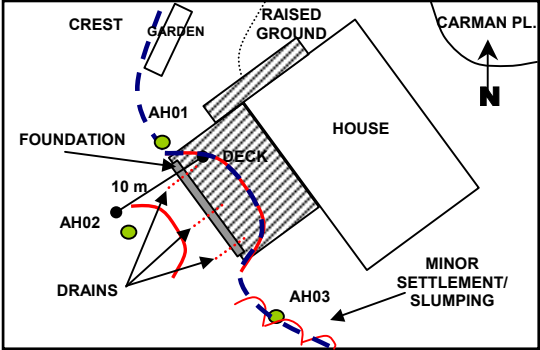
DEFORMATION IN BACKYARD	YES <input checked="" type="checkbox"/>	NO
LOCATION: South west corner of property on lawn at crest of slope.		
DESCRIPTION: Minor slumping or settlement.

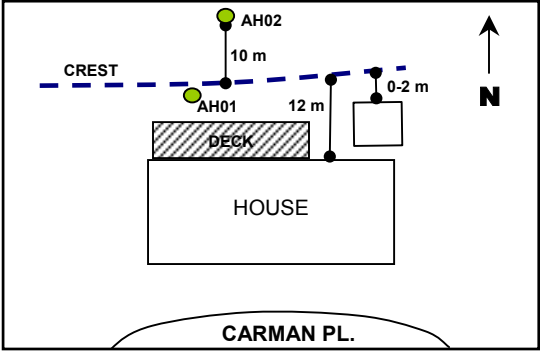
DEFORMATION IN BACKYARD	YES <input checked="" type="checkbox"/>	NO
LOCATION: Centre of backyard.		
DESCRIPTION: Minor localized settlement.
