SITE OBSERVATION FORM: DNV Landslide Risk Assessment
LOCATION: 1839 Layton Drive
INSPECTION DATE: (mm/dd/yy) 10/31/05
WEATHER: Raining, heavy rain for several days prior to visit.

Project : DNV Landslide Risk Assessment

Project No. : 0404-002-01

Client: District of North Vancouver

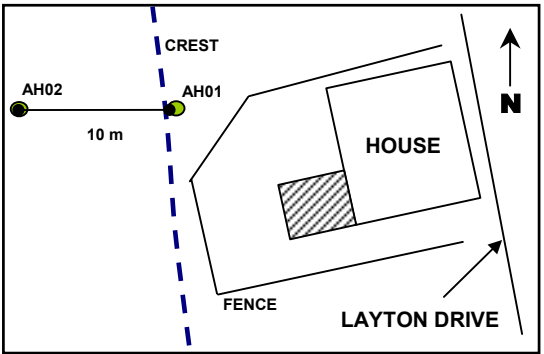
DEFORMATION IN BACKYARD	YES	NO <input checked="" type="checkbox"/>
LOCATION: None		
DESCRIPTION: None observed

HOUSE DISTANCE TO CREST = 20-25 m

- Oversteepening at crest of slope due to loose, organic compost deposit
- 25m from crest (downslope) 1m vertical outcrop of Sand (SP) med-coarse sand, also found @ 1.2m in downslope hole
- Appears to be very little fill in backyard for levelling purposes

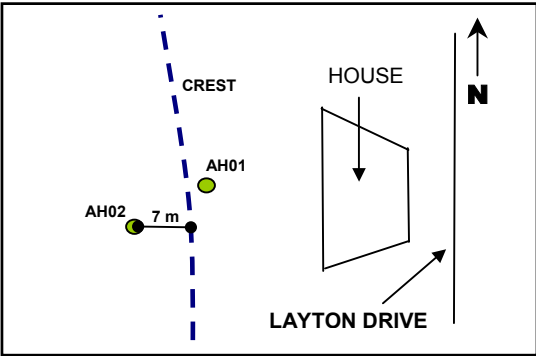
DEFORMATION IN BACKYARD	YES <input checked="" type="checkbox"/>	NO
LOCATION: At/near crest		
DESCRIPTION: Some settlement in yard

HOUSE DISTANCE TO CREST = 16 m

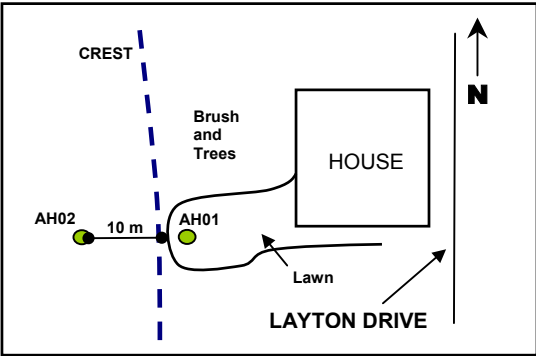
DEFORMATION IN BACKYARD	YES	NO <input checked="" type="checkbox"/>
LOCATION:		
DESCRIPTION: None observed

HOUSE DISTANCE TO CREST = 14 m

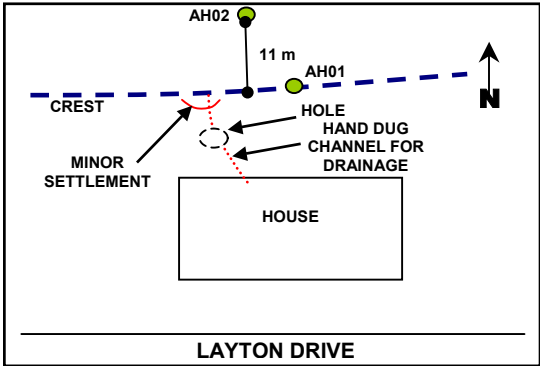
DEFORMATION IN BACKYARD	YES <input checked="" type="checkbox"/>	NO
LOCATION:		
DESCRIPTION:	Minor settlement in northwest corner of property.

POOLS	YES	NO <input checked="" type="checkbox"/>
DESCRIPTION:	There is hole (1.5 m x 2.5 m x 0.30 m) in the lawn that is lined with plastic that is connected to drainage channel. Some water collects here.	
SEEPAGE/ SPRINGS IN OR BELOW FILL	YES	NO <input checked="" type="checkbox"/>
OBSERVATIONS:	None observed.

HOUSE DISTANCE TO CREST = 20 m
