SITE OBSERVATION FORM: DNV Landslide Risk Assessment
LOCATION: Hayseed-Layton Gully
INSPECTION DATE: (mm/dd/yy) 10/28/05
WEATHER: Cloudy with periods of rain

BGC ENGINEERING INC.
 AN APPLIED EARTH SCIENCES COMPANY

Project : DNV Landslide Risk Assessment

Project No. : 0404-002-01

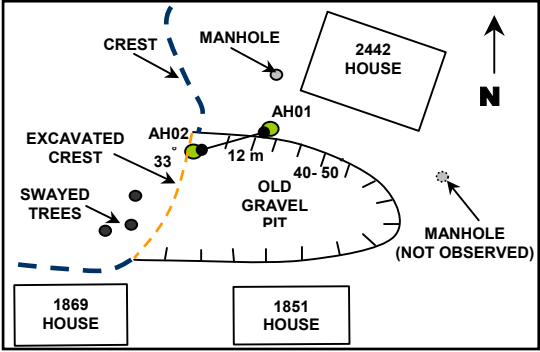
| SLOPE BELOW FENCE/ RETAINING STRUCTURE | SLOPE = 33° | | |
|---|---|---|---|
| OBSERVATIONS: None slope deformation observed. House is 15-16m from the old gravel pit and over 30m to the crest of the slope | | | |

HOUSE DISTANCE TO CREST = 30 m

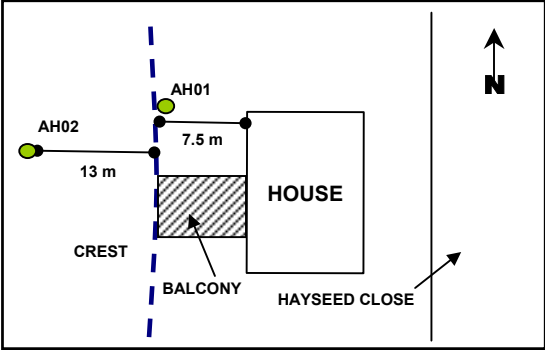
HOUSE DISTANCE TO CREST = 7.5 m

- GENERAL OBSERVATIONS**
- Old septic system exists in backyard
 - Retaining wall consists of 2 steps with a walkway between
 - Thickness of loose materials at crest are estimated since auger hole 1 refused at 0.8m in coarse gravel that was imported for the old septic system

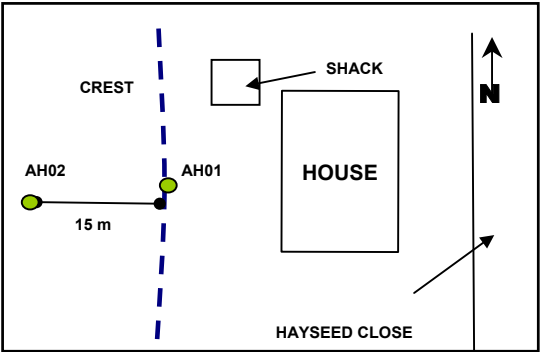
| DESCRIPTION: Backyard dips towards slope. Slight cracks in concrete patio 2 m from house. | | |

HOUSE DISTANCE TO CREST = 9.7 m

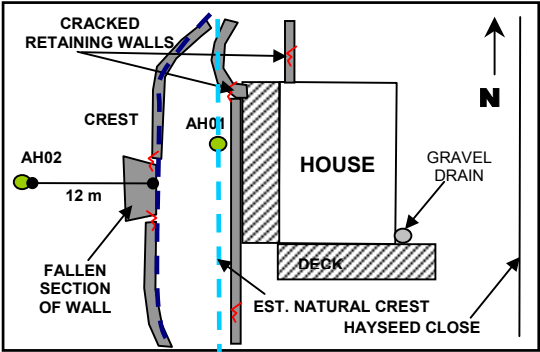
| OBSERVATIONS: 3 terraced retaining walls. All are cracking, leaning or are detached and falling over. | | | |

| <ul style="list-style-type: none"> House distance to landscaped crest/ retaining wall is 10.6 m; House distance to estimated natural crest of slope is 4 m. Boulders and cement from lower retaining wall fallen down slope. Surface erosion below north part of retaining wall. |

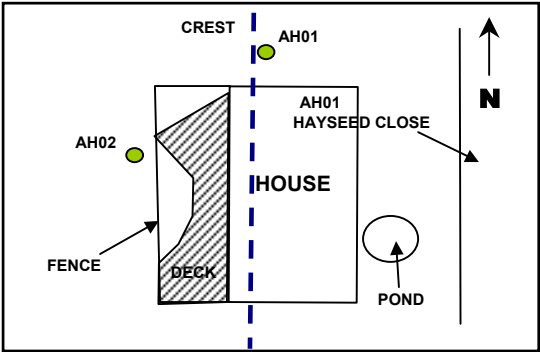
HOUSE DISTANCE TO CREST = 0 m

| <ul style="list-style-type: none"> House built on crest, wood deck overhangs crest of slope. Two drainage pipes collect water off the north end of the house and drain below the sundeck Thicknesses of loose materials are estimated since auger holes 1 and 2 reached maximum depths of 0.75m and 0.95m respectively. Both holes refused on gravels in loose materials. |

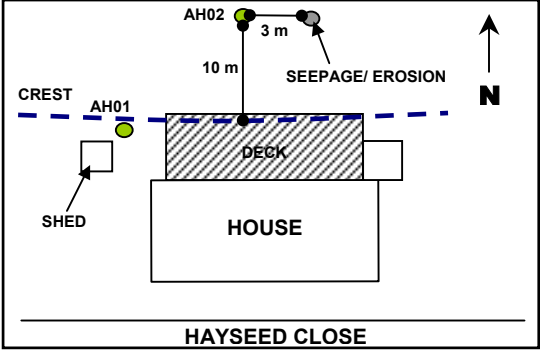
- Sundeck support posts being replaced (evidence of work in progress).
- Patio/deck built at crest of slope.
- Slope thickly vegetated; fallen trees observed.

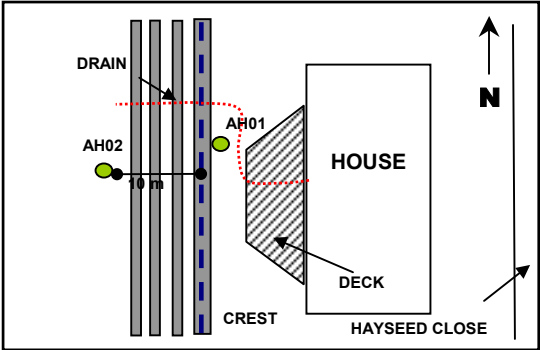
HOUSE DISTANCE TO CREST = 5.4 m

| <ul style="list-style-type: none"> House is 5.4 m from crest of retaining wall and 2.5-3 m from the original crest line as estimated by neighbours yards. Drainage pipe runs from roof, through backyard fill and out near the base of the retaining wall, but not all roof drains are connected Chicken wire holding gravely material behind retaining walls between timbers in upper sections of wall |

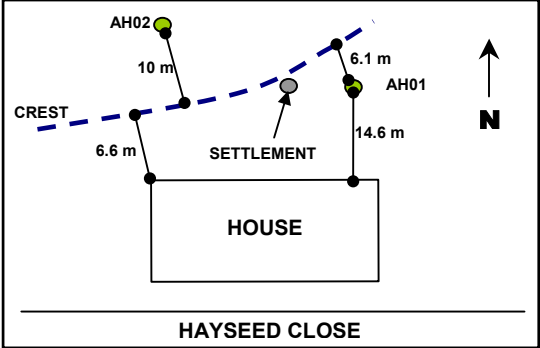
| DESCRIPTION: Settling in backyard at top of retaining structure. | | |

| <ul style="list-style-type: none"> Owner noted slight slumping of soil behind wood/brick retaining wall on east side of backyard within last couple of days Owner notes that 3 trees on west side of backyard fell 10 years ago during a heavy storm Bricks/ logs and pieces of asphalt lying on slope |
