SITE OBSERVATION FORM: DNV Landslide Risk Assessment
LOCATION: 2125 Berkley Avenue
INSPECTION DATE: (mm/dd/yy) 10/27/05
WEATHER: Sunny, clear skies, no rain 1 day prior, heavy rain 2 days prior to visit.

BGC ENGINEERING INC.
 AN APPLIED EARTH SCIENCES COMPANY

Project : DNV Landslide Risk Assessment

Project No. : 0404-002-01

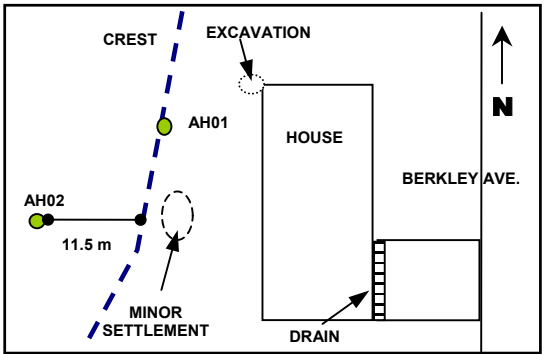
| DEFORMATION IN BACKYARD | YES <input checked="" type="checkbox"/> | NO |
| LOCATION: Backyard | | |
| DESCRIPTION: Very minor settlement. | | |

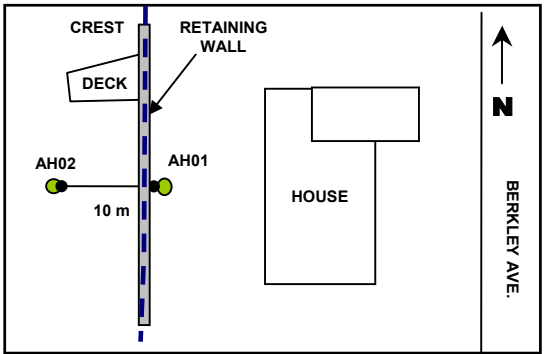
| RETAINING STRUCTURES | YES <input checked="" type="checkbox"/> | NO | HEIGHT= 1.60 m |
|---|--|---|---|
| OBSERVATIONS: Wall spans width of yard. A sun deck extends down slope from the wall structure. No deformation observed. | | | |

| DEFORMATION IN BACKYARD | YES | NO <input checked="" type="checkbox"/> |
|---|---|--|
| DESCRIPTION: Backyard gently slopes toward sundeck. | | |

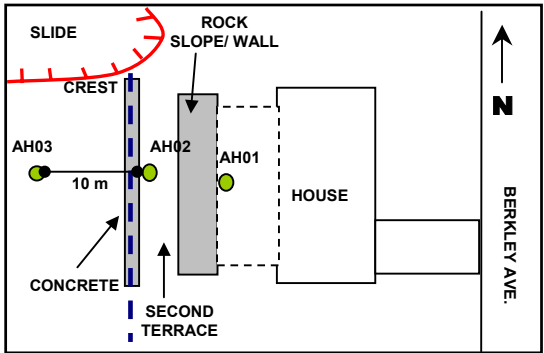
| SEEPAGE/ SPRINGS IN OR BELOW FILL | YES | NO <input checked="" type="checkbox"/> |
| OBSERVATIONS: None observed. | | |

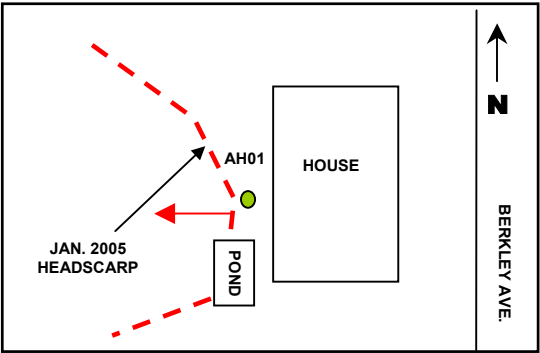
| LOCATION: Backyard | | |
| DESCRIPTION: Site of January 2005 slide. | | |
