**SITE OBSERVATION FORM:** DNV Landslide Risk Assessment  
**LOCATION:** 2191 Berkley Avenue  
**INSPECTION DATE:** (mm/dd/yy) 10/26/05  
**WEATHER:** Sunny, clear skies, no rain 1 day prior, heavy rain 2 days prior to visit.

**Project :** DNV Landslide Risk Assessment

**Project No. :** 0404-002-01

*Client: District of North Vancouver*

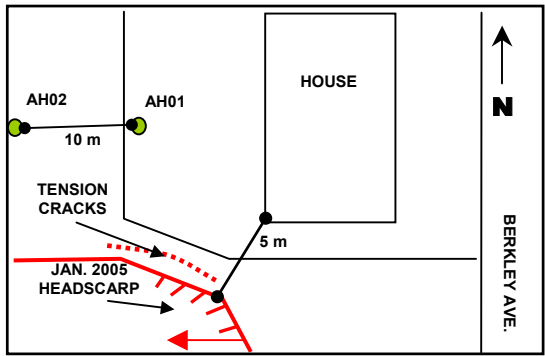
RETAINING STRUCTURES	YES <input checked="" type="checkbox"/>	NO	HEIGHT= 0.5 m
TYPE	CONCRETE <input checked="" type="checkbox"/>	TIMBER CRIB	OTHER:
DEFORMATION	CRACKED <input checked="" type="checkbox"/>	SETTLED <input checked="" type="checkbox"/>	BULGING
<b>OBSERVATIONS:</b> Slightly cracked, bulging slightly. Tilted, rotating at base approximately 20°.

DEFORMATION IN BACKYARD	YES <input checked="" type="checkbox"/>	NO
LOCATION: South side of backyard at fence line.		
DESCRIPTION: Surficial tension cracks near January 2005 slide site.

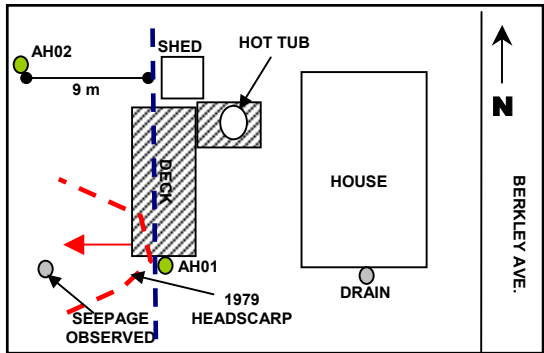
SEEPAGE/ SPRINGS IN OR BELOW FILL	YES <input checked="" type="checkbox"/>	NO
<b>OBSERVATIONS:</b> Seepage (visibly flowing) observed in scarp. Appears to come from above the Glaciomarine sediments that are exposed in scarp. May be an old drain, as mentioned in Klohn 1980 report.

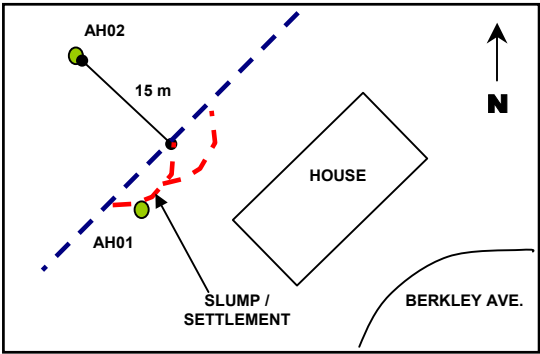
<b>DEFORMATION IN BACKYARD</b>	YES <input checked="" type="checkbox"/>	NO
<b>LOCATION:</b> Backyard		
<b>DESCRIPTION:</b> Slumping observed near crest of slope.
