SITE OBSERVATION FORM: DNV Landslide Risk Assessment
LOCATION: 2307 Berkley Avenue
INSPECTION DATE: (mm/dd/yy) 11/09/05
WEATHER: Raining, heavy rain for several days prior to visit.

BGC ENGINEERING INC.
 AN APPLIED EARTH SCIENCES COMPANY

Project : DNV Landslide Risk Assessment

Project No. : 0404-002-01

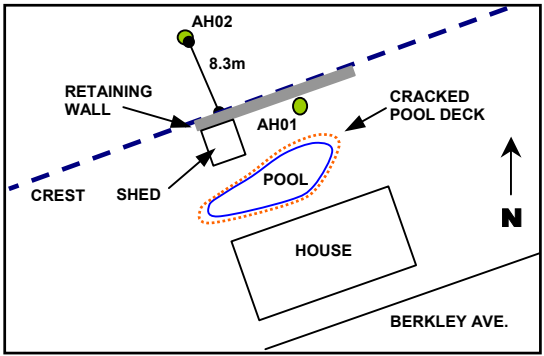
| POOLS | YES <input checked="" type="checkbox"/> | NO |
|--|---|---|
| DESCRIPTION: Settlement around pool, cracked pool deck | | |

- Oversteepening of slope at west side of crest due to compost deposit
- Slope below property is not visible due to very dense shrubs

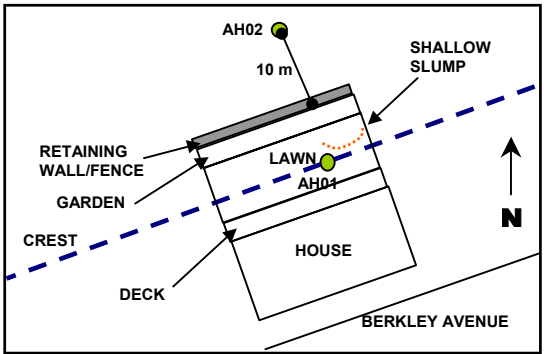
HOUSE DISTANCE TO CREST = 5.3 m

| SEEPAGE/ SPRINGS IN OR BELOW FILL | YES <input checked="" type="checkbox"/> | NO |
|--|---|---|
| OBSERVATIONS: Evidence of minor seepage 10 m down slope. | | |

- Crest of slope begins 5.3 m from house in middle of backyard

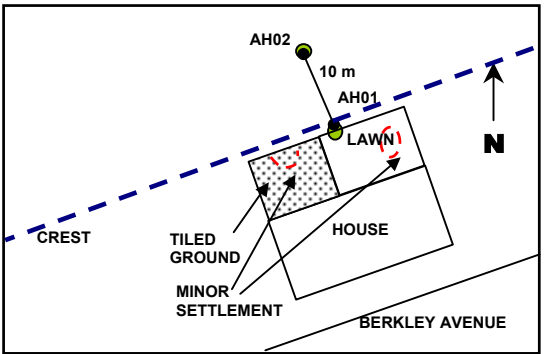
HOUSE DISTANCE TO CREST = 16 m

| DEFORMATION IN BACKYARD | YES | NO <input checked="" type="checkbox"/> |
|--|---|--|
| DESCRIPTION: Minor localized settlement near house (<10 cm). | | |

- Water dripping from deck causes lawn to be saturated near house.
- Minor settlement in tiles by garden and lawn by house.
- Compost and garden waste deposited on crest and behind fence.

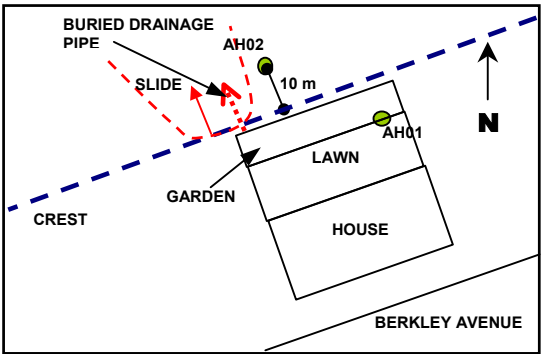
HOUSE DISTANCE TO CREST = 12.8 m

| SEEPAGE/ SPRINGS IN OR BELOW FILL | YES <input checked="" type="checkbox"/> | NO |
|--|---|---|
| OBSERVATIONS: Buried pipe empties a considerable amount of water onto slope | | |

- A high-flow drainage pipe empties on to top of slope at south end of yard.
- Site of a recent landslide between 2363 and 2349 Berkley Road.
- Balcony to crest distance is 9.8 m
