**SITE OBSERVATION FORM:** DNV Landslide Risk Assessment  
**LOCATION:** 2377 Berkley Avenue  
**INSPECTION DATE:** (mm/dd/yy) 11/10/05  
**WEATHER:** Raining, heavy rain for several days prior to visit.

**Project :** DNV Landslide Risk Assessment

**Project No. :** 0404-002-01

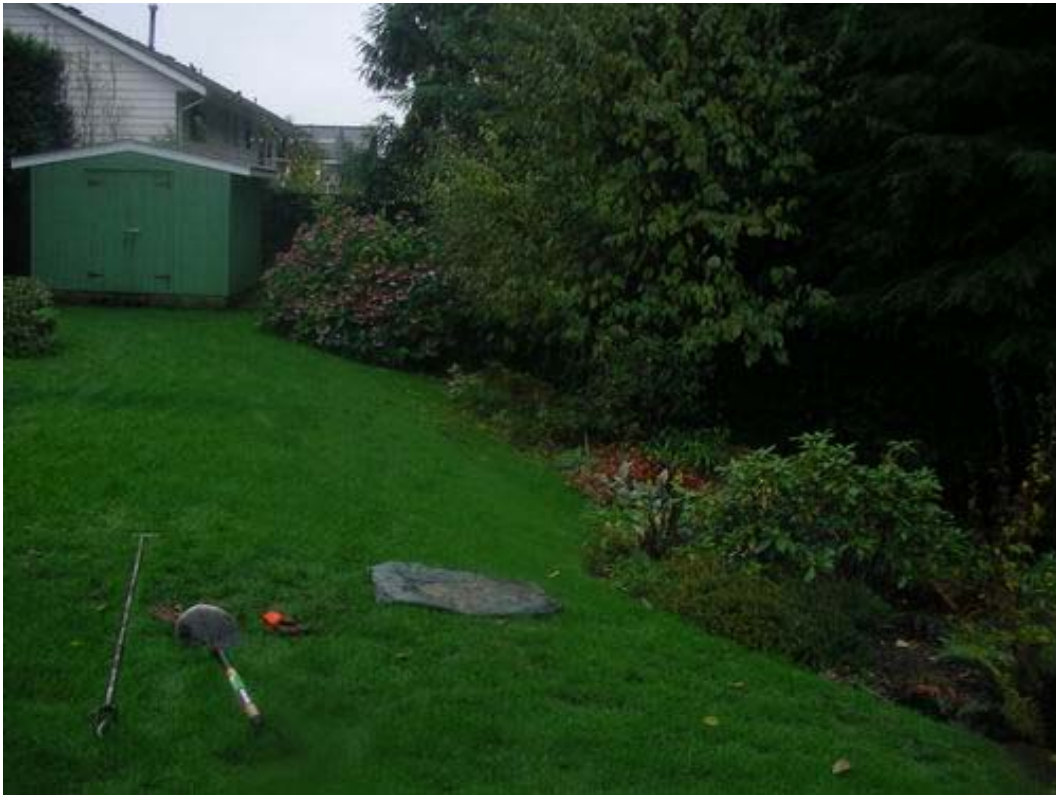
Figure 3. 2377 Berkley Avenue – View looking south along crest

<b>SLOPE BELOW FENCE/ RETAINING STRUCTURE</b>	SLOPE = 43° upper 15m of slope, 36° below 15m		
	CRACKS	SLIDES	EROSION
		<input checked="" type="checkbox"/>	
<b>OBSERVATIONS:</b> North side of the slope is adjacent to site of 1999 slide. Gully at south side of slope appears to be an 8 m wide, old scarp.

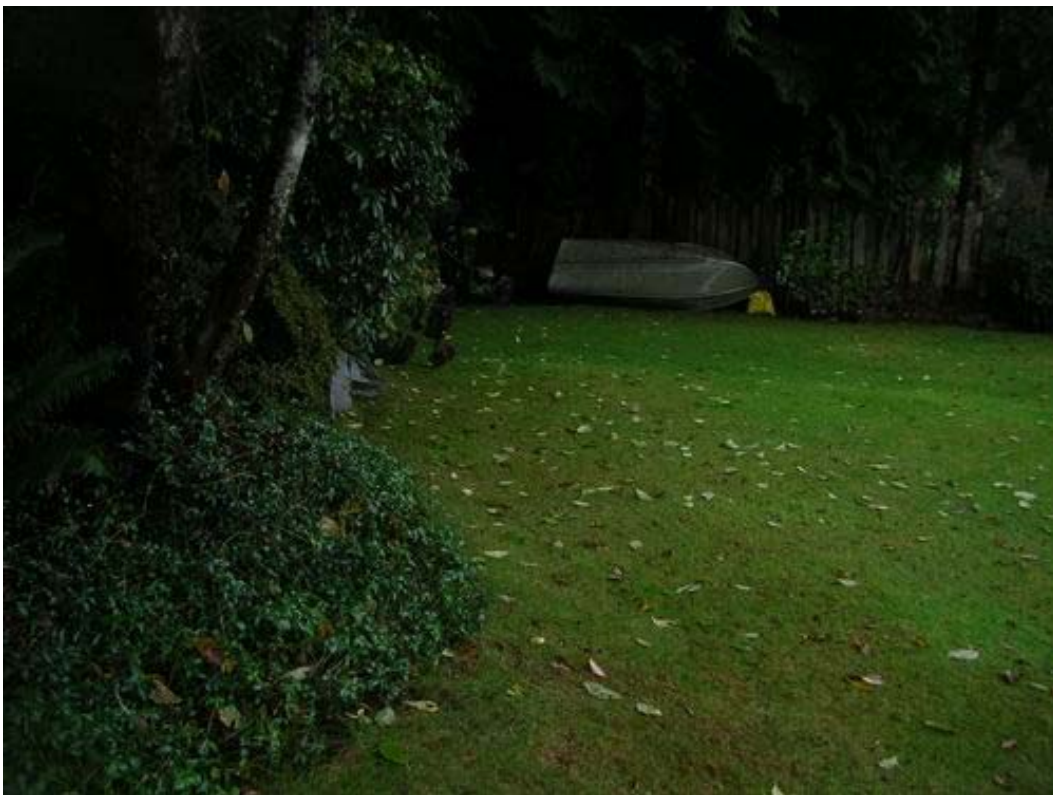
Figure 2. 2409 Berkley Avenue – View looking north along crest

<b>SLOPE BELOW FENCE/ RETAINING STRUCTURE</b>	SLOPE = 22° from crest to 15m down slope, 37° below 15m		
	CRACKS	SLIDES	EROSION
	<input checked="" type="checkbox"/>		
OBSERVATIONS: Evidence of slumping just below crest.

- Large area excavated for basement access. Timber crib retaining walls and block walls hold up backyard around the access. Lowest part of excavation is 3 m lower than backyard level.
- Slump blocks found just below crest

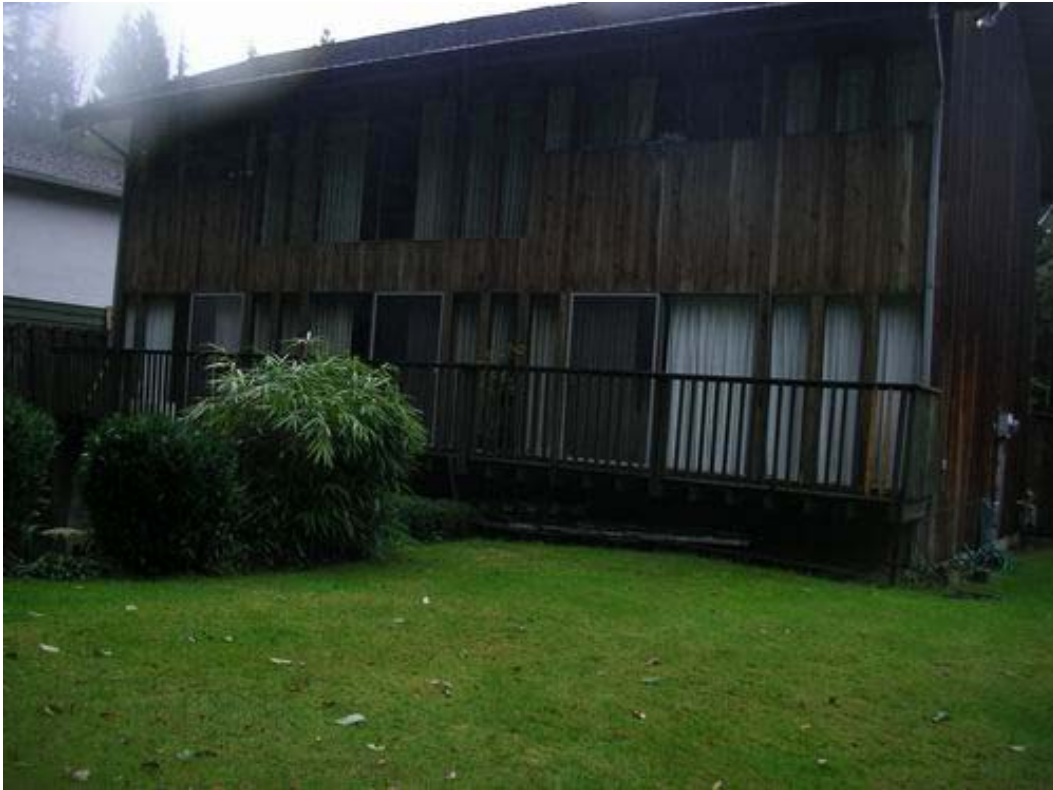
Figure 3. 2409 Berkley Avenue – View of backyard

<b>DEFORMATION IN BACKYARD</b>	YES <input checked="" type="checkbox"/>	NO
LOCATION: backyard		
DESCRIPTION: Minor differential settlement. Small linear depression runs from basement garden stairs to crest.
