SITE OBSERVATION FORM: DNV Landslide Risk Assessment
LOCATION: 1231 Lennox Street
INSPECTION DATE: (mm/dd/yy) 11/04/05
WEATHER: Raining, heavy rain for several days prior to visit.

Project : DNV Landslide Risk Assessment

Project No. : 0404-002-01

Client: District of North Vancouver

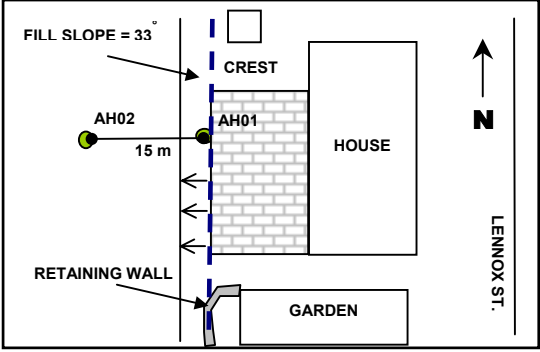
RETAINING STRUCTURES	YES <input checked="" type="checkbox"/>	NO	HEIGHT= 2.0 m
TYPE	BLOCKS <input checked="" type="checkbox"/>	CONCRETE <input checked="" type="checkbox"/>	TIMBER CRIB
DEFORMATION	UNDEFORMED	CRACKED	SETTLED
			BULGING <input checked="" type="checkbox"/>
OBSERVATIONS: No mortar used to construct the concrete block wall located at south end of backyard. Young trees are leaning at base.

- Patio is level, owners note there has been no change in the last 50 years.
- Possible failure scarp in gully at north property boundary with adjacent property.
- Property flattens out approximately 50 m down slope.

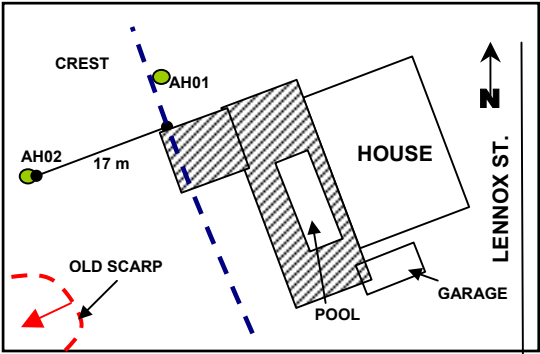
SLOPE BELOW FENCE/ RETAINING STRUCTURE	SLOPE = 45° to 15m downslope, 42° below 15m		
	CRACKS	SLIDES	EROSION
		<input checked="" type="checkbox"/>	
OBSERVATIONS: Appears to be an old slide scarp that has partially re-vegetated (55%). Deciduous trees present around the scarp. No other slope deformation observed due to dense groundcover.

- The elevated deck is built on and over the crest.
- Old slide site approx. 20 m down slope from the crest.
- Part of retaining wall from adjacent house runs onto this property.

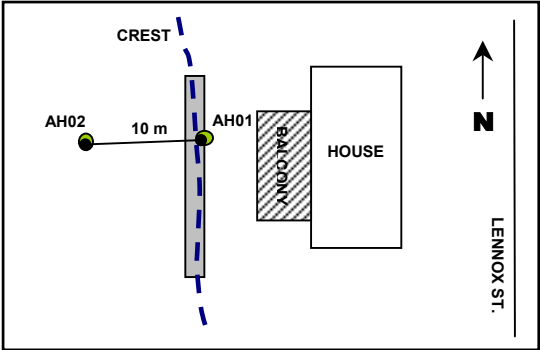
SLOPE BELOW FENCE/ RETAINING STRUCTURE	SLOPE = 40°		
	CRACKS	SLIDES	EROSION
		<input checked="" type="checkbox"/>	<input checked="" type="checkbox"/>
OBSERVATIONS: Minor erosion. Small slide above AH02. 40' from crest of slope to 10 m down slope, 35' from 10 m down slope to bottom. Possible oversteepening.

RETAINING STRUCTURES	YES <input checked="" type="checkbox"/>	NO	HEIGHT= 0.70 m
TYPE	BLOCKS	CONCRETE	TIMBER CRIB
DEFORMATION	UNDEFORMED	CRACKED	SETTLED
			BULGING
OBSERVATIONS: Structure collapsing.

- House distance to crest measurement is to retaining wall. Balcony foundation is 3.5 m from retaining wall.
- Natural slope crest appears to be closer to the house (4 m).

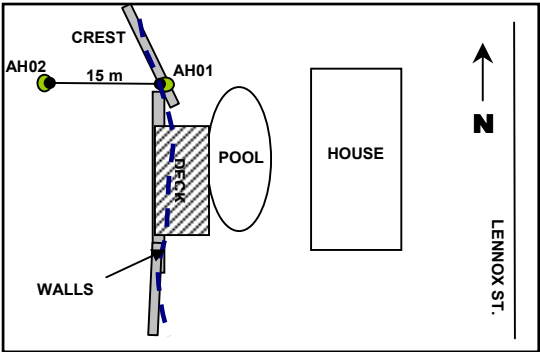
RETAINING STRUCTURES	YES <input checked="" type="checkbox"/>	NO	HEIGHT= 3.3 m
TYPE	BLOCKS	CONCRETE	TIMBER CRIB
DEFORMATION	UNDEFORMED	CRACKED	SETTLED
			BULGING
OBSERVATIONS: Many generations of retaining structures, some tilting, mainly built with timber cribbing with stones. Main retaining wall is concrete. Complicated system of steps, timbers and retaining walls down slope. Timber crib is bulging and cracking.

DEFORMATION IN BACKYARD	YES <input checked="" type="checkbox"/>	NO
LOCATION: Backyard		
DESCRIPTION: Backyard dips toward crest of slope.

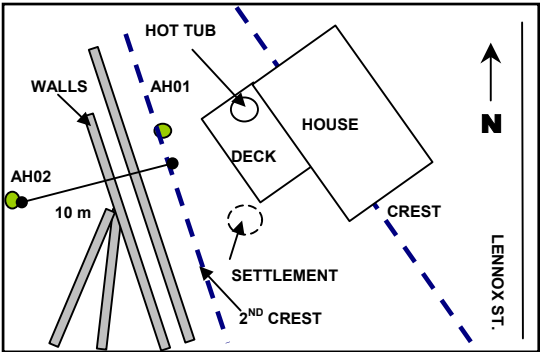
RETAINING STRUCTURES	YES <input checked="" type="checkbox"/>	NO	HEIGHT= 0.3 – 1.5 m
TYPE	CONCRETE	TIMBER CRIB	OTHER:
DEFORMATION	UNDEFORMED <input checked="" type="checkbox"/>	CRACKED	BULGING
OBSERVATIONS: 4 terraces ranging in height; walls increase with height down slope. Total height = 5 m. Top wall (0.30 m high) is slightly tilted.

DEFORMATION IN BACKYARD	YES <input checked="" type="checkbox"/>	NO
LOCATION: Backyard lawn.		
DESCRIPTION: Lawn is hummocky and there is a depression in the centre that may have been from a septic tank. Appears to be settlement along the crest of slope.

- GENERAL OBSERVATIONS**
- Sprinkler system in back yard.
 - Two crests, one beneath the house and the second in the back yard. All auger holes are referenced to the second crest.
 - Surficial slumping and erosion down slope; silty colluvium, potentially an old slide path on south side of slope.
