SITE OBSERVATION FORM: DNV Landslide Risk Assessment
LOCATION: 1535 Lennox Street
INSPECTION DATE: (mm/dd/yy) 11/03/05
WEATHER: Rain, heavy rain for several days prior to visit.

Project : DNV Landslide Risk Assessment

Project No. : 0404-002-01

Client: District of North Vancouver

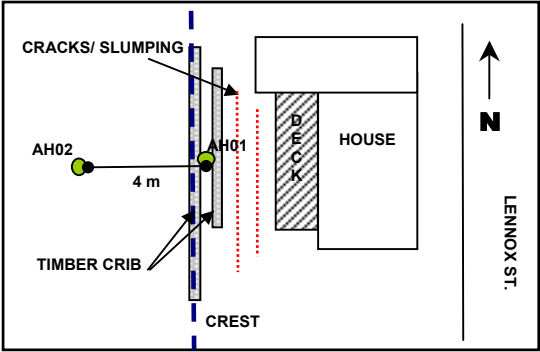
THICKNESS OF LOOSE MATERIALS	<1 m	1-2 m	2-3 m	>3 m
FENCE LINE			<input checked="" type="checkbox"/>	
4 m DOWNSLOPE FROM SLOPE CREST		<input checked="" type="checkbox"/>

SLOPE BELOW FENCE/ RETAINING STRUCTURE	SLOPE = 39°		
	CRACKS	SLIDES	EROSION
OBSERVATIONS: Loose organic material on surface of slope (branches and leaves).

TREES BELOW FENCE/ RETAINING STRUCTURE	STRAIGHT	PISTOL-BUTT	LEANING
PERCENT CONIFER: 50%			<input checked="" type="checkbox"/>
OBSERVATIONS: Leaning tree at crest immediately below the crib wall. Some leaning trees observed, however generally straight.

RETAINING STRUCTURES	YES <input checked="" type="checkbox"/>	NO	HEIGHT= 1.90 m
TYPE	BLOCKS CONCRETE	TIMBER CRIB	OTHER:
DEFORMATION	UNDEFORMED	CRACKED	BULGING
OBSERVATIONS: A small crib wall by patio is slumping. Bulging wall down slope is breaking apart. Wall being pressed against a tree at the crest causing the tree to lean.

DEFORMATION IN BACKYARD	YES <input checked="" type="checkbox"/>	NO
LOCATION: Immediately behind crib wall.		
DESCRIPTION: Backyard is settling, and slumping in the down slope direction. Displacement on large crack is approximately 40 cm.

HOUSE DISTANCE TO CREST = 3.2 m

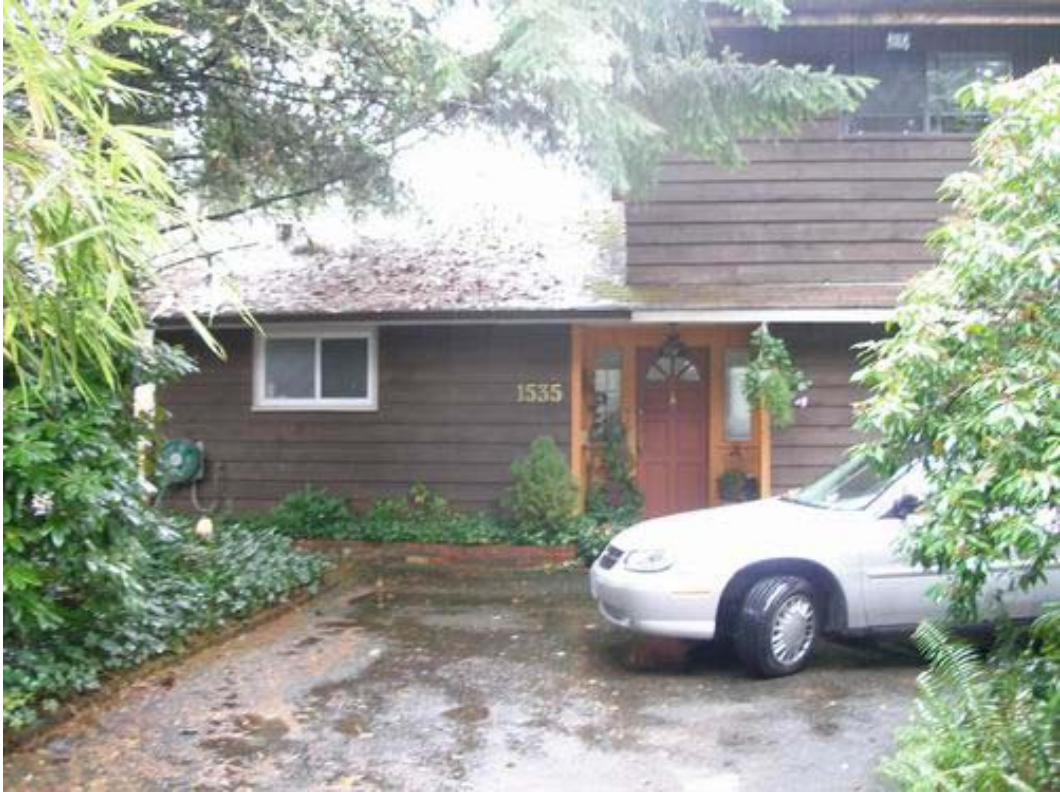
Figure 1. 1535 Lennox Street – Front of the house

- House is 3.2 m from the crest at the closest point.
- Corrugated pipe runs onto slope at the south edge of the property.
- A concrete block wall between this yard and the neighbouring property (1557) is cracked and tilted down slope.

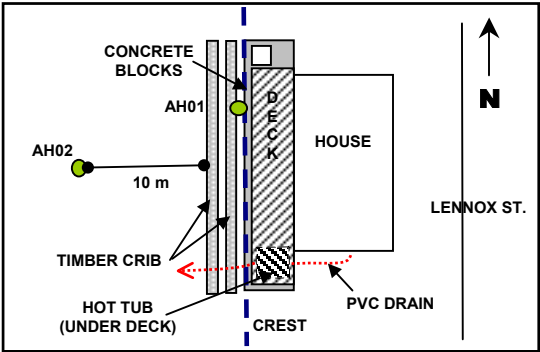
SLOPE BELOW FENCE/ RETAINING STRUCTURE	SLOPE = 35°		
	CRACKS	SLIDES	EROSION
			<input checked="" type="checkbox"/>
OBSERVATIONS: Slope wash observed. Assorted rubbish and roof tiles below slope crest. Large granite boulder, ~1.5 m diameter, adjacent to second auger hole.

RETAINING STRUCTURES	YES <input checked="" type="checkbox"/>	NO	HEIGHT= 0.75-1.5 m
TYPE	CONCRETE <input checked="" type="checkbox"/>	TIMBER CRIB <input checked="" type="checkbox"/>	OTHER:
DEFORMATION	UNDEFORMED <input checked="" type="checkbox"/>	CRACKED <input checked="" type="checkbox"/>	BULGING
OBSERVATIONS: 3 retaining walls on slope. Lowest wall is timber crib (0.75 m high) and undeformed. Middle retaining wall is 1.5m high with concrete patio on top (covered by brush), appears competent, undeformed except for top 0.5 m near trail access (leaning 10° down slope). Top retaining wall is 1.5 m high concrete blocks and mortar, beneath deck, cracking observed beneath deck and at south east corner of property.

DEFORMATION IN BACKYARD	YES <input checked="" type="checkbox"/>	NO
LOCATION:		
DESCRIPTION:	Entire backyard is covered by deck and concrete retaining wall. Cracking observed in concrete retaining wall.

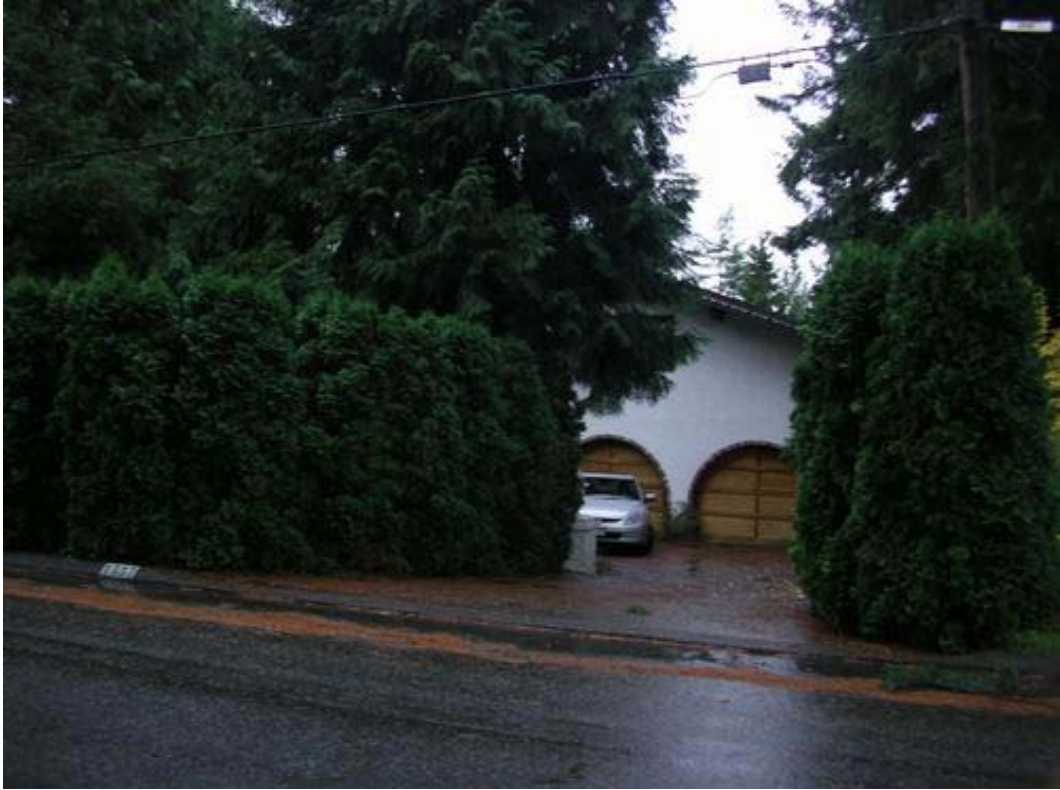
Figure 1. 1557 Lennox Street – Front of the house

- Owner reports that this site has been monitored by a geotechnical engineer
- Various cracks (maximum displacement approx. 5 cm) were observed in upper retaining wall below wood deck.

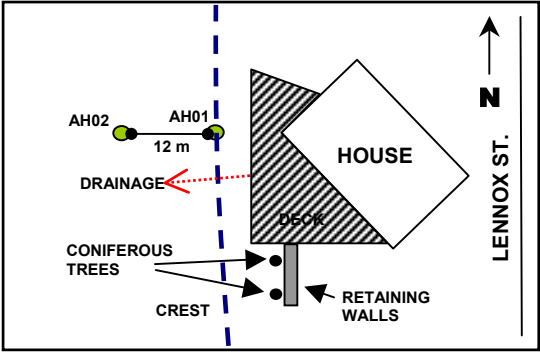
SLOPE BELOW FENCE/ RETAINING STRUCTURE	SLOPE = 35° to 36°		
	CRACKS	SLIDES	EROSION
OBSERVATIONS: No slope deformation was observed. Slope is heavily vegetated.

RETAINING STRUCTURES	YES <input checked="" type="checkbox"/>	NO	HEIGHT = 2.0 m
TYPE	CONCRETE <input checked="" type="checkbox"/>	TIMBER CRIB <input checked="" type="checkbox"/>	OTHER:
DEFORMATION	UNDEFORMED <input checked="" type="checkbox"/>	CRACKED <input checked="" type="checkbox"/>	BULGING
OBSERVATIONS: Retaining wall at south end of property consists of 3 adjacent parts: 2m high timber crib, 0.5m high cinder blocks, 0.75m high stone and mortar segment. All parts are slightly cracked but are somewhat supported by two 2' diameter straight conifers.

DEFORMATION IN BACKYARD	YES	NO <input checked="" type="checkbox"/>
LOCATION:		
DESCRIPTION: None observed. Backyard almost completely occupied by deck.

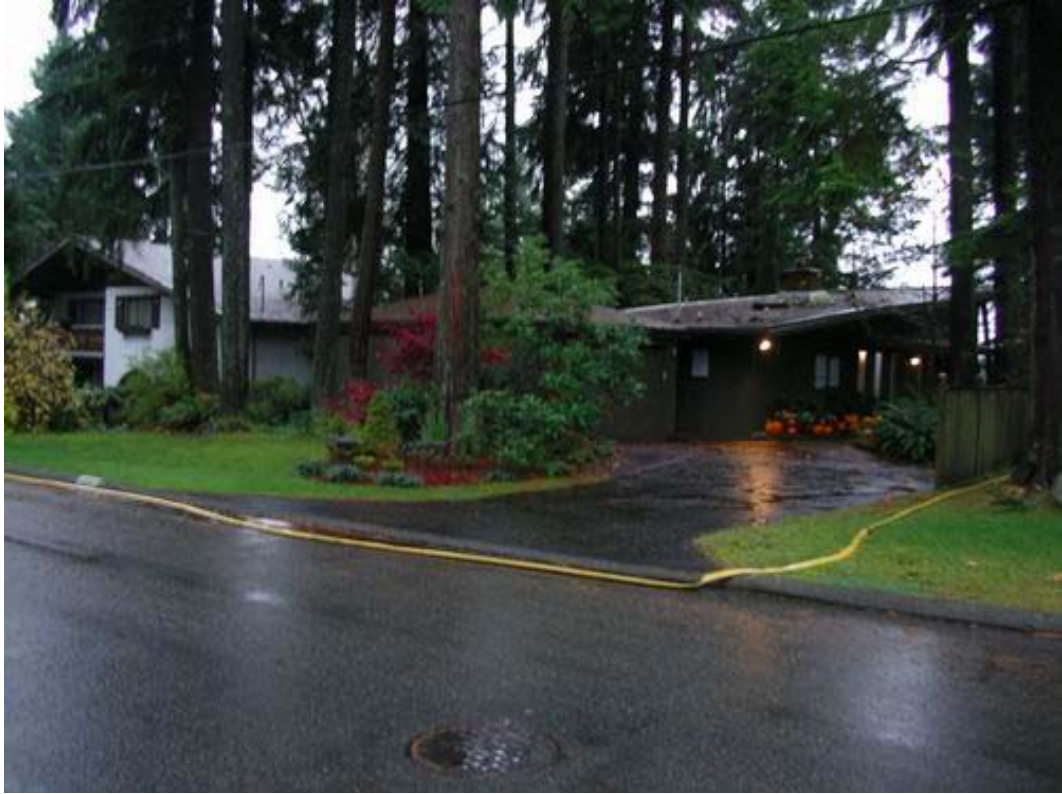
Figure 1. 1583 Lennox Street – Front of the house

- Large conifers support the retaining wall.
- Retaining walls support garden and not house.

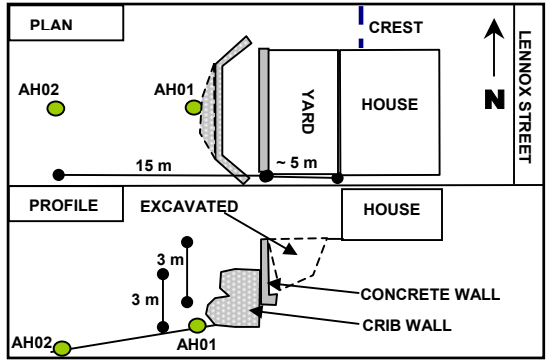
RETAINING STRUCTURES	YES <input checked="" type="checkbox"/>	NO	HEIGHT= 3 m concrete; 3 m timber
TYPE	CONCRETE <input checked="" type="checkbox"/>	TIMBER CRIB <input checked="" type="checkbox"/>	OTHER: <input checked="" type="checkbox"/>
DEFORMATION	UNDEFORMED <input checked="" type="checkbox"/>	CRACKED <input checked="" type="checkbox"/>	SETTLED <input checked="" type="checkbox"/>
OBSERVATIONS: Concrete and timber crib walls overlap by 1.5 m. Concrete wall is constructed with concrete blocks above the timber crib wall. Concrete wall is cracking in several places. Timber crib wall is bulging (1 m horizontal bulge from original placement).

DEFORMATION IN BACKYARD	YES <input checked="" type="checkbox"/>	NO
LOCATION: Backyard above concrete block wall.		
DESCRIPTION: Slumping observed in the down slope direction.

SEEPAGE/ SPRINGS IN OR BELOW FILL	YES <input checked="" type="checkbox"/>	NO
OBSERVATIONS: Seepage through the timber crib wall observed.

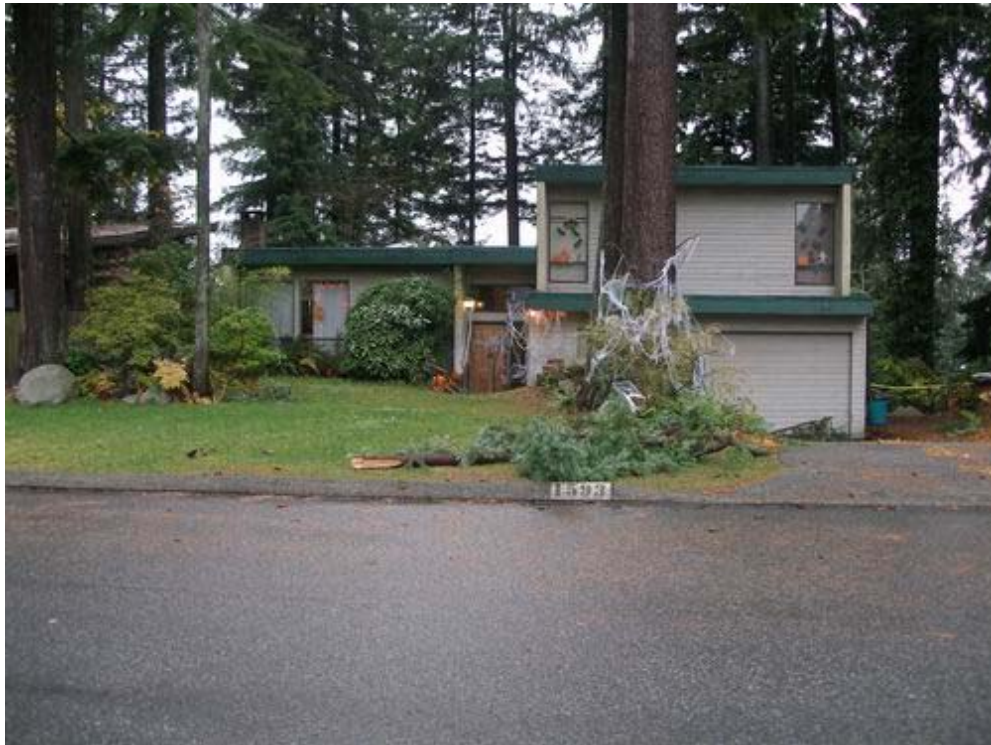
Figure 1. 1593 Lennox Street - Front of the house

- House is constructed on the crest of the slope at west side of property.
- DNV geotech. eng. Brian Thompson has been working at this site; dug test pits.
- Backyard is fill behind concrete retaining wall; most of fill was removed after Jan. 2005 event; patio tiles dipping down slope
