SITE OBSERVATION FORM: DNV Landslide Risk Assessment
LOCATION: 2402 Swinburne Avenue
INSPECTION DATE: (mm/dd/yy) 11/02/05
WEATHER: Rain, heavy rain for several days prior to visit.

SITE OBSERVATION FORM: DNV Landslide Risk Assessment
LOCATION: 2410 Swinburne Avenue
INSPECTION DATE: (mm/dd/yy) 11/02/05
WEATHER: Raining, heavy rain for several days prior to visit.

SITE OBSERVATION FORM: DNV Landslide Risk Assessment
LOCATION: 2414 Swinburne Avenue
INSPECTION DATE: (mm/dd/yy) 11/02/05
WEATHER: Light rain, heavy rain for several days prior to visit.

Client: District of North Vancouver

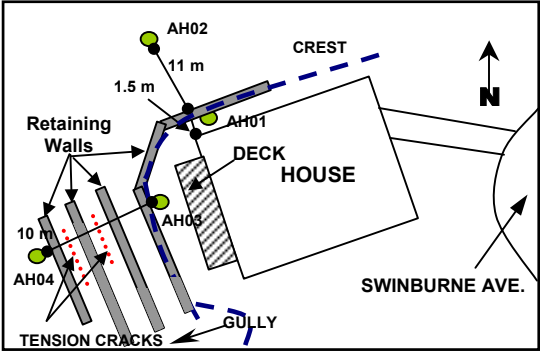
| SEEPAGE/ SPRINGS IN OR BELOW FILL | YES | NO <input checked="" type="checkbox"/> |
|---|---|--|
| OBSERVATIONS: None observed. | | |

HOUSE DISTANCE TO CREST = 1.5 m

- The timber cribbing at the lowest terrace level on the southeast side of the property is failing.
- Gully located on south side of property.

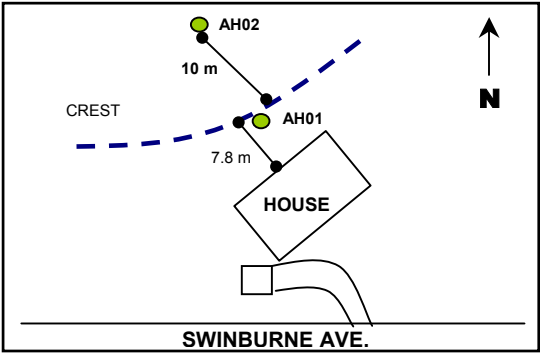
| DEFORMATION IN BACKYARD | YES | NO <input checked="" type="checkbox"/> |
|---|---|--|
| DESCRIPTION: | None observed. | |

| POOLS | YES | NO <input checked="" type="checkbox"/> |
|---|--|--|
| DESCRIPTION: | Owner noted that there was an old pond somewhere in the vicinity of his home and filled in when house was built; location uncertain. | |

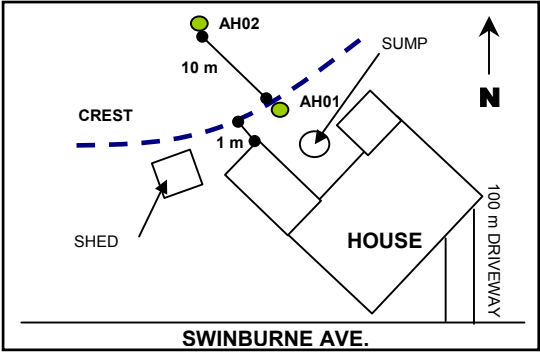
| DEFORMATION IN BACKYARD | YES | NO <input checked="" type="checkbox"/> |
|---|---|--|
| DESCRIPTION: | No backyard. Some possible slumping steps at crest. | |
