SITE OBSERVATION FORM: DNV Landslide Risk Assessment
LOCATION: 1677 Layton Drive
INSPECTION DATE: (mm/dd/yy) 11/02/05
WEATHER: Raining, heavy rain for several days prior to visit.

Project : DNV Landslide Risk Assessment

Project No. : 0404-002-01

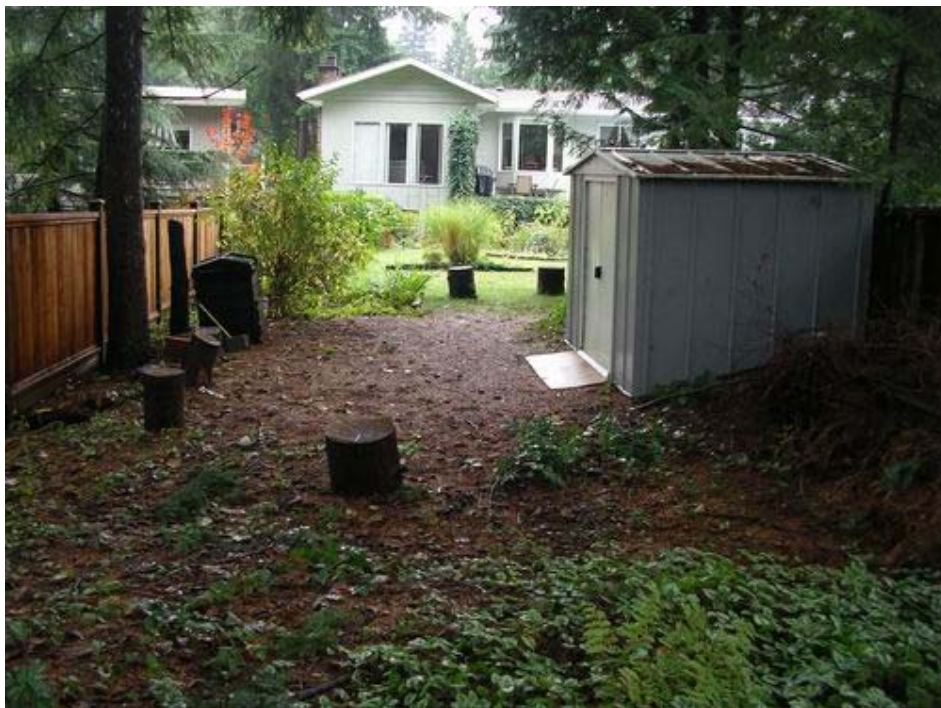
Figure 3. 1677 Layton Drive – View looking NE towards house from crest

- House is a long distance from the crest of the slope; Fill extends over the slope
- Slope is steep below the crest and appears to be oversteepened by compost and mulch that have been placed over the edge.
- Evidence of slope movement activity observed along property line with adjacent property to the south. 30 cm settlement above headscarp.

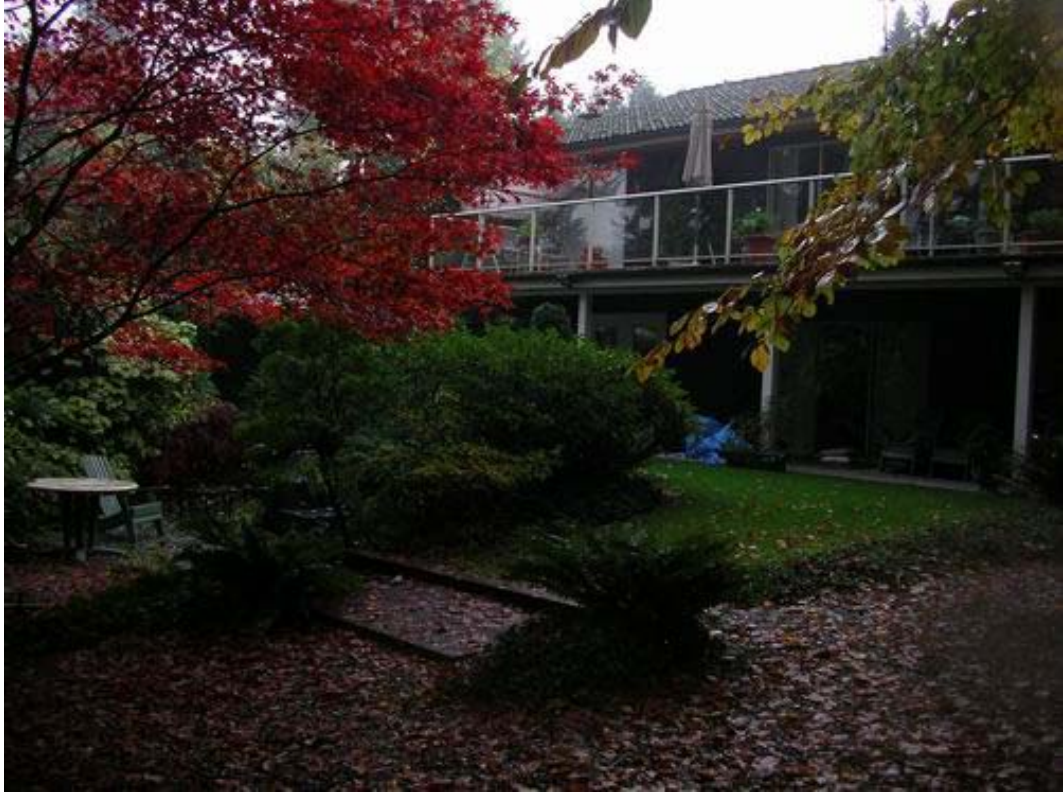
Figure 3. 1709 Layton Drive – View looking north towards house from backyard

- Landscaping makes it difficult to see any natural settlement.
- Slope crest at south end of property appears to be an old scarp.

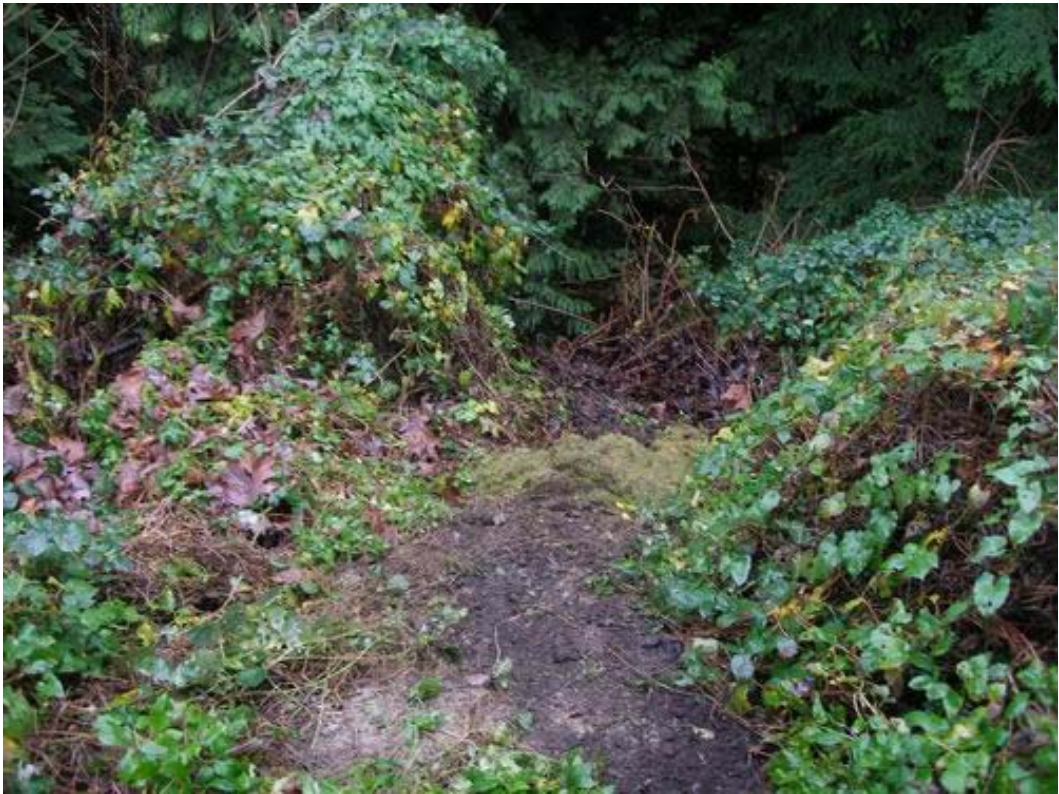
Figure 2. 1731 Layton Drive – View downslope looking SW

- GENERAL OBSERVATIONS**
- Owner notes that he constantly jacks up his deck to keep it level. Footing is located on down slope side of crest. Owner estimated that the deck settles 2" per year.
 - House does not have a basement below ground level.
 - Compost thrown over crest.

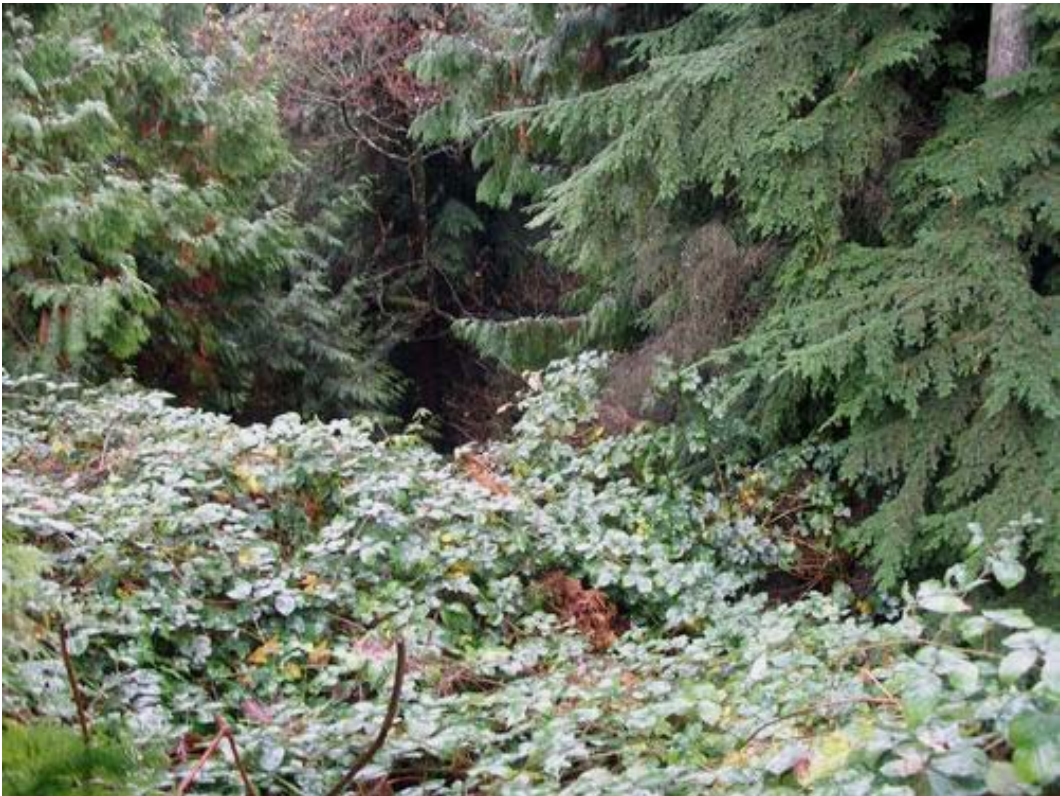
Figure 2. 1775 Layton Drive – View looking SW downslope from crest

SLOPE BELOW FENCE/ RETAINING STRUCTURE	SLOPE = 37°		
	CRACKS	SLIDES	EROSION
OBSERVATIONS: No evidence of slope deformation.
